September 30, 2005
J.N. 173-05

Subject: Preliminary Geotechnical Investigation of the Ferrocarril Landslide, City of Mission Viejo, California.

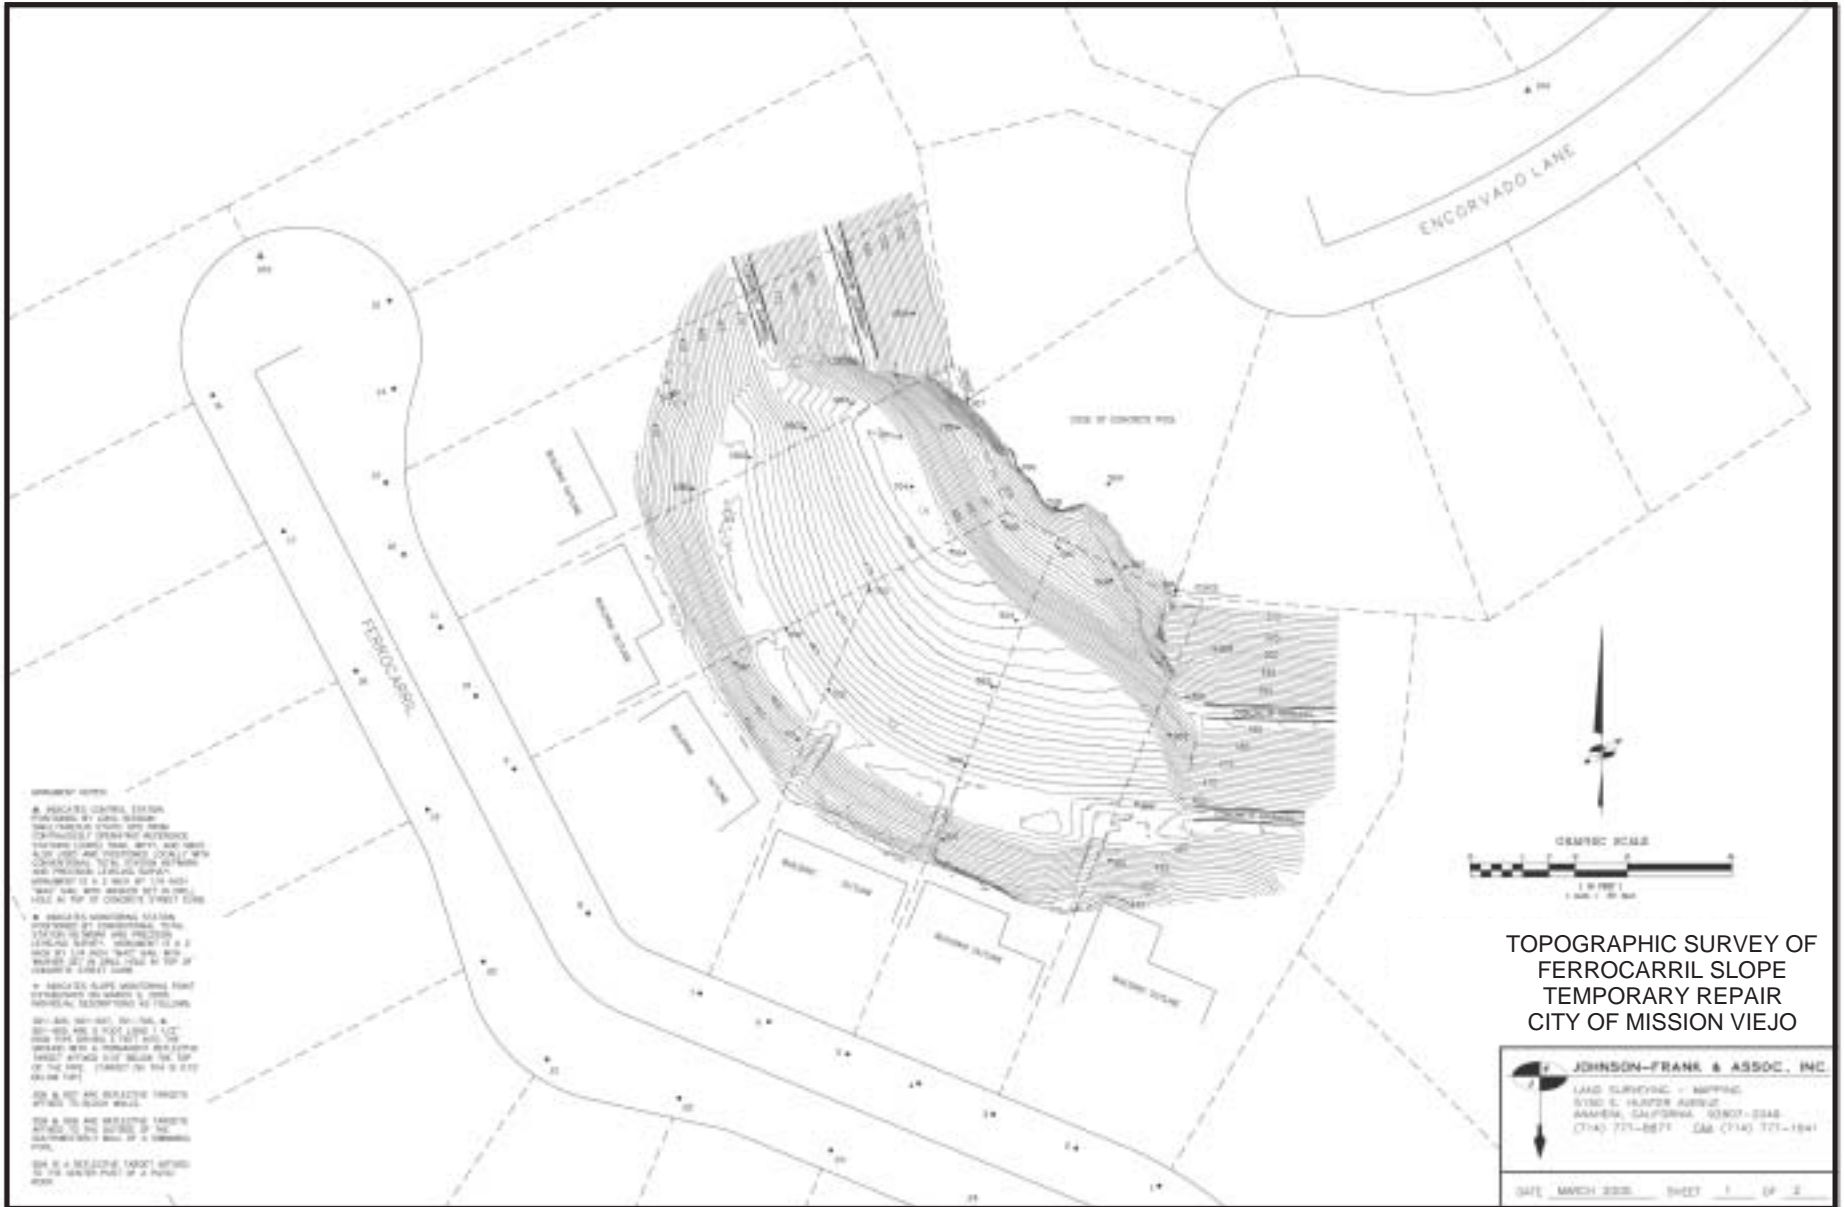
SURVEY MONITORING SYSTEM

In order to determine the effectiveness of the temporarily stabilization, a survey monitoring program was implemented by Johnson – Frank & Associates, Inc. under contract to the City. Figure 3 shows the location of the survey monuments established as part of the monitoring program. Regular measurements of these monuments indicate that the temporarily stabilized slope is moving an equivalent of about 1/8-inch per day, which is much less than the 2 to 4 inches per day measured during failure. Both vertical and horizontal movements were recorded as part of the survey monitoring program. Between March 3, 2005 and July 7, 2005, vertical and horizontal movements of over one foot were measured within the slope. As anticipated, a vertical movement of about one foot occurred in the upper portions of the slope in the graben area. Vertical movements on other portions of the slope were minimal. Horizontal movements of about one foot occurred over most of the central and lower portions of the slope from about 24452 through 24492 Ferrocarril. This movement indicates that the

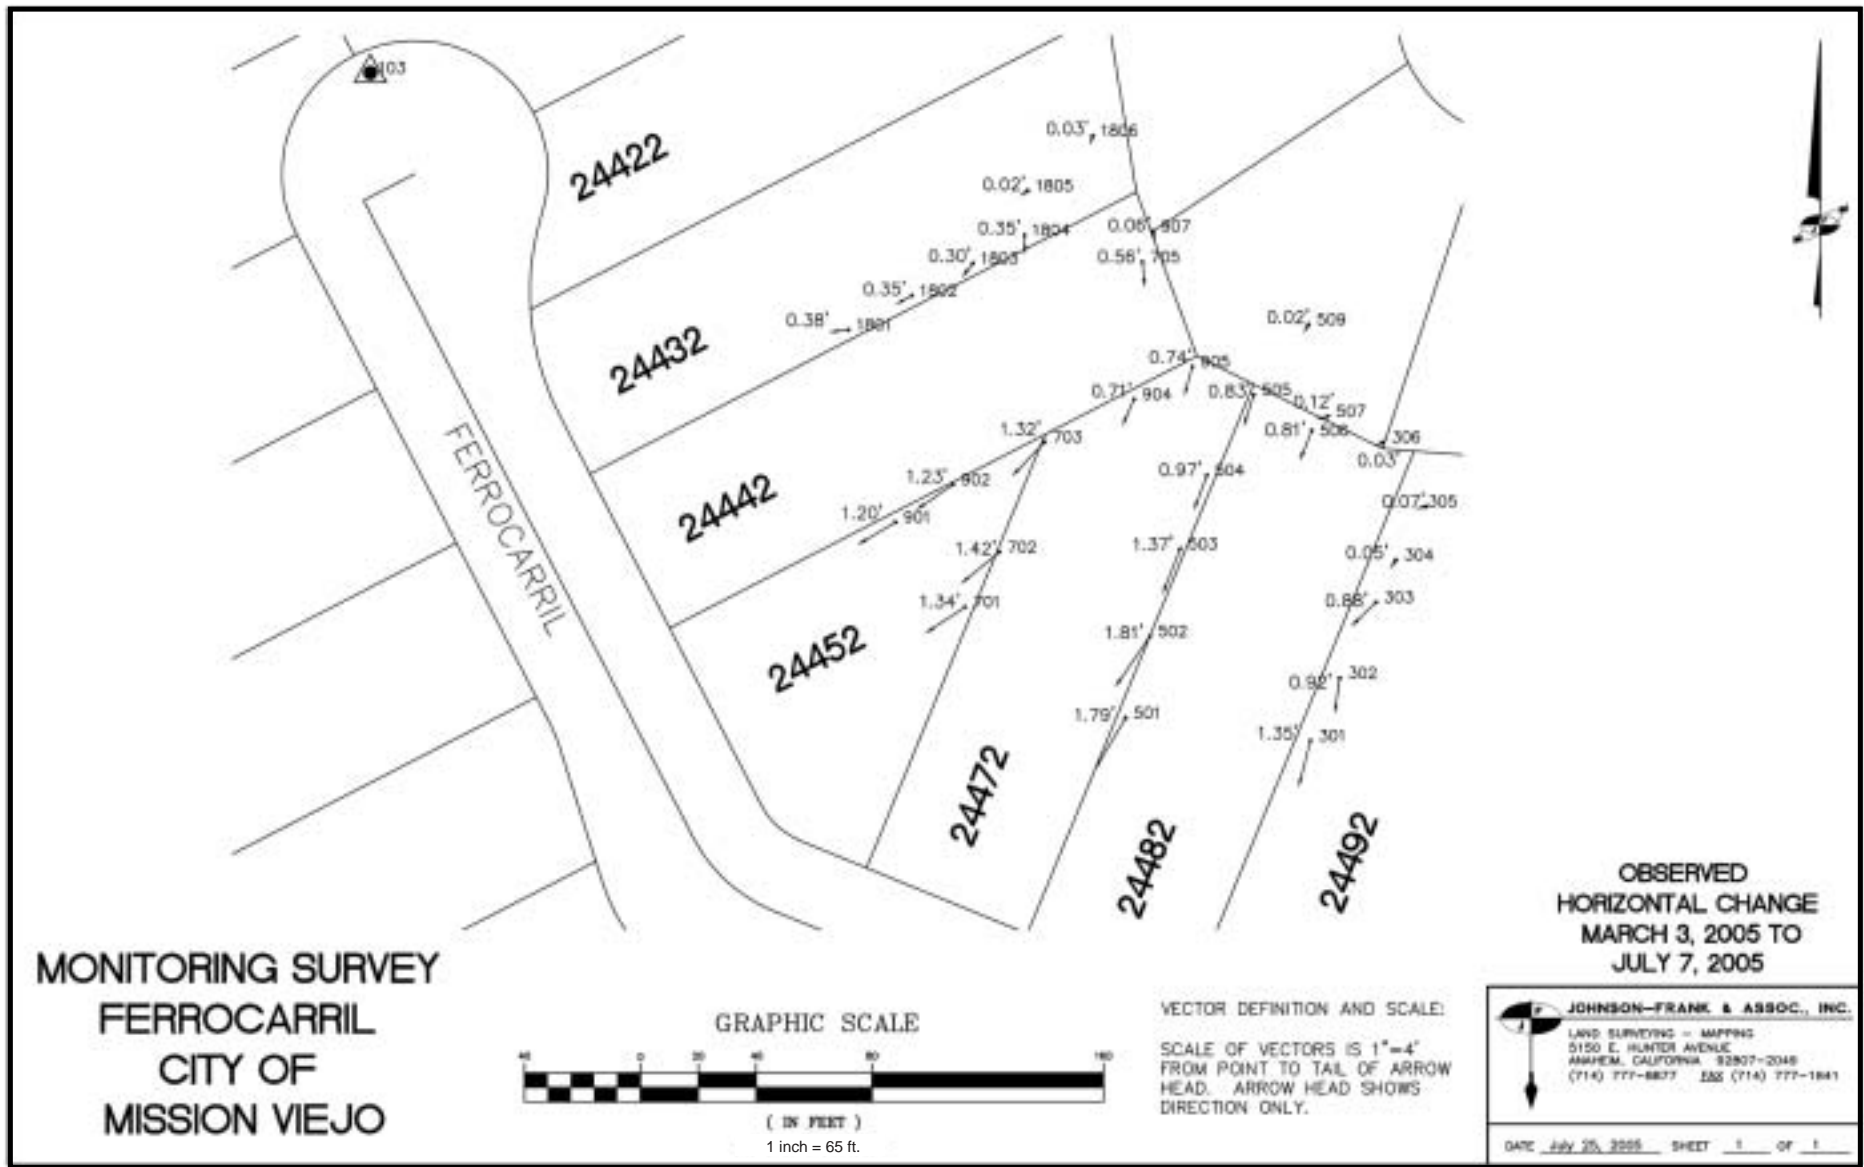
HORIZONTAL MOVEMENT OF SLOPE

Prior to temporary stabilization, the landslide was moving from 2 to 4 inches per day. After the landslide was temporarily stabilized, a survey monitoring system was installed that included numerous survey points on and adjacent to the landslide. Results of the survey monitoring program indicated that the slope went from moving a few inches per day prior to repair to about 1/8 inch per day after repair. Figure 3 depicts the topographic conditions created by the temporary stabilization and the location of the survey monitoring points. Figures 3a and 3b depict the amount of horizontal and vertical movement that occurred during the period from March 3, 2005 to July 7, 2005.

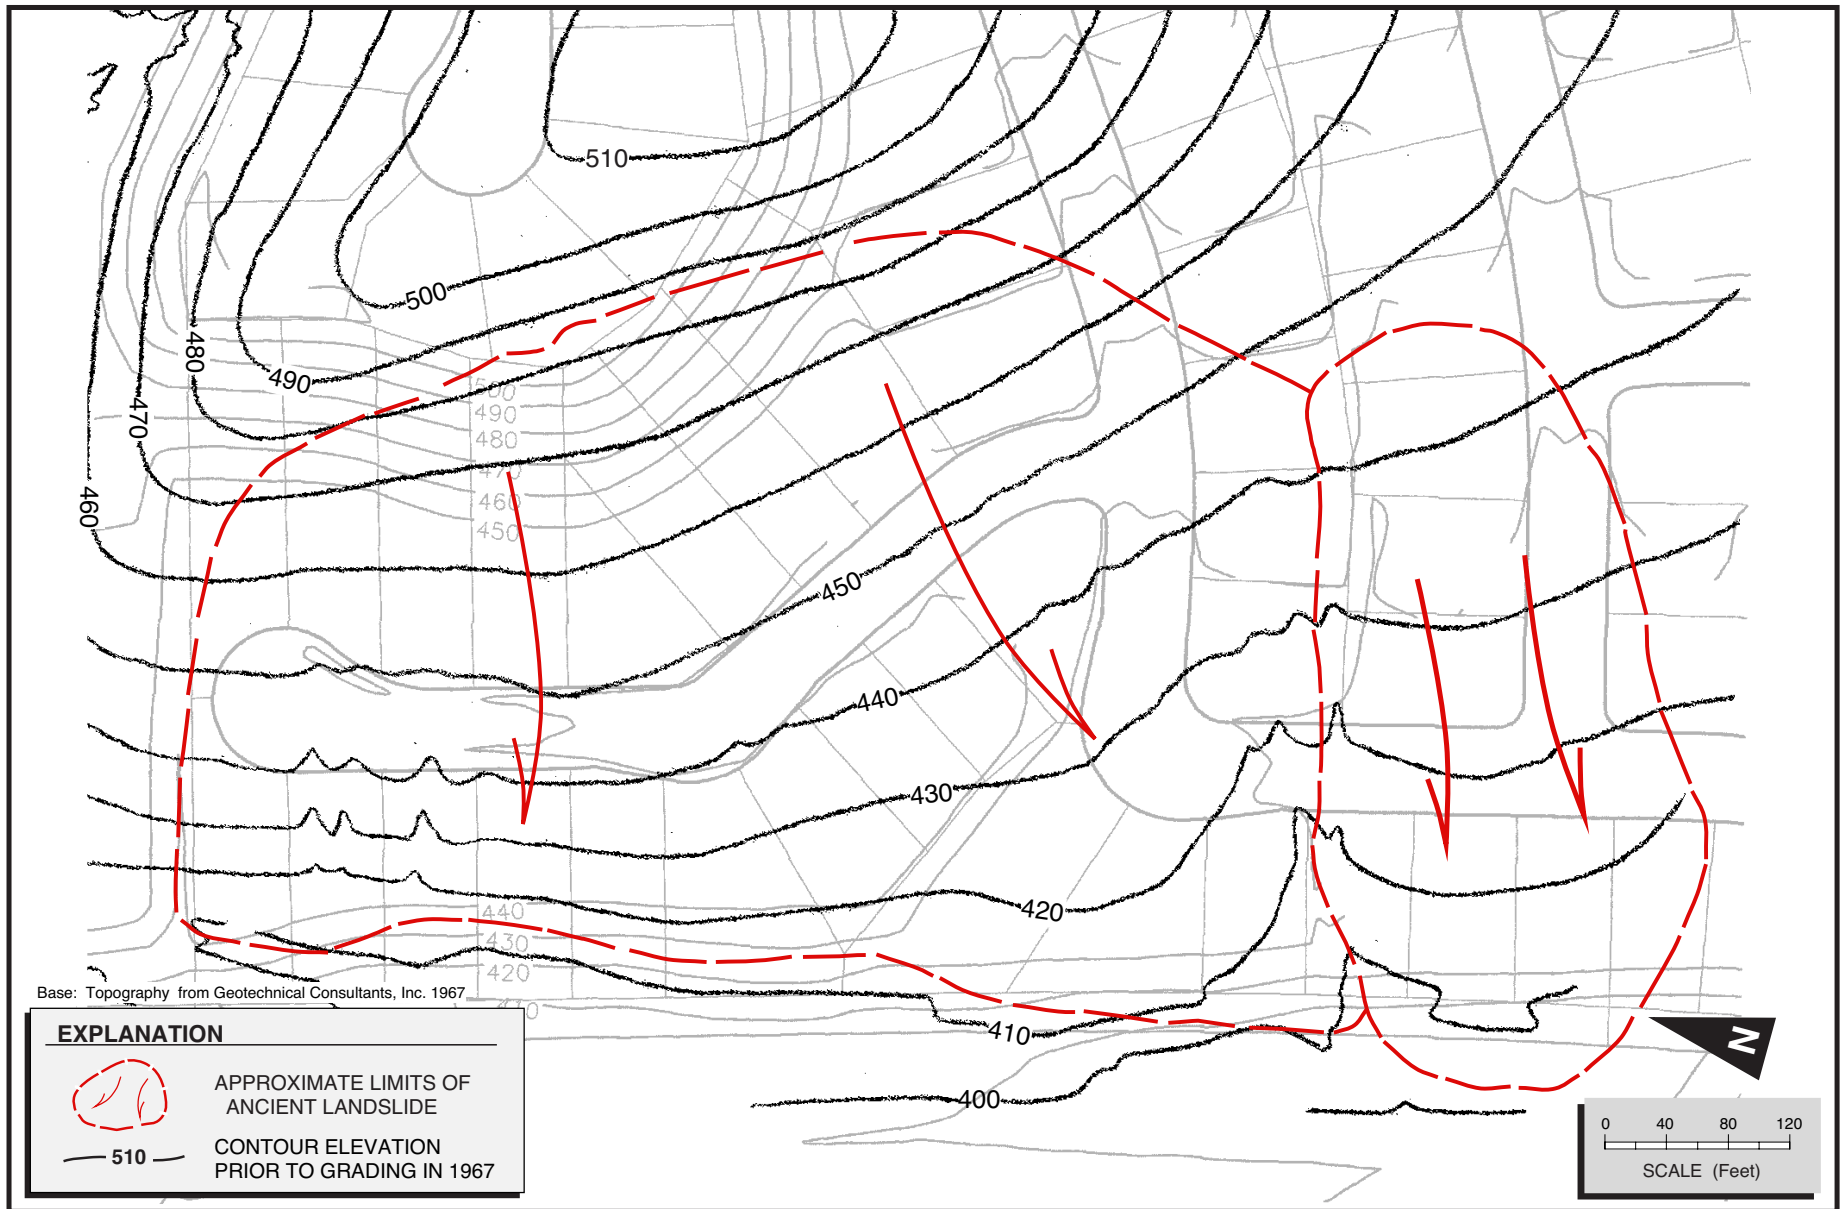
ANCIENT LANDSLIDE MAP

permeable sandstone beds increased pore water pressures within the bedrock and added weight to the slope. In addition, the water saturated the existing clay layer resulting in a loss of shear strength. Together these factors caused the slope to fail along the weakened layer of clay. This clay layer is believed to be the rupture surface of an ancient landslide, which is visible on historical aerial photographs that were taken prior to residential development. The presence of the clay layer in borings drilled outside the limits of the active landslide also supports this interpretation. The approximate limits of the ancient landslide, which measured about 750 wide by 500 feet long and 25 to 35 feet deep, are depicted on Figure 4 and Plate 1. The active landslide is actually thicker than the ancient slide as it includes artificial fill materials that were placed on top of the ancient landslide mass along the top of slope. The ancient landslide was also buried by artificial fill on the western side of Ferrocarril, where fills were placed to construct the slopes that descend toward the railroad tracks. This fill slope covers the toe of the ancient slide, and acts as a gravity buttress that resists reactivation of the ancient landslide.

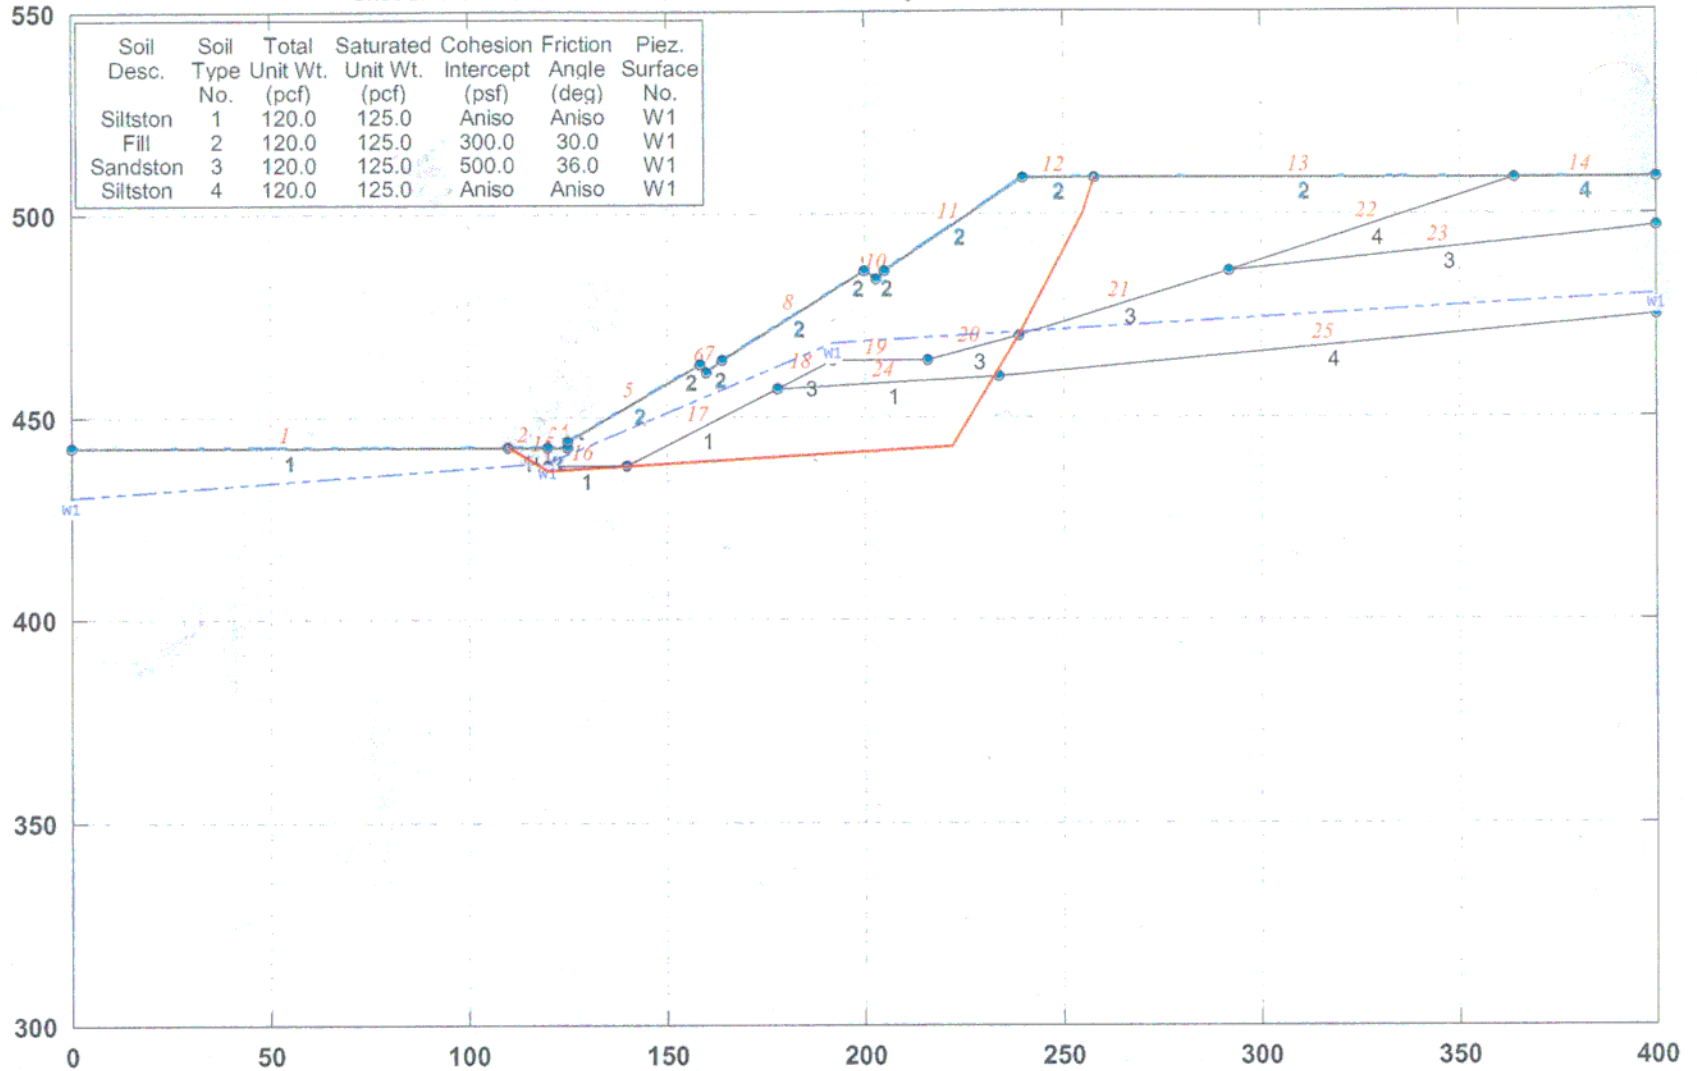
FERROCERRIL LANDSLIDE, SECTION A-A' (Original Ground - Back Calculation)

Back Calculations – used to assess the geometry of the geologic model and strength of the geologic units prior to failure of the slope. The subsurface data obtained from the three borings drilled for the homeowners in conjunction with geologic mapping of the landslide and information obtained from the 1967 grading reports were used to model the subsurface geologic conditions. This preliminary geologic model was used in our back analysis to determine the strength of the underlying clay layer. The results of these analyses were used to develop a temporary stabilization plan.

GSTABL7 FSmin=1.00

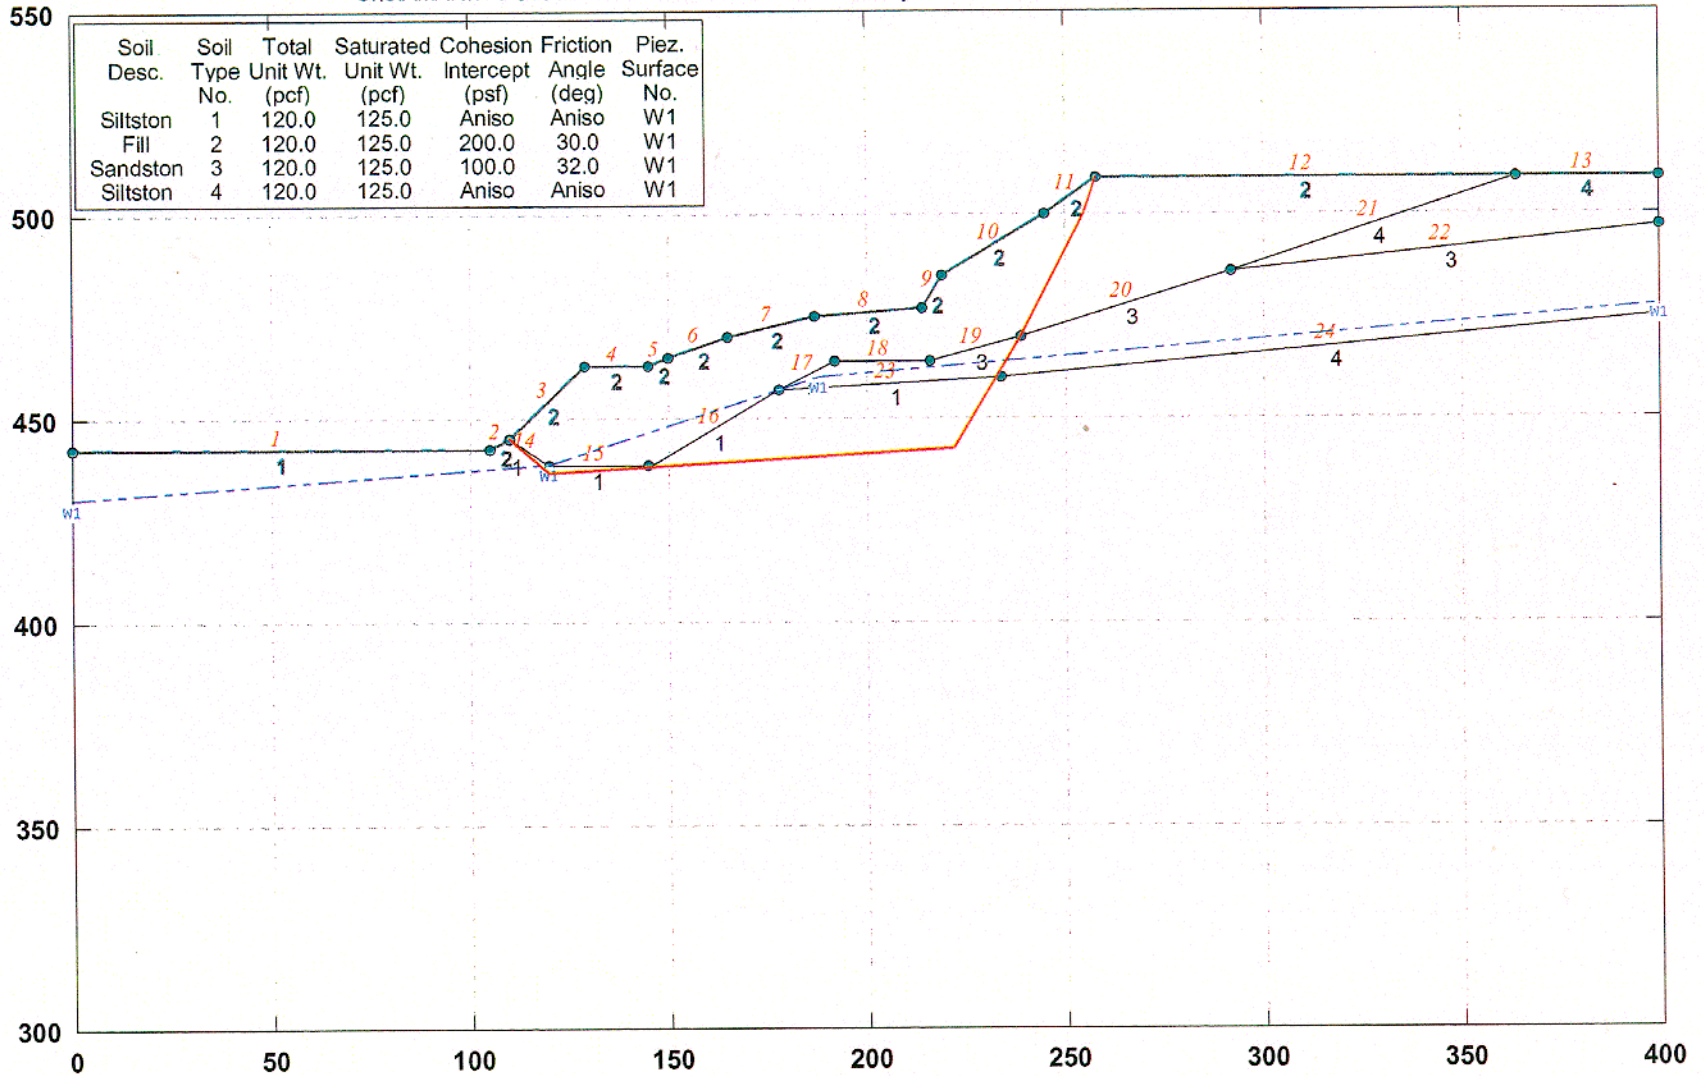
FERROCERRIL LANDSLIDE, SECTION A-A' (Post Failure Temporary Repair)

In general, the results of the stability analyses indicate that the temporarily repaired portion of the slope is marginally stable, and has a Factor of Safety of slightly less than 1.1 in the critical direction, and about 1.2 in a less critical direction. The Factor of Safety is based on the same groundwater table utilized in our back calculations. Our analyses also indicate that portions of the slope adjacent to the repaired area have a Factor of Safety ranging from about 1.0 to 1.4 depending upon the interpreted geologic conditions.

GSTABL7 FSmin=1.06

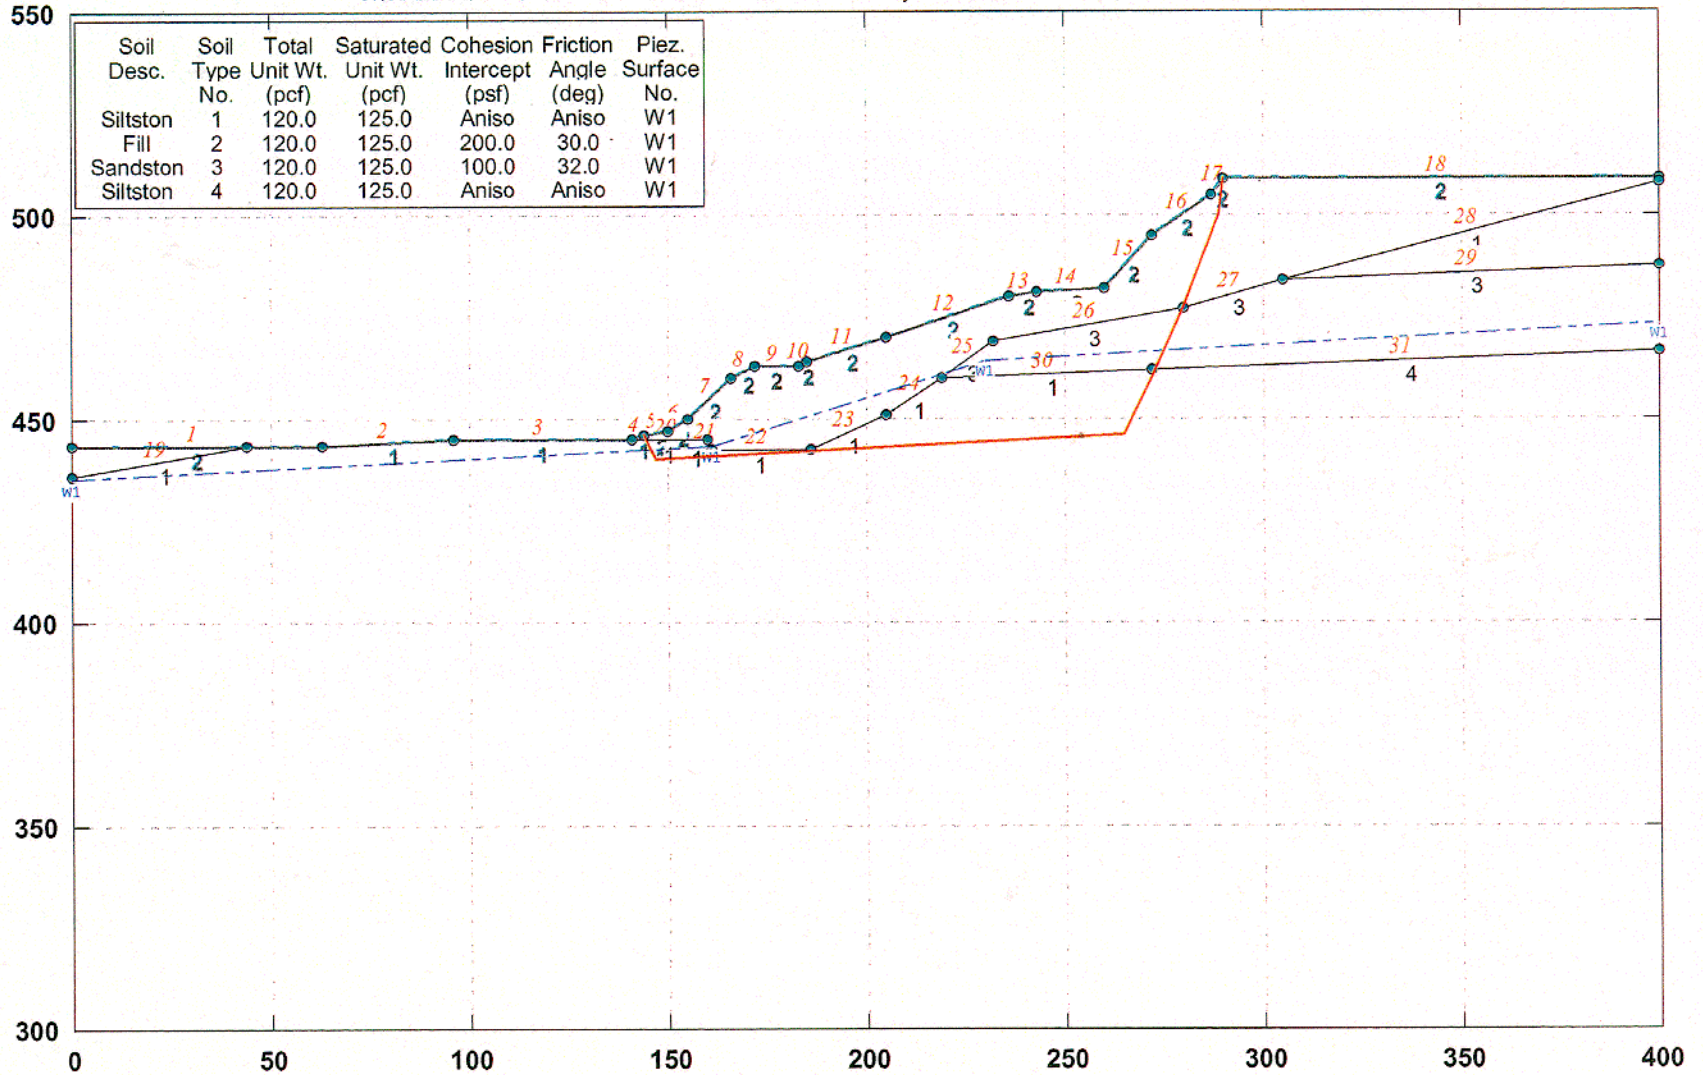
FERROCERRIL LANDSLIDE, Section B-B' (Post Failure Temporary Repair)

GSTABL7 FSmin=1.23
