Mission Viejo

SYSTEMIC SAFETY ANALYSIS REPORT & LOCAL ROAD SAFETY PLAN

December 2021

Prepared by:
Kittelson & Associates, Inc.
750 The City Drive, Suite 410
Orange, CA 92868
714.468.1997

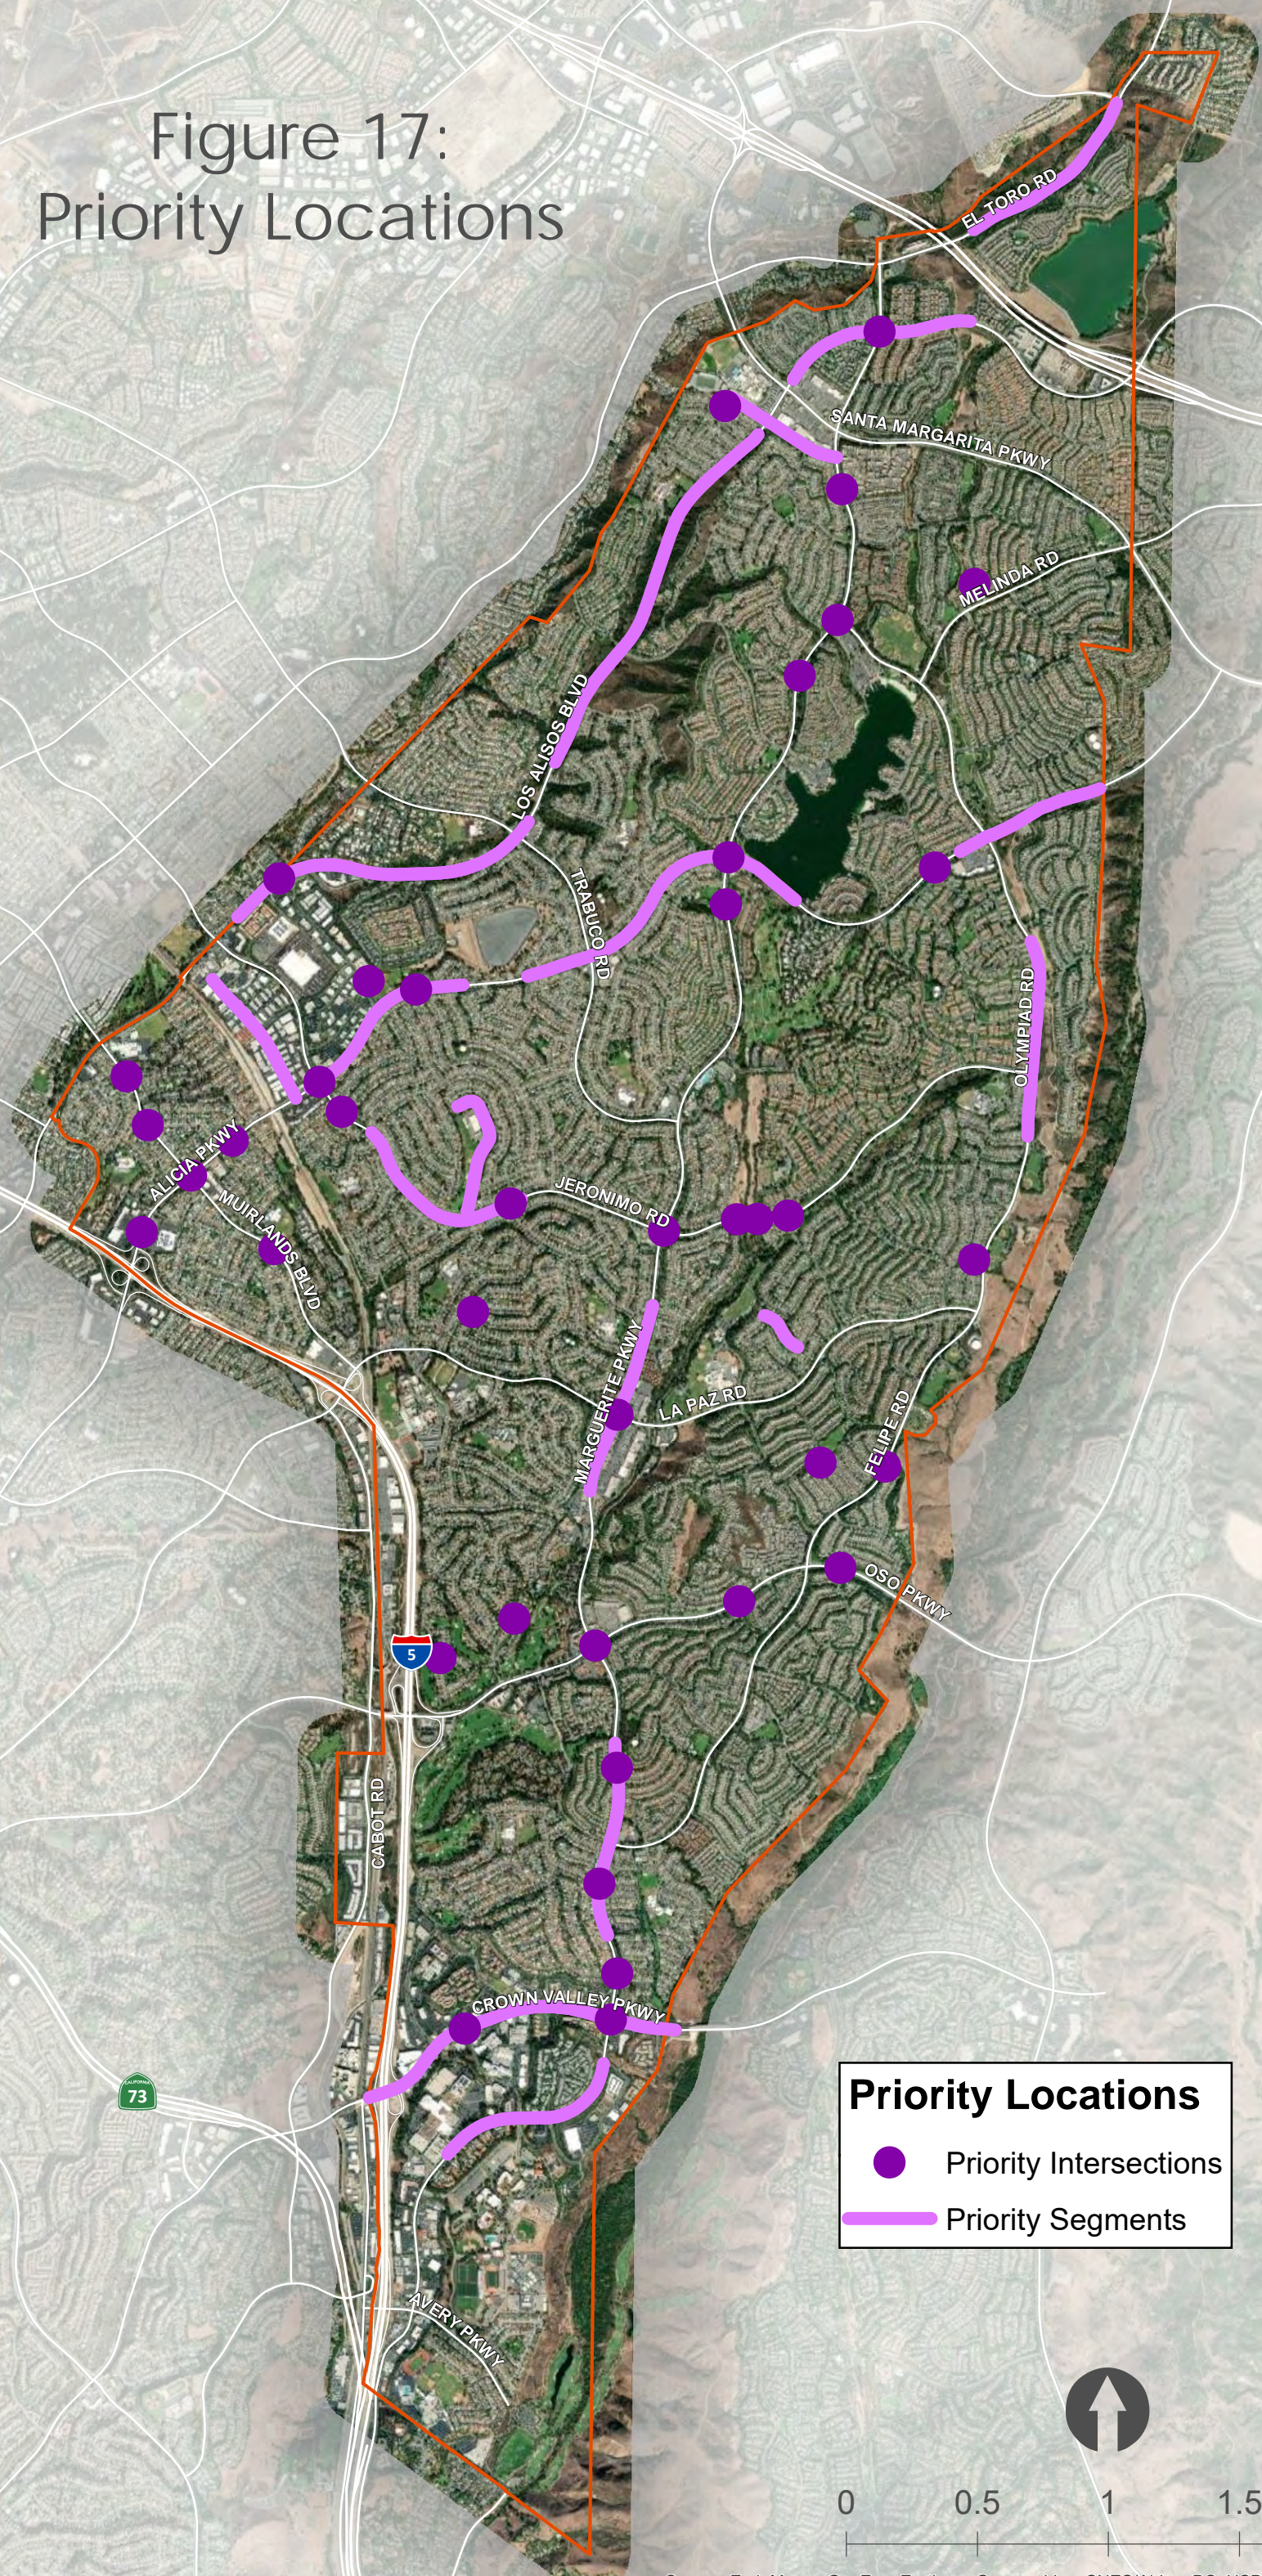
Figure 17:
Priority Locations

Priority Locations

- Priority Intersections
- Priority Segments

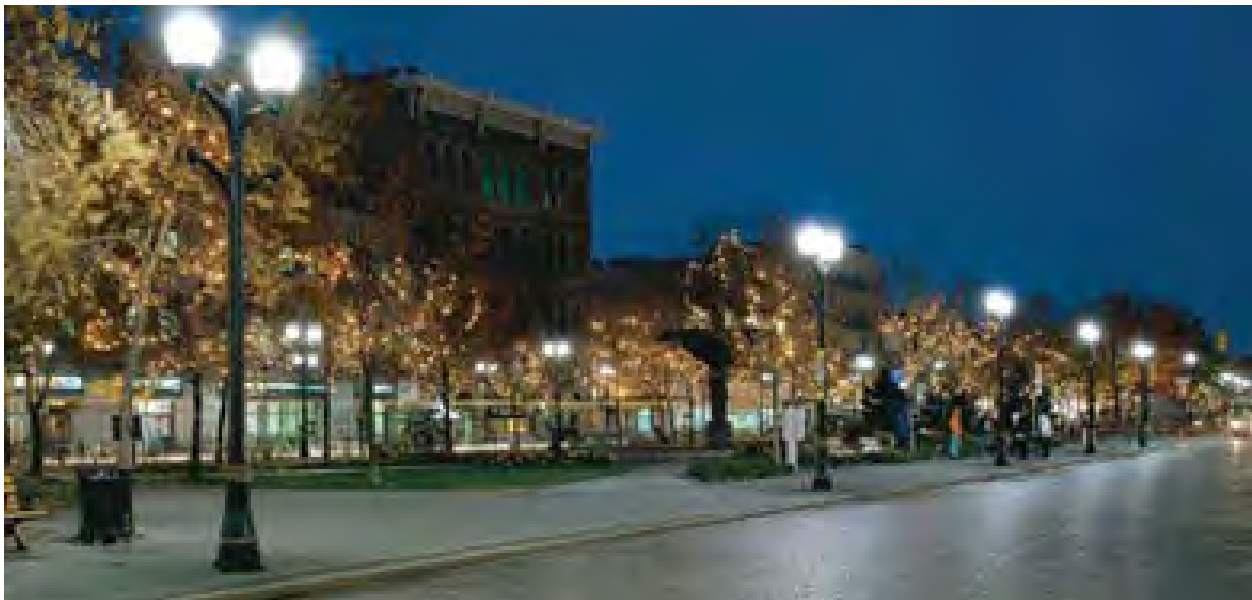
FIGURE 18: EXAMPLE OF PEDESTRIAN-SCALE LIGHTING

This countermeasure was selected for Mission Viejo because darkness was a factor in 35% of reported total collisions and 29% of reported fatal and severe injury collisions. Increased visibility would contribute to pedestrian, bicycle, and motorist safety, allowing drivers to see the activity at an upcoming intersection, especially illumination of non-motorized users.

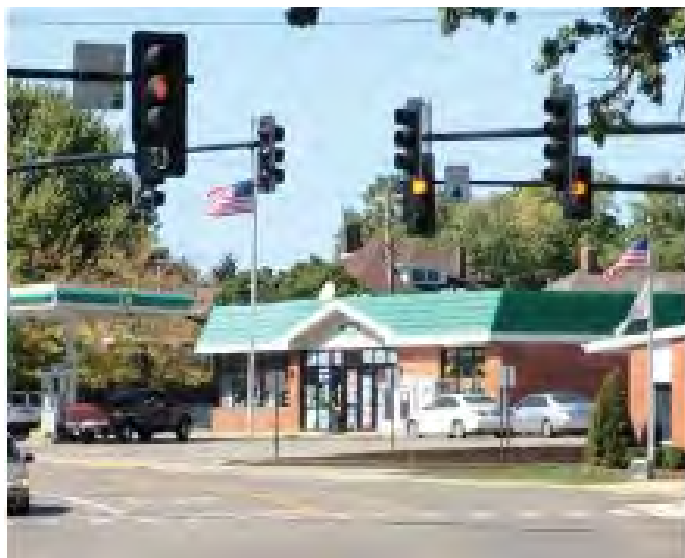
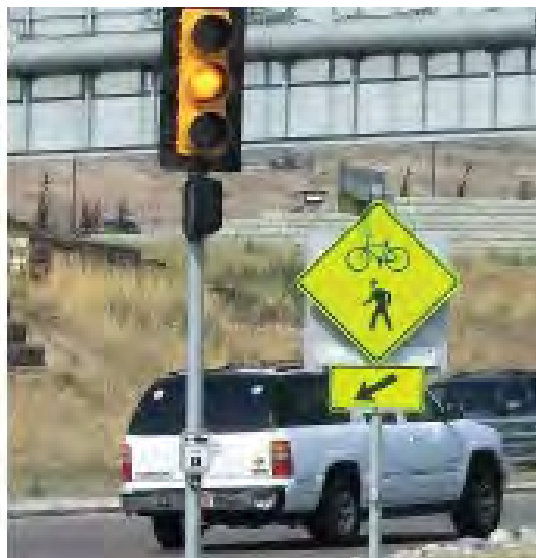
FIGURE 20: PHOTOS OF YELLOW SIGNAL CLEARANCE INTERVAL

This countermeasure was selected for Mission Viejo because broadside collision was the top collision type representing 28% of total reported collisions and 36% of reported fatal and severe injury collisions. Having appropriately timed yellow and red intervals reduces the risk of collision, for instance, when a driver is in the dilemma zone or does not comply with yellow signal indications, particularly at larger signalized intersections.

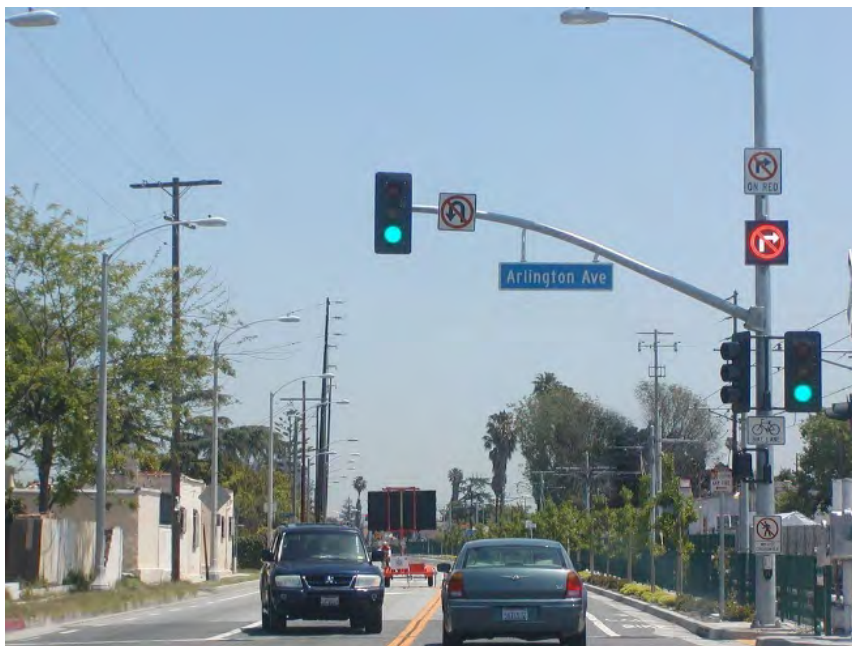
FIGURE 22: EXAMPLE OF DYNAMIC RIGHT TURN ON RED RESTRICTION

This countermeasure was selected for Mission Viejo because vehicle-pedestrians was a top three collision type for fatal and severe injuries with 13% of reported collisions and because improper turning was a factor in 19% of reported total collisions and 14% of reported fatal and severe injury collisions. Restricting right-turn movements increases driver compliance with traffic signals and would reduce potential for conflicts between vehicles and pedestrians.

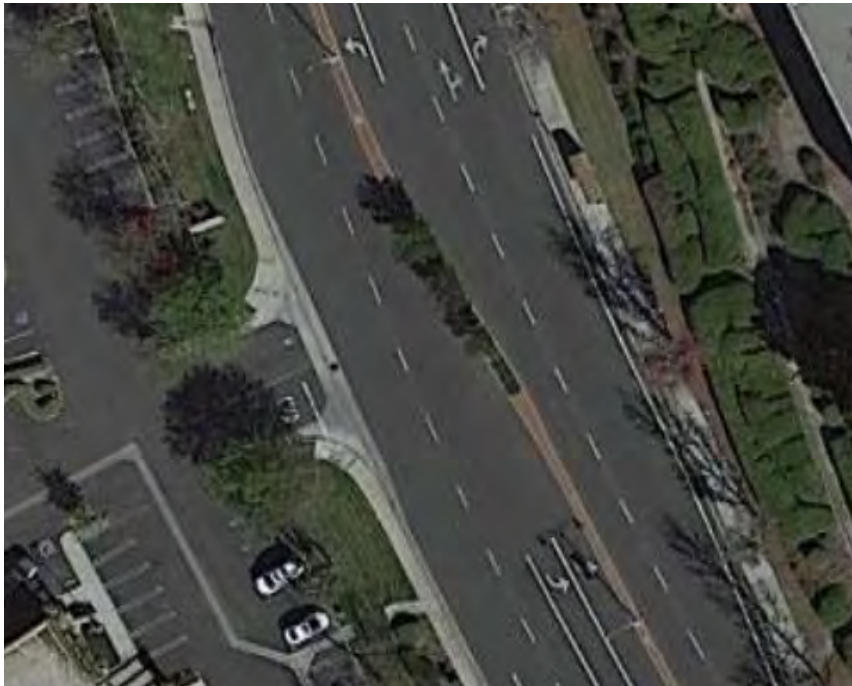
FIGURE 23: EXAMPLE OF CROSS-MEDIAN ACCESS RESTRICTIONS

This countermeasure was selected for Mission Viejo because 78% of reported collisions occurred within an intersection influence area and 28% of total reported collisions were broadside. Managing access near intersections would reduce potential conflict points, especially where motorists may attempt to cross multiple lanes of opposing travel or queued vehicles.

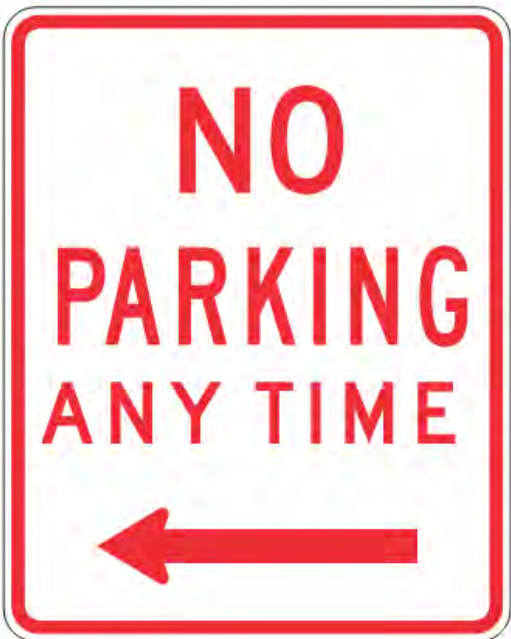
FIGURE 24: EXAMPLE OF PARKING RESTRICTION SIGN ON INTERSECTION APPROACHES

This countermeasure was selected for Mission Viejo because 78% of reported collisions occurred within an intersection influence area and 28% of total reported collisions were rear-end. Removing parking near intersections would reduce potential conflict between vehicles parking or re-entering the roadway from parking and vehicles that are continuing straight at a higher speed.

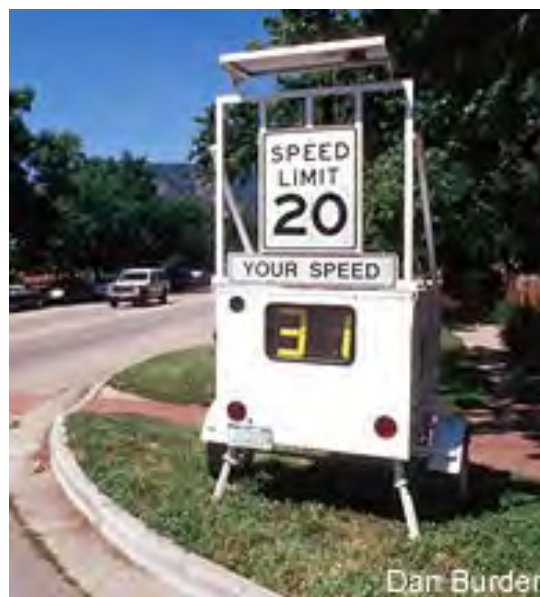
FIGURE 25: EXAMPLE OF DYNAMIC REGULATORY WARNING SIGN AND SPEED TRAILERS

Brief Description: These countermeasures are used to reduce motorist speeds in urban and suburban areas. They provide a message to drivers exceeding a certain speed threshold (or posted speed limit) in urban areas. The intent of these countermeasures is to get drivers' attention and provide them with a visual warning that they may be traveling over the recommended speed on the roadway. An example of this countermeasure is shown in Figure 25.

This countermeasure was selected for Mission Viejo because unsafe speed was the top primary contributing factor (20%) of total reported collisions. Providing speed feedback signing can address speed-related collisions in the urban areas.

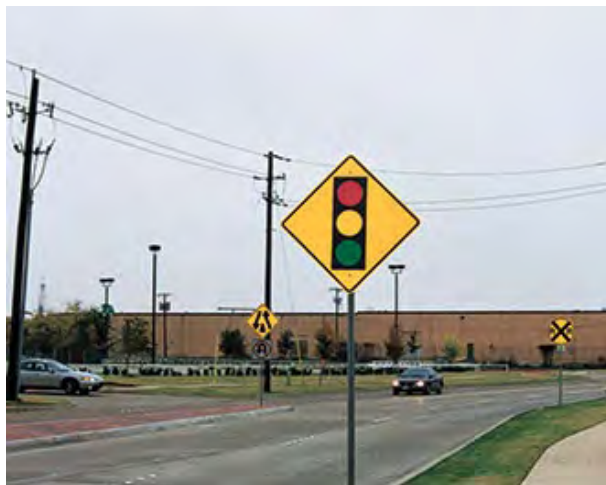
FIGURE 27: EXAMPLE SIGNS WITH FLUORESCENT SHEETING

Brief Description: This countermeasure involves installing and/or upgrading signs with fluorescent sheeting, which provides drivers with a visual warning of the presence of a specific roadway feature or regulatory requirement they may have missed with existing signs. This countermeasure is appropriate on roadway segments with a history of head-on, nighttime, non-intersection, run-off-road, and sideswipe collisions. This countermeasure should be installed in combination with additional countermeasures, such as installing or adding chevrons, warning signs, delineators, markers and beacons, and relocating existing signs. An example countermeasure is shown in Figure 27.

This countermeasure was selected for Mission Viejo because hit-object collisions are among the top three collision types resulting in a fatality or severe injury (18%). Furthermore, collisions that occurred during dark conditions accounted for 35% of the total reported collisions and 29% of the reported fatal and severe injury collisions. Installing and/or upgrading signs with new fluorescent sheeting would provide drivers with increased awareness of changing roadway elements.

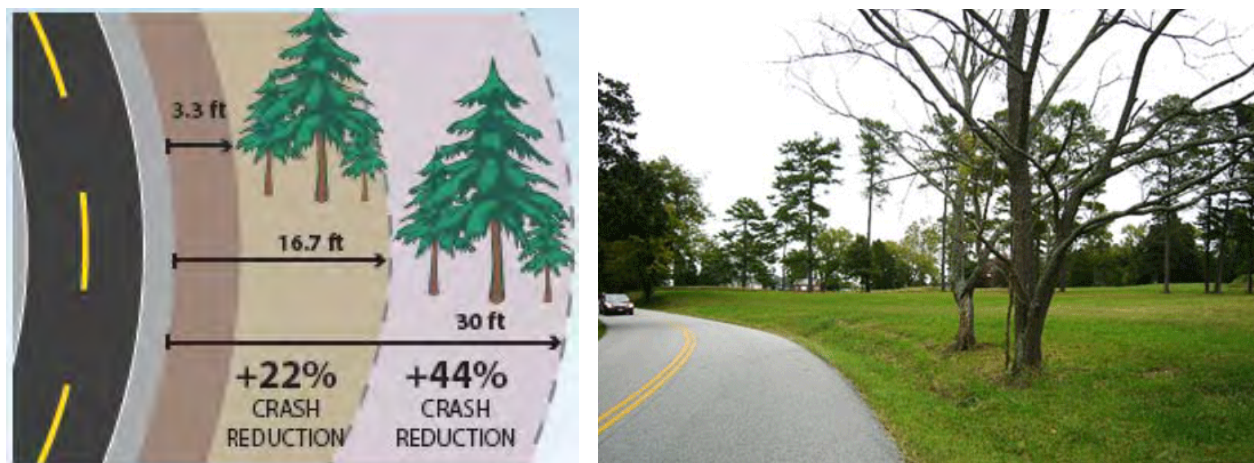
FIGURE 28: EXAMPLE OF REMOVING OR RELOCATING FIXED OBJECT

Brief Description: Removing or relocating roadside fixed objects such as utility poles, drainage, trees, or other fixed objects provides a clear recovery zone that allows drivers to correct their path of travel when they leave the roadway. This countermeasure is particularly effective outside of curves, along lane drops and in traffic islands where fixed object collisions are more common. A clear recovery zone should be developed in more rural context roadways, as space is available. The jurisdictions are only able to address sight obstructions within jurisdiction's right-of-way. Where public right-of-way is limited, steps should be taken to request assistance from property owners. An example of this countermeasure is shown in Figure 28.

This countermeasure was selected for Mission Viejo because hit-object collisions are among the top three collision types resulting in a fatality or severe injury (21%). Removing or relocating fixed objects outside of a clear recovery zone would provide an opportunity for drivers to correct their path of travel and can proactively address a history of hit-object collisions.

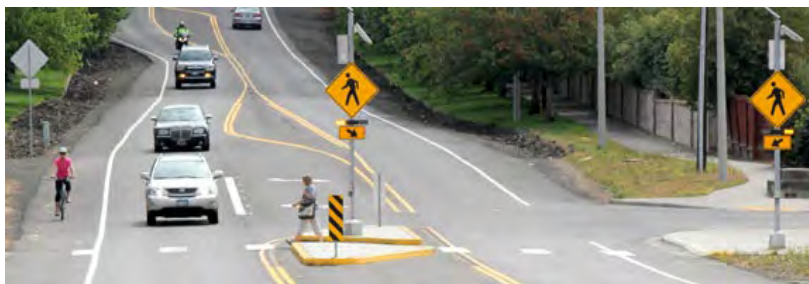
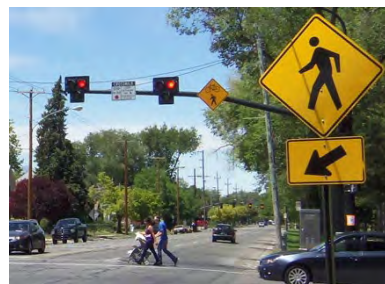
FIGURE 30: EXAMPLE OF ENHANCED PEDESTRIAN CROSSING

This countermeasure was selected for Mission Viejo because vehicle-pedestrian collisions accounted for 13% of the fatal and severe injury collisions. Pedestrians crossing in a crosswalk at an intersection is the top contributing factor (57% of total reported collisions and 36% of reported fatal and severe injury collisions) associated with pedestrian collisions. Installing enhanced pedestrian crossings can help increase drivers' yielding behavior and reduce the risk of pedestrian and bicycle collisions.

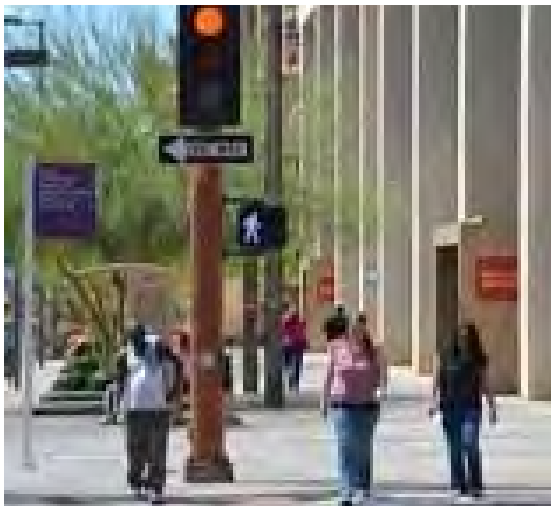
FIGURE 31: EXAMPLE OF A LEADING PEDESTRIAN INTERVAL

This countermeasure was selected for Mission Viejo because vehicle-pedestrian fatal and severe injury collisions (13%) are overrepresented for signalized and unsignalized intersections. Leading Pedestrian Intervals may be considered at signalized intersections with medium to high vehicle-turning volumes and pedestrian volumes.

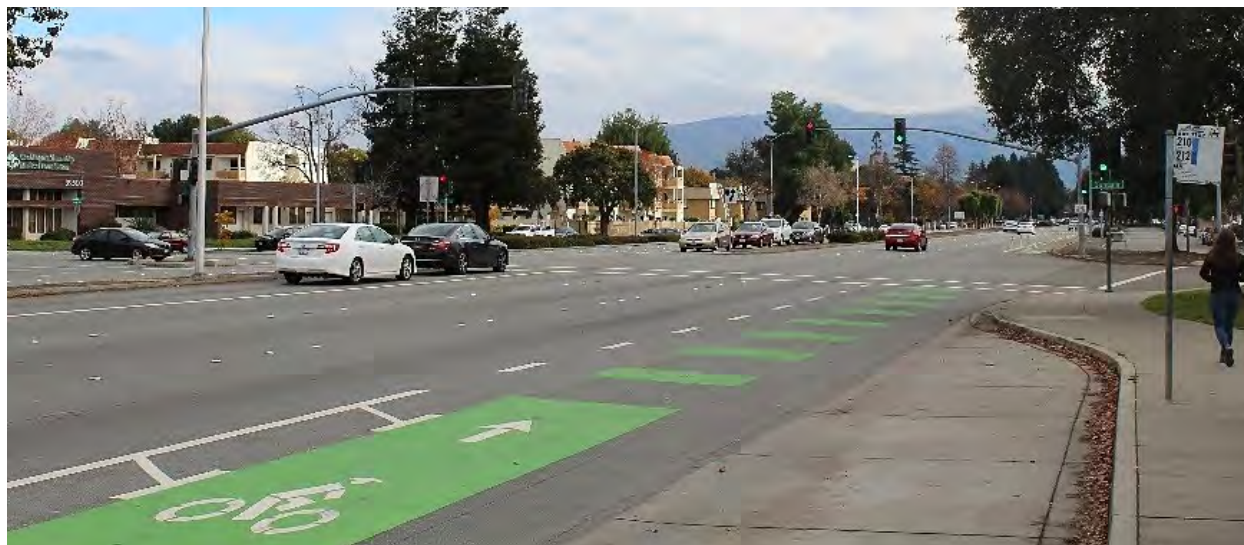
FIGURE 32: EXAMPLE OF BUFFERED BIKE LANE APPROACHING AN INTERSECTION

This countermeasure was selected for Mission Viejo because bicycle fatal and severe injury collisions (6%) are overrepresented. The use of bike lanes helps bicyclists to ride at their preferred speed without interference from prevailing traffic conditions and facilitates predictable behavior and movements between motorists and bicyclists.

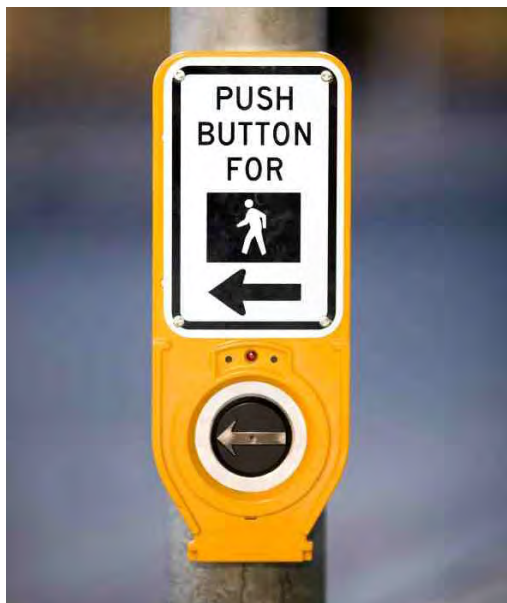
FIGURE 33: EXAMPLE OF PEDESTRIAN COUNTDOWN SIGNAL HEAD AT AN INTERSECTION

This countermeasure was selected for Mission Viejo because vehicle-pedestrian collisions accounted for 13% of the fatal and severe injury collisions. Pedestrians crossing in a crosswalk at an intersection is the top contributing factor (57% of total reported collisions and 36% of reported fatal and severe injury collisions) associated with pedestrian collisions. Installing audible pedestrian push buttons would assist in informing pedestrians of the walk indication status during their phase of a controlled crossing.

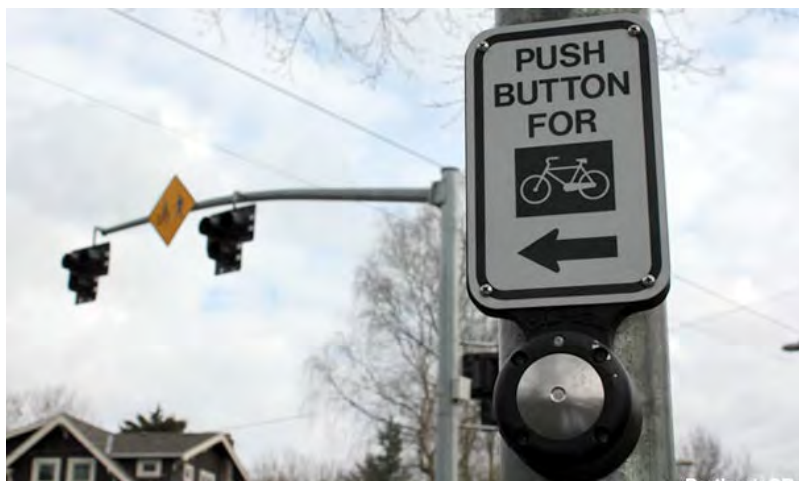
FIGURE 34: EXAMPLE OF BICYCLIST PUSH BUTTON

This countermeasure was selected for Mission Viejo because bicycle fatal and severe injury collisions (6%) are overrepresented. The use of bicycle push buttons increases convenience and safety of bicycling and helps establish bicycling as a feasible mode of transportation.

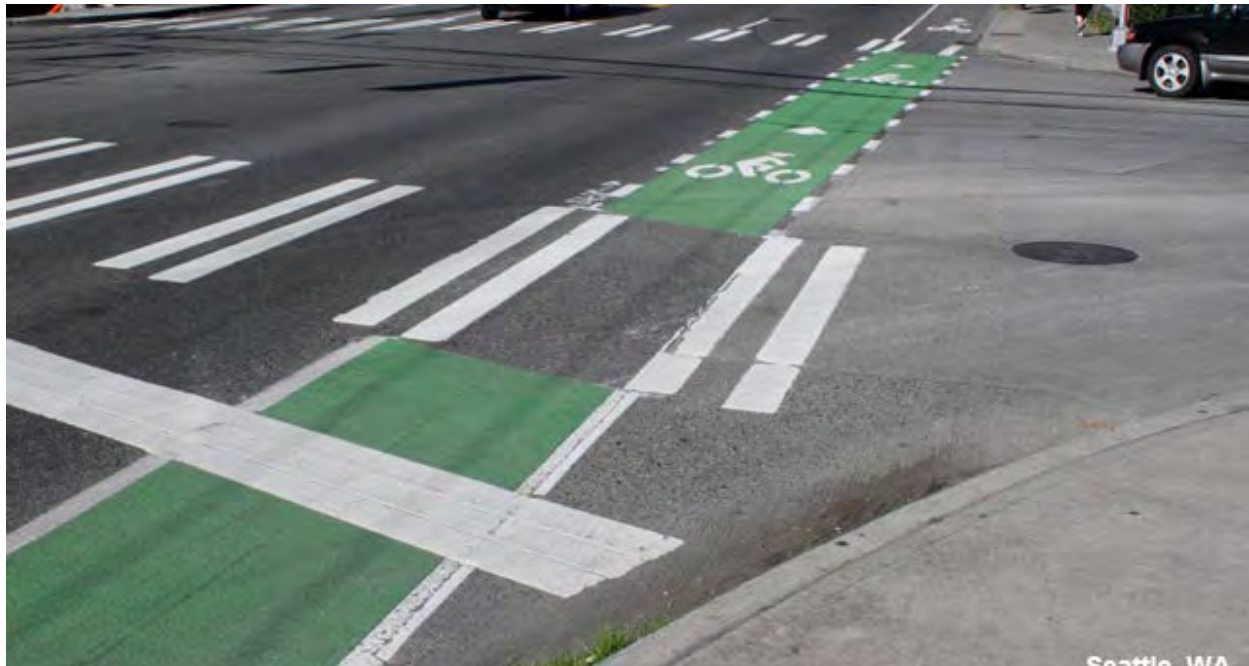
FIGURE 35: EXAMPLE OF BIKE LANE EXTENSION THROUGH INTERSECTION

This countermeasure was selected for Mission Viejo because bicycle fatal and severe injury collisions (6%) are overrepresented. High visibility bike lane markings are intended to provide notice to drivers and bicyclists of areas where the two may come into conflict. Since the effectiveness of markings depends entirely on their visibility, maintaining markings should be a priority where this countermeasure is considered.

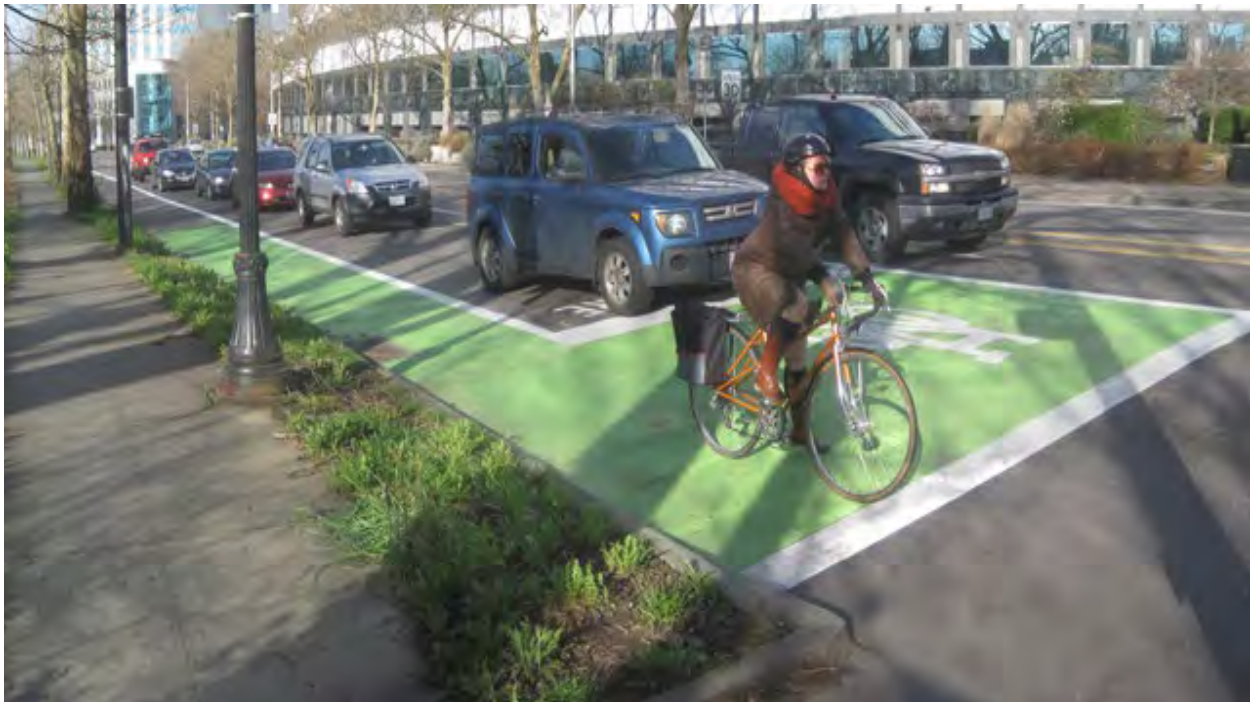
FIGURE 36: EXAMPLE OF BIKE BOX

Brief Description: This countermeasure involves installing a bike box, which is a designated area at the head of the traffic lane at a signalized intersection. This is to provide bicyclists with a safe and visible way to get ahead of the motor vehicle queuing traffic during the red signal phase. Bike boxes increase the visibility of bicyclists at an intersection and helps prevent right-hook or left-hook conflicts with turning motor vehicles at the start of the green indication. An example of the countermeasure is shown in Figure 36.

This countermeasure was selected for Mission Viejo because bicycle fatal and severe injury collisions (6%) are overrepresented. Bike boxes are intended to provide notice to drivers and bicyclists of areas where the two may come into conflict at intersections and allow for a better queue space for bicyclists to be visible to motor vehicle traffic.

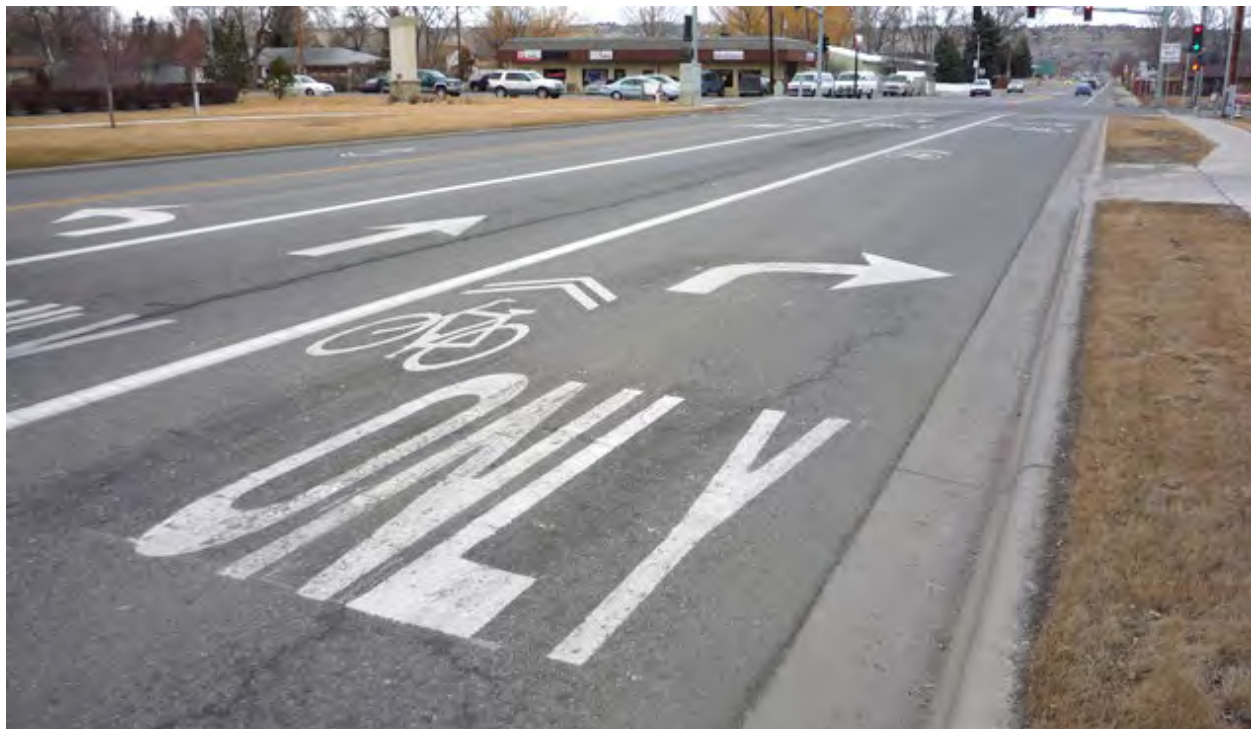
FIGURE 37: EXAMPLE OF A COMBINED BIKE LANE/TURN LANE

Brief Description: This countermeasure involves establishing a combined bike lane/turn lane to designate shared space for bicyclists and vehicles. Shared lane markings or conventional bicycle stencils with a dashed line can delineate the space for bicyclists and motorists within the shared lane or indicate the intended path for through bicyclists. This treatment includes signage advising motorists and bicyclists of proper positioning within the lane. An example of the countermeasure is shown in Figure 37.

This countermeasure was selected for Mission Viejo because bicycle fatal and severe injury collisions (6%) are overrepresented. Combined bike lane/turn lanes are intended to provide notice to drivers and bicyclists of areas where the two may come into conflict at intersections and provide guidance for bicyclists approaching intersections where the bike lane has been terminated.

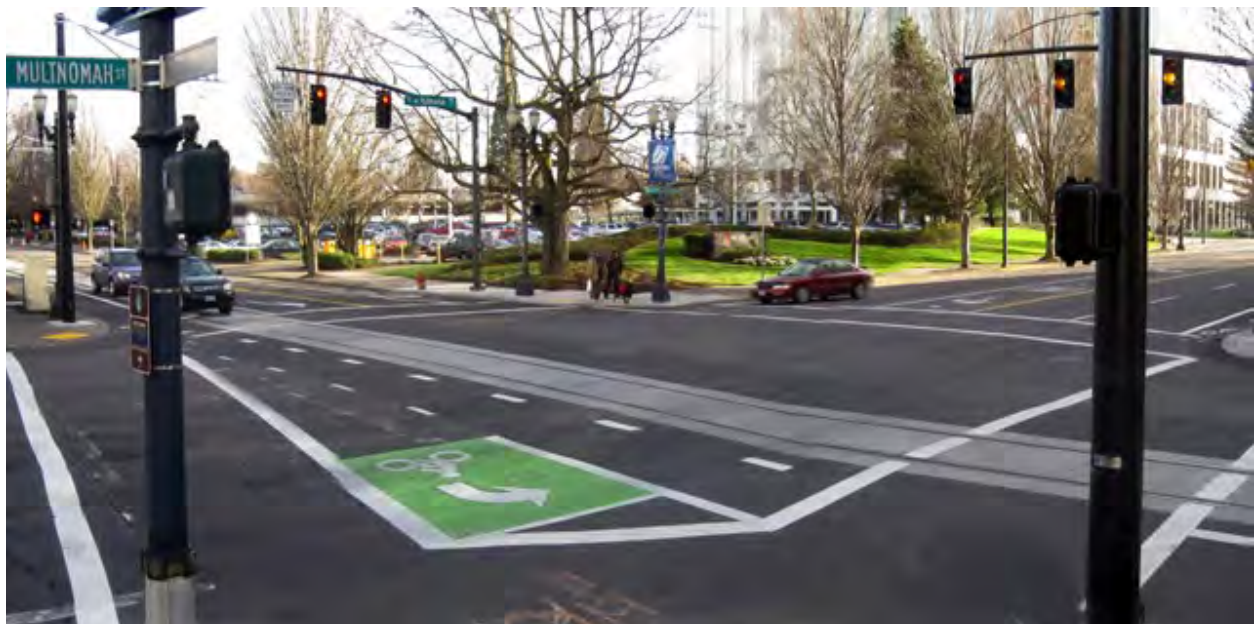
FIGURE 38: EXAMPLE OF BICYCLE TWO-STAGE LEFT-TURN QUEUE BOX

Brief Description: This countermeasure involves installing a bike box, which is a designated area at the head of the traffic lane at a signalized intersection. This is to provide bicyclists with a safe and visible way to get ahead of the motor vehicle queuing traffic during the red signal phase. Bike boxes increase the visibility of bicyclists at an intersection and helps prevent right-hook or left-hook conflicts with turning motor vehicles at the start of the green indication. Multiple positions are available for queuing boxes depending on the intersection configuration. An example of the countermeasure is shown in Figure 38.

This countermeasure was selected for Mission Viejo because bicycle fatal and severe injury collisions (6%) are overrepresented. Bike boxes allow for a better accommodation of turning bicycle traffic and are most beneficial along multi-lane roadways with high speeds and signalized intersections.

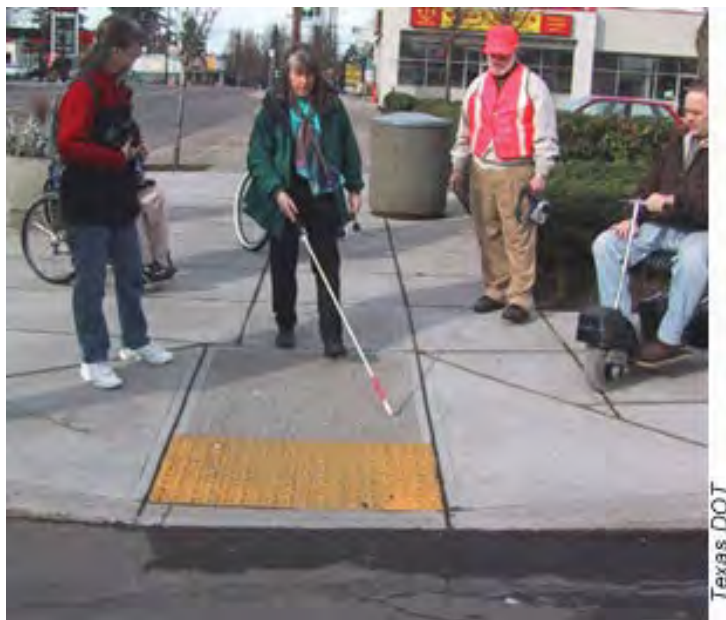
FIGURE 39: EXAMPLE OF TRUNCATED DOMES ON A PEDESTRIAN RAMP

Brief Description: This countermeasure installs truncated domes on pedestrian curb ramps. These bumps, which can either be installed individually or together on a tile or detectable warning pad, are large enough to be felt underfoot or detected with a walking cane yet small enough as to not create any tripping hazards. Truncated dome tiles also make a distinct audible noise when using a guidance cane, marking a difference between the sidewalk and the ADA detectable warning. Further adding another level of detectability, tactile panels and detectable warning systems are required to provide a stark visual contrast. This means if the domes are being applied on a light surface, the truncated domes must be a darker color or vice versa. An example of the countermeasure is shown in Figure 39.

This countermeasure was selected for Mission Viejo because vehicle-pedestrian collisions accounted for 13% of the fatal and severe injury collisions. Pedestrians crossing in a crosswalk at an intersection is the top contributing factor (57% of total reported collisions and 36% of reported fatal and severe injury collisions) associated with pedestrian collisions. Installing truncated domes would assist in informing pedestrians they are entering the roadway and provide visual cues of crosswalk locations.

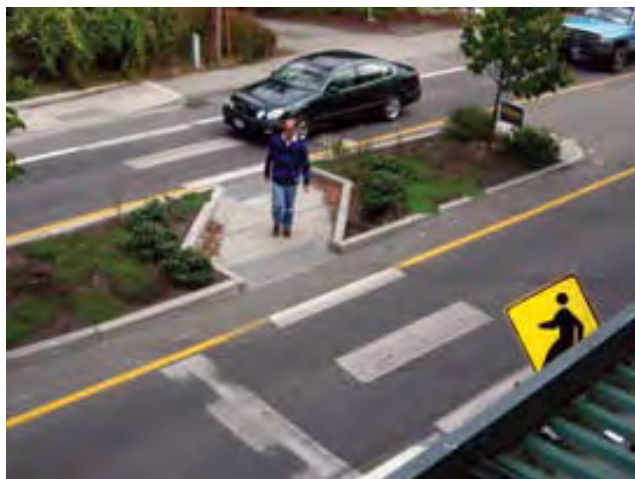
FIGURE 40: EXAMPLE OF A RAISED MEDIAN PEDESTRIAN REFUGE AREA

Brief Description: This countermeasure involves using raised medians with pedestrian refuge islands designed to provide dedicated areas for pedestrians and bicyclists between vehicle travel lanes at intersections and midblock locations. The refuge area must have a minimum width of 6 feet to meet pedestrian accessibility requirements. To provide bicyclists refuge and to accommodate larger groups of pedestrians, the minimum should be increased to 8 feet. This countermeasure improves the safety for pedestrians and bicyclists by reducing crossing distances and creating a place of refuge to allow multiple-stage crossings. They are particularly beneficial at uncontrolled crossings, large signalized crossings, or complex intersections where people may have difficulty completing crossings. An example of the countermeasure is shown in Figure 40.

This countermeasure was selected for Mission Viejo because vehicle-pedestrian collisions accounted for 13% of the fatal and severe injury collisions. The second most common primary collision factor is listed pedestrian violation, which can indicate the need for improved pedestrian crossings. These countermeasures would provide a space for pedestrians to wait on longer crossings to allow multiple-stage crossings.

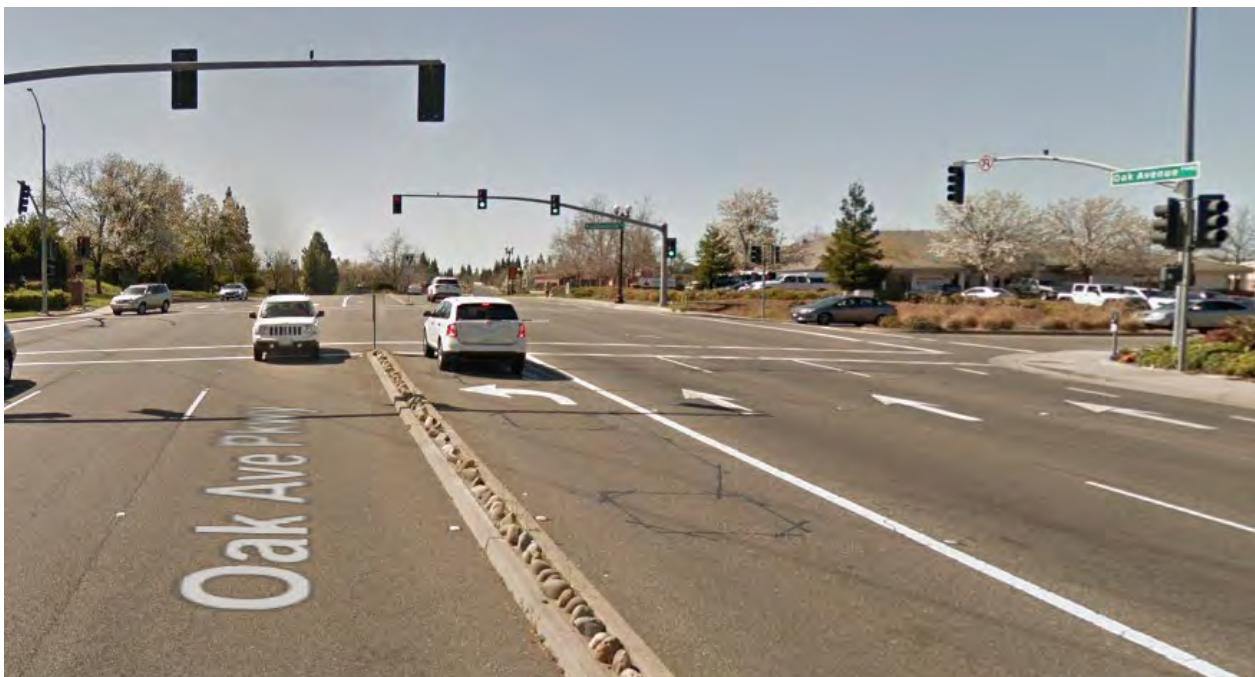
FIGURE 41: EXAMPLE OF A PROTECTED LEFT-TURN PHASE AND LANE

This countermeasure was selected for Mission Viejo because rear-end and broadside collisions each account for 28% of the total reported collisions and vehicle-pedestrian collisions accounted for 13% of the fatal and severe injury collisions. Providing protected left-turn phases allows for dedicated time for left-turn vehicles and pedestrian phases.

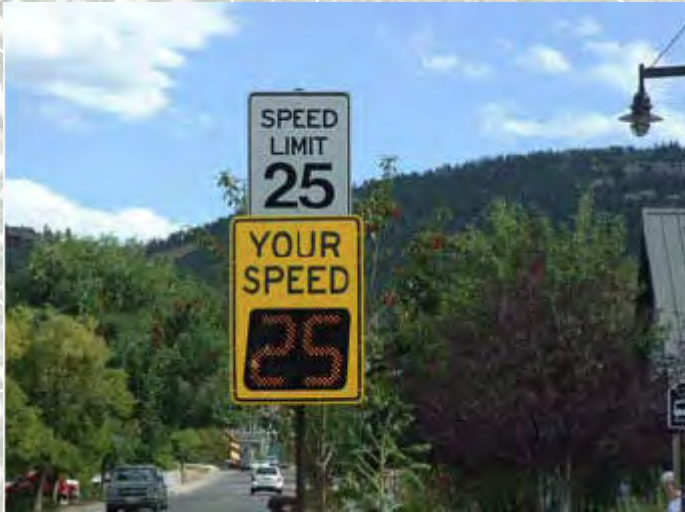
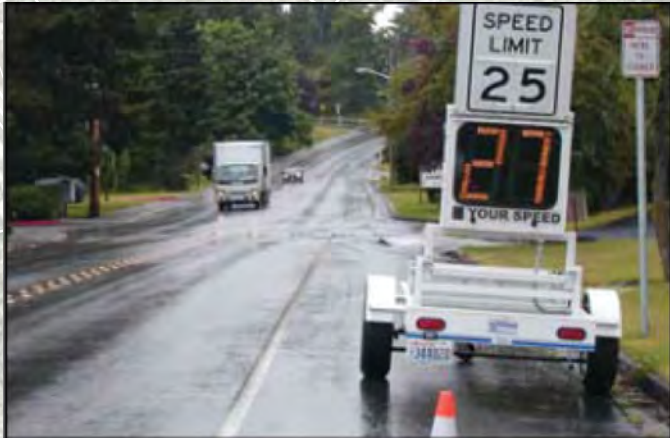
Figure 48:
Systemic Speed
Management Approach
(North Area)

● Dynamic Regulatory Speed Feedback Sign Location

● Speed Radar Trailer Location

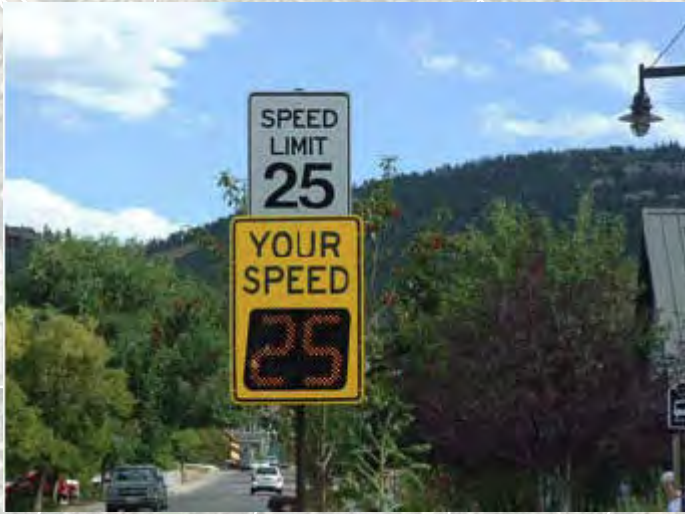
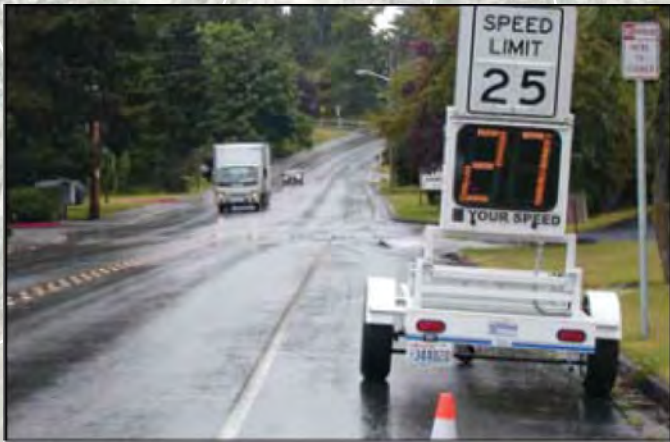
Figure 49:
Systemic Speed
Management Approach
(South Area)

● Dynamic Regulatory Speed Feedback Sign Location

● Speed Radar Trailer Location
