Mission Viejo

SYSTEMIC SAFETY ANALYSIS REPORT & LOCAL ROAD SAFETY PLAN

December 2021

Prepared by:
Kittelson & Associates, Inc.
750 The City Drive, Suite 410
Orange, CA 92868
714.468.1997

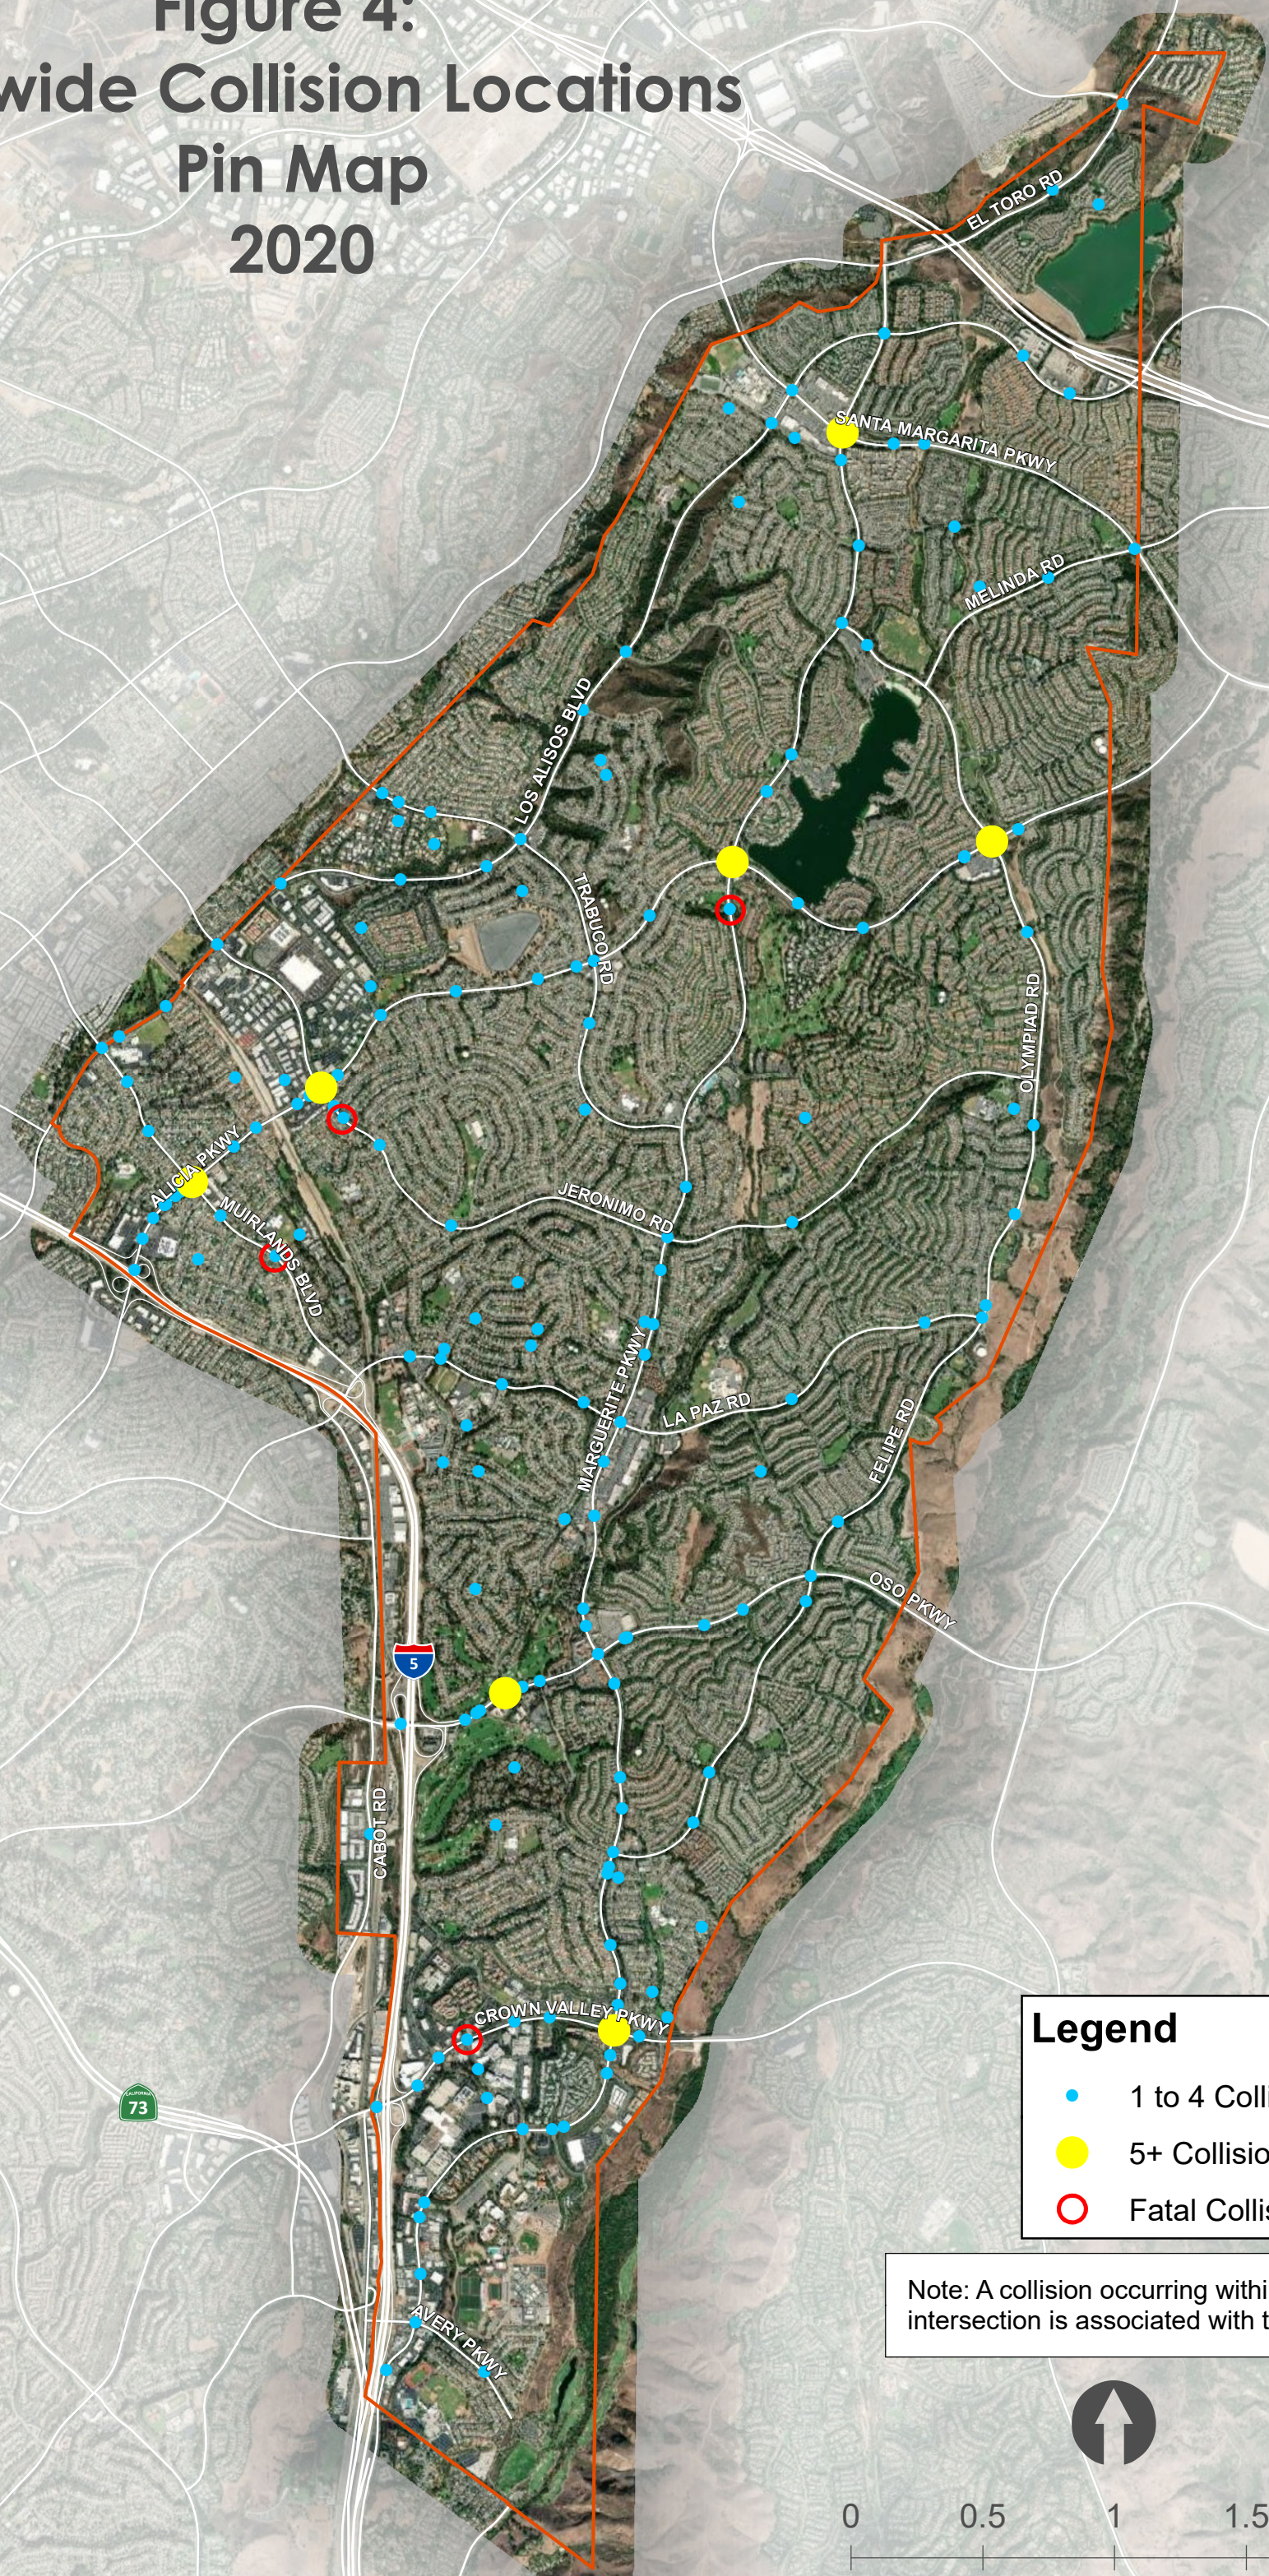
Figure 4: Citywide Collision Locations Pin Map 2020

- 1 to 4 Collisions
- 5+ Collisions
- Fatal Collision

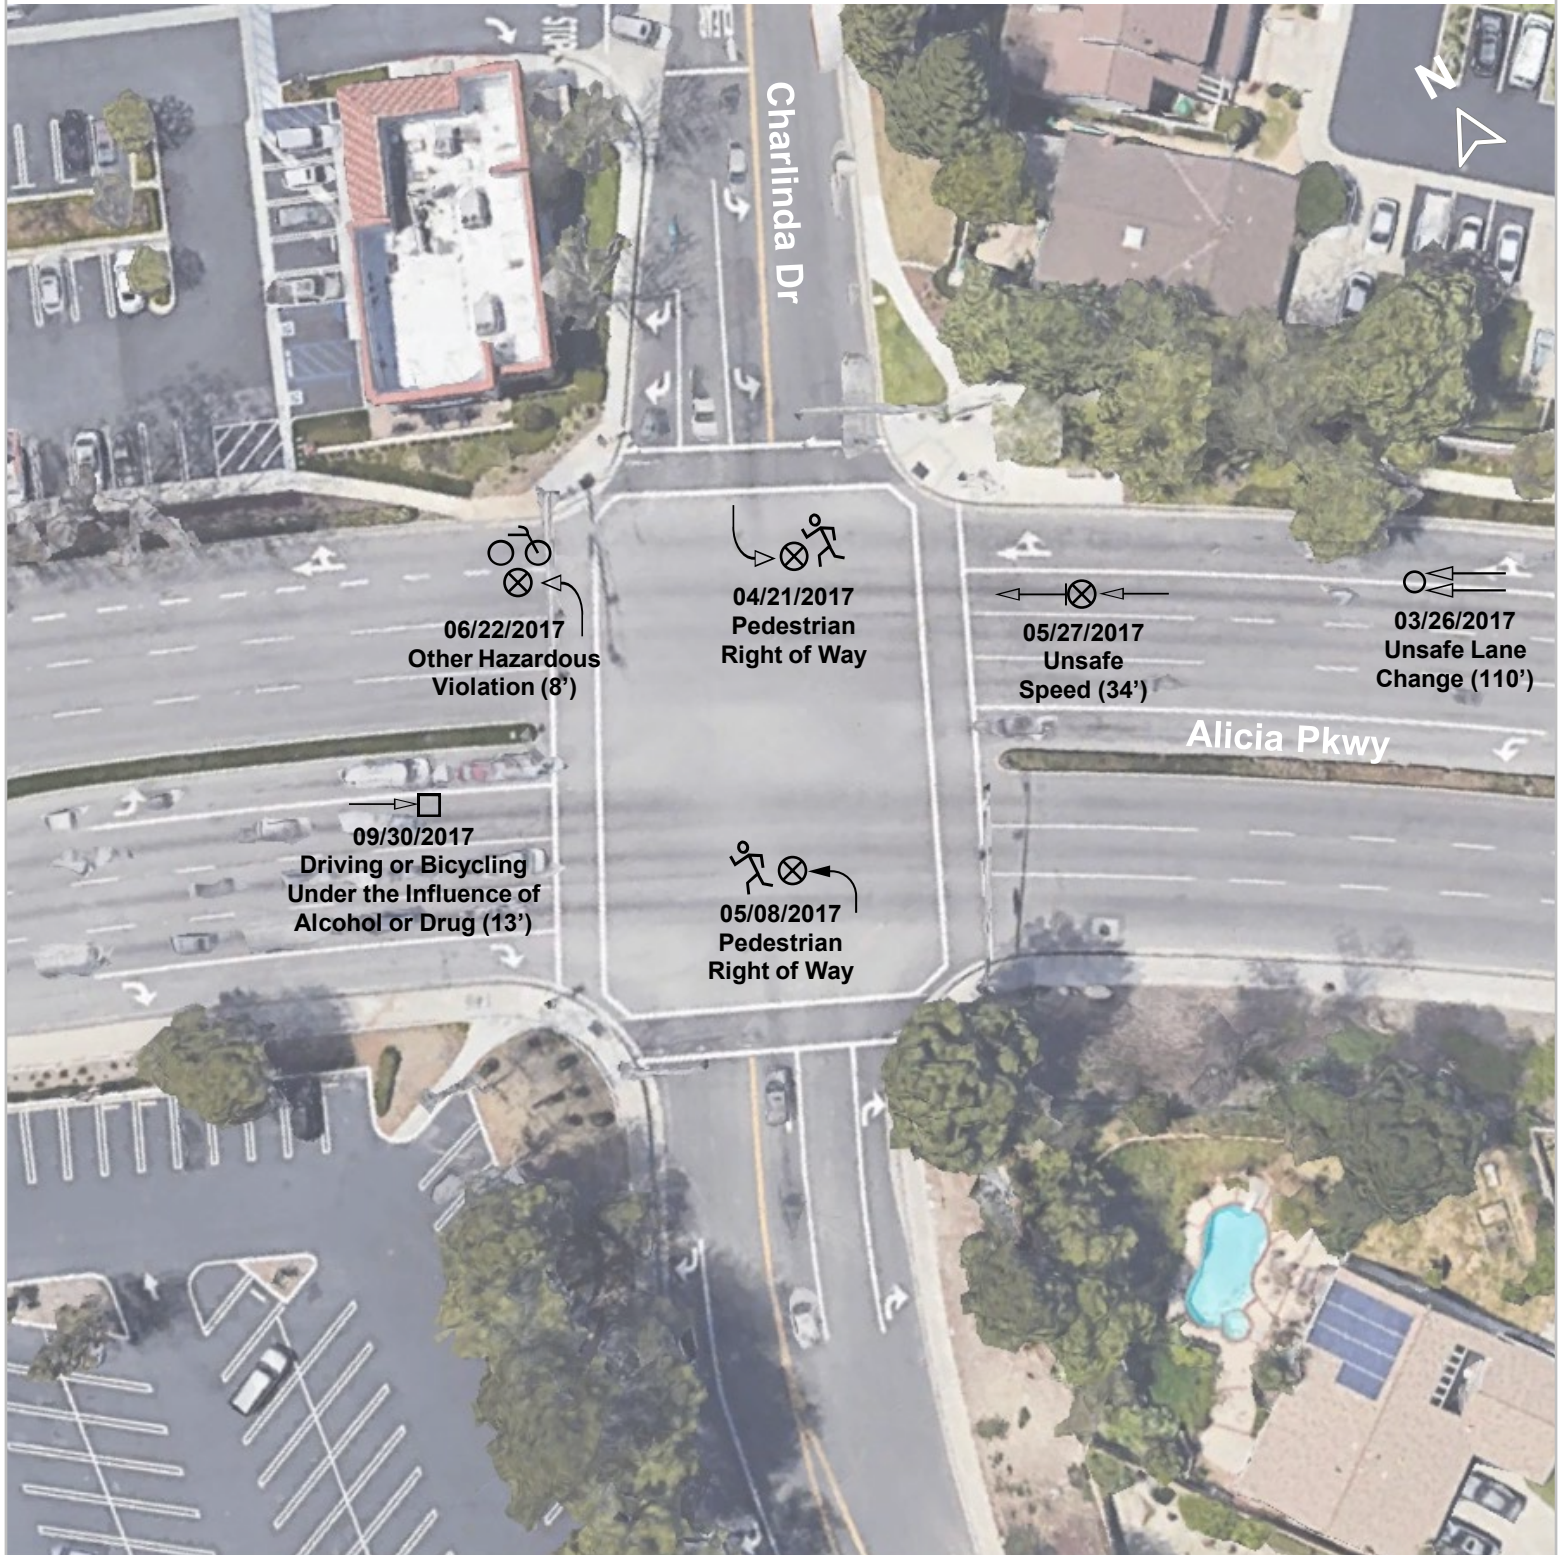
2 Property Damage Only 4 Injury Collisions 0 Fatal Collisions 6 Total Collisions

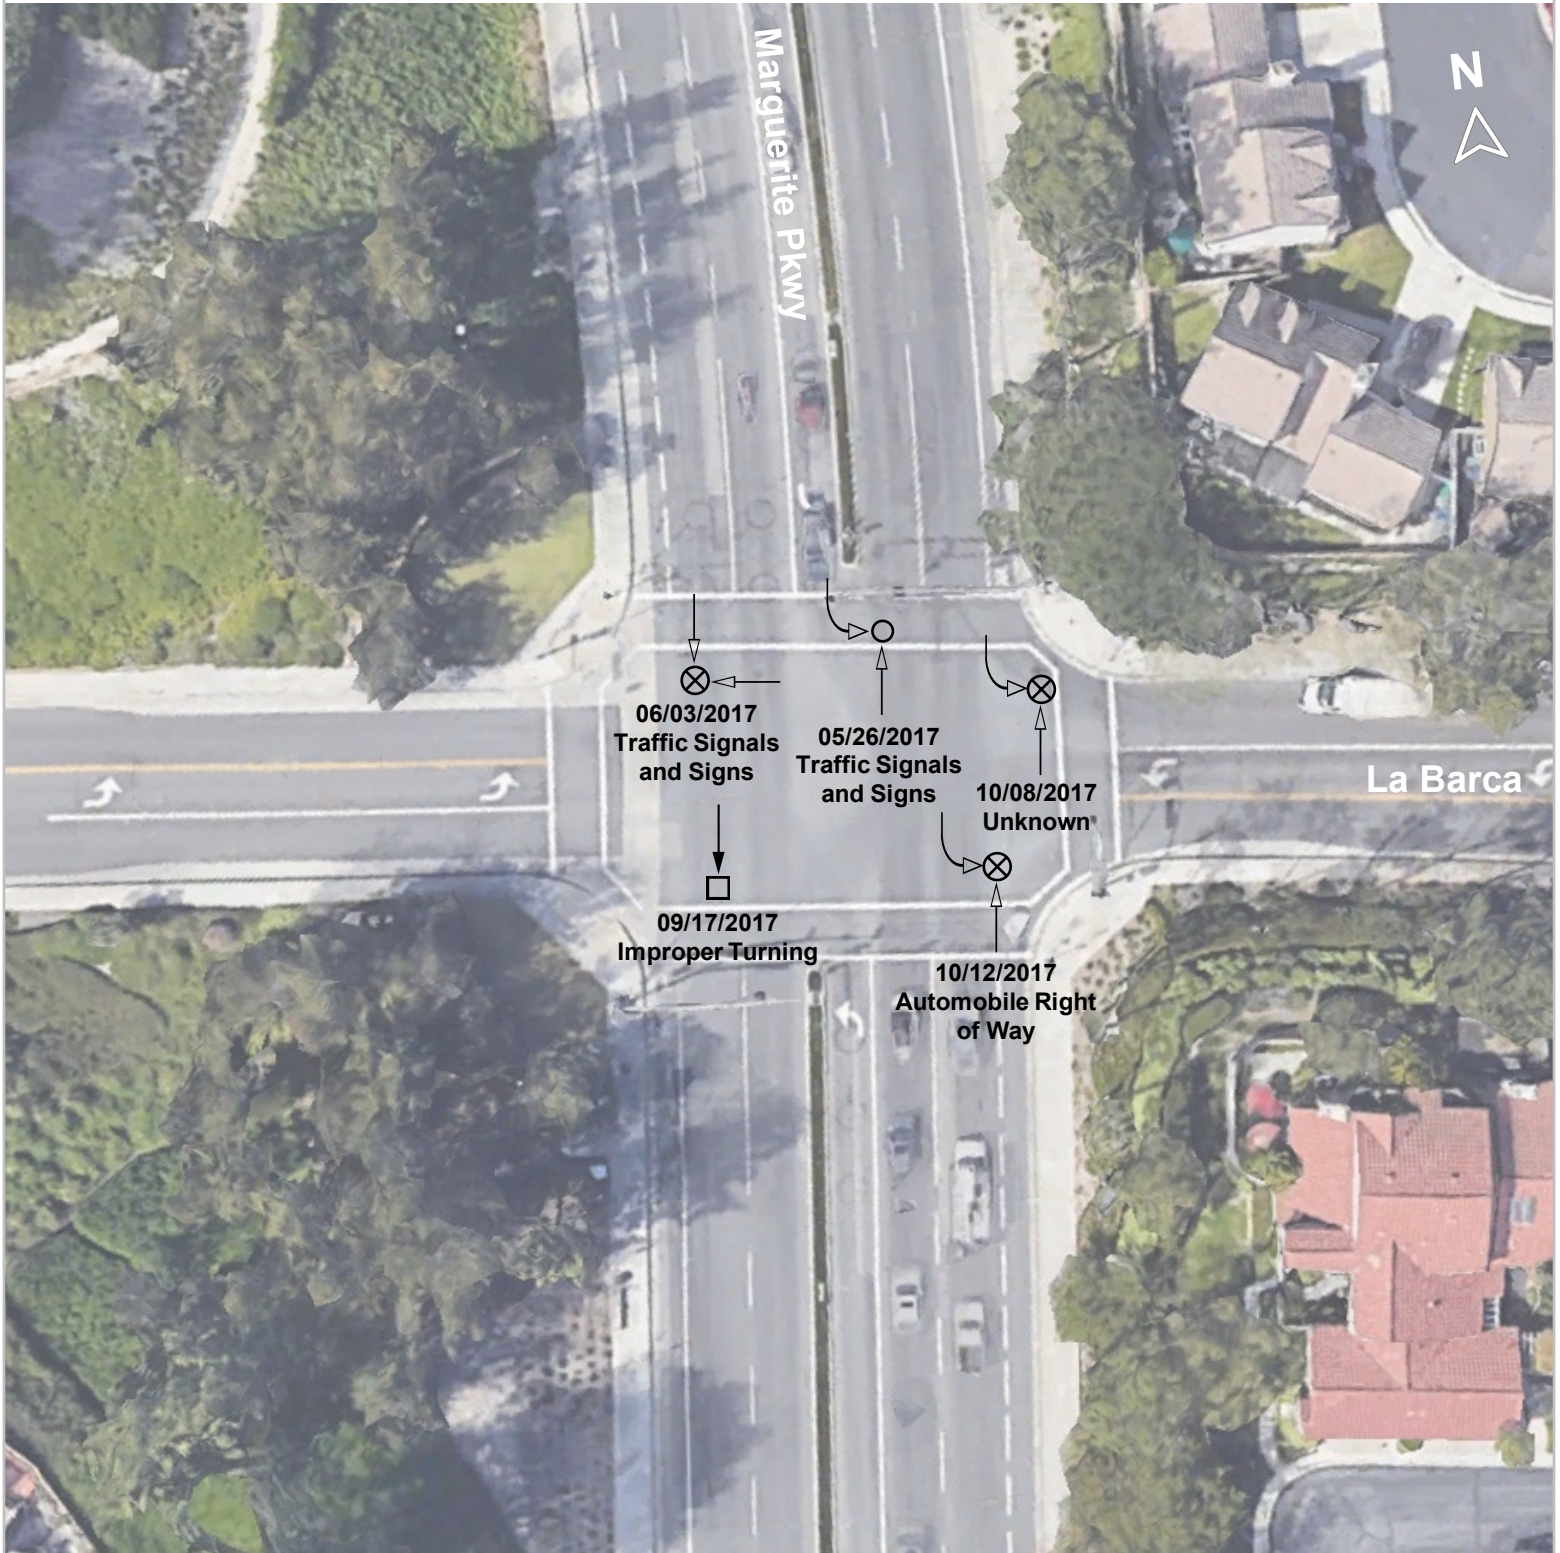
North-South Street: **La Barca**

2 Property Damage Only 3 Injury Collisions 0 Fatal Collisions 5 Total Collisions

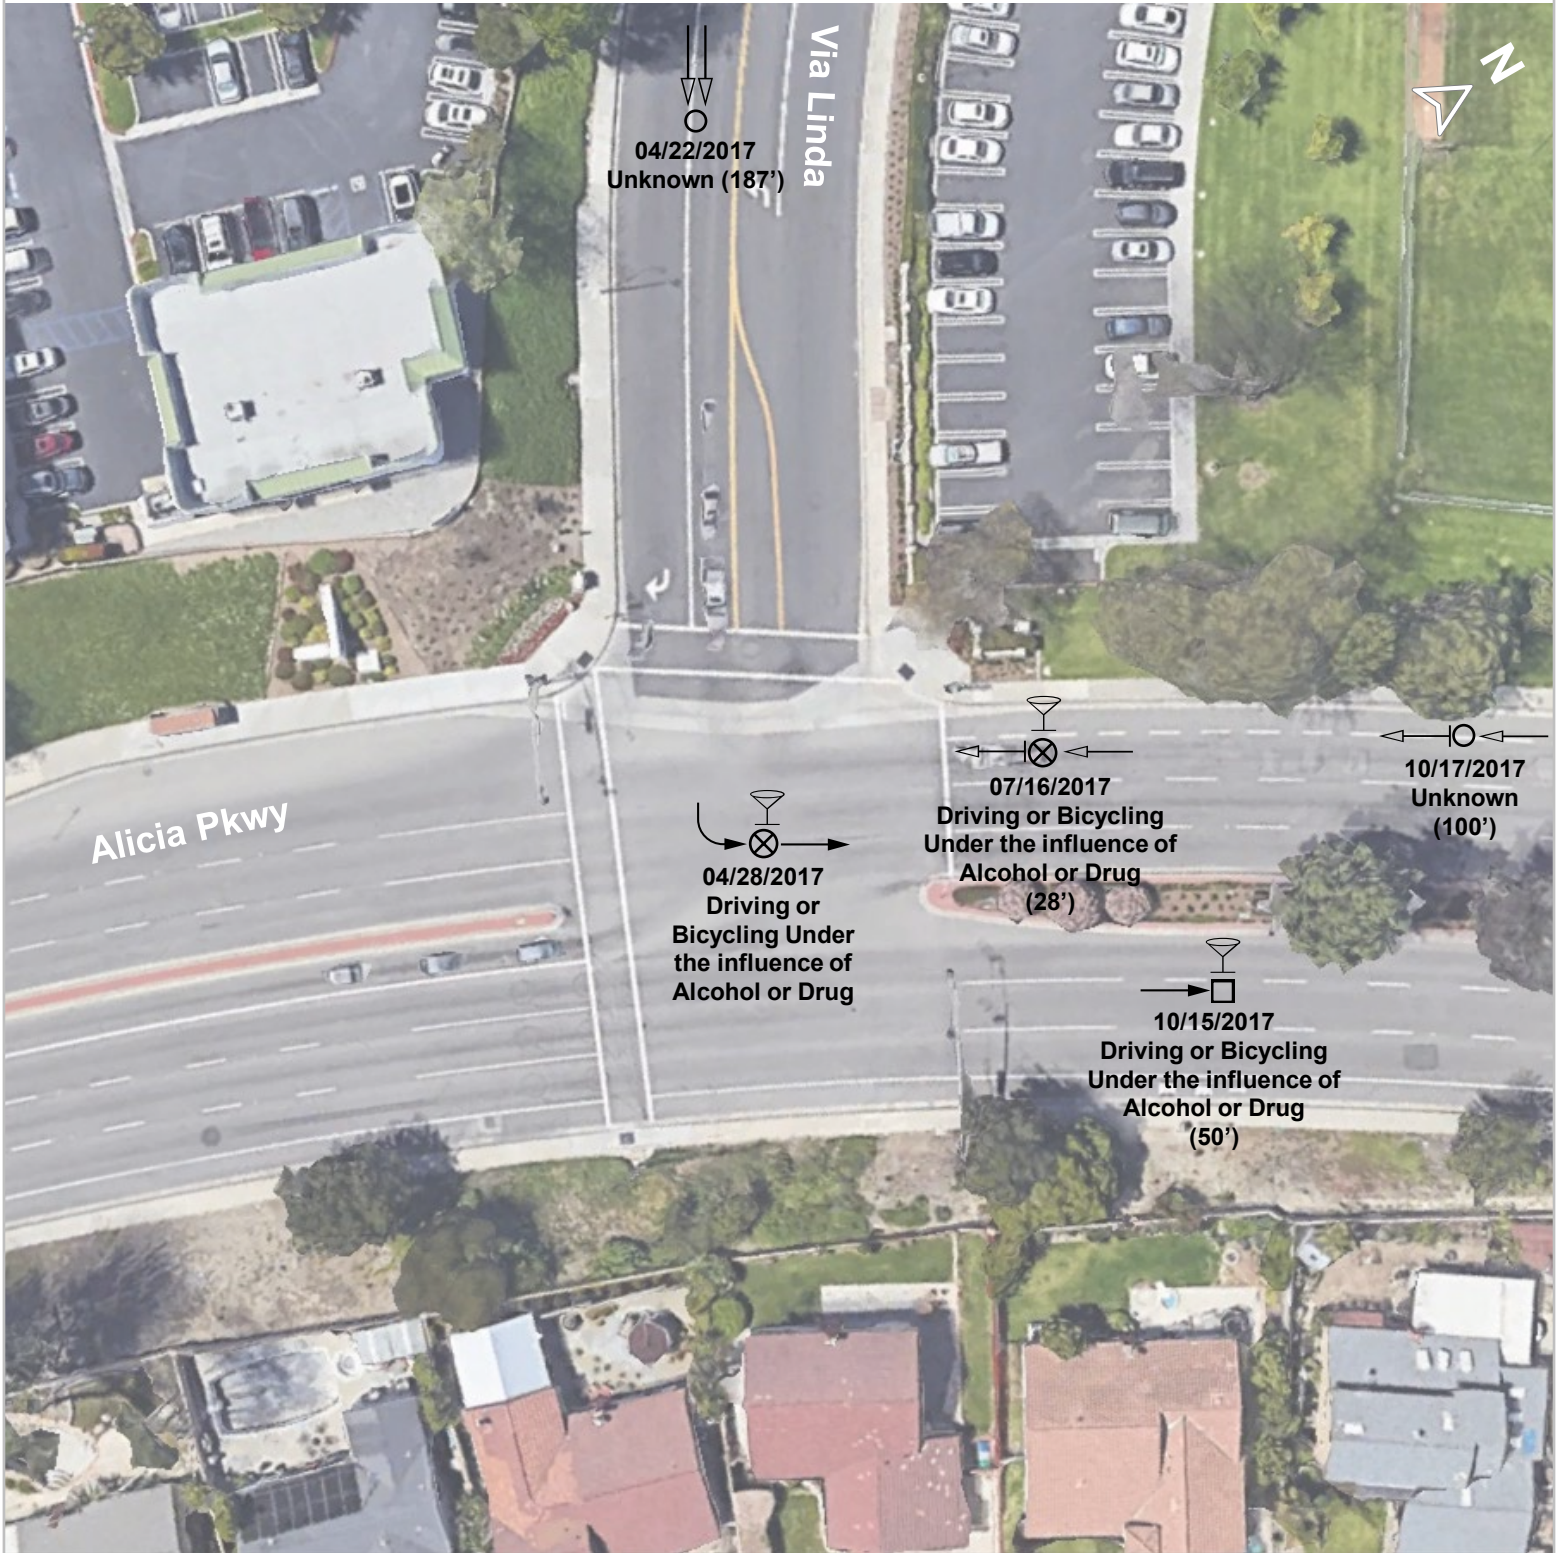
North-South Street: **Via Linda**

3 Property Damage Only 2 Injury Collisions 0 Fatal Collisions 5 Total Collisions

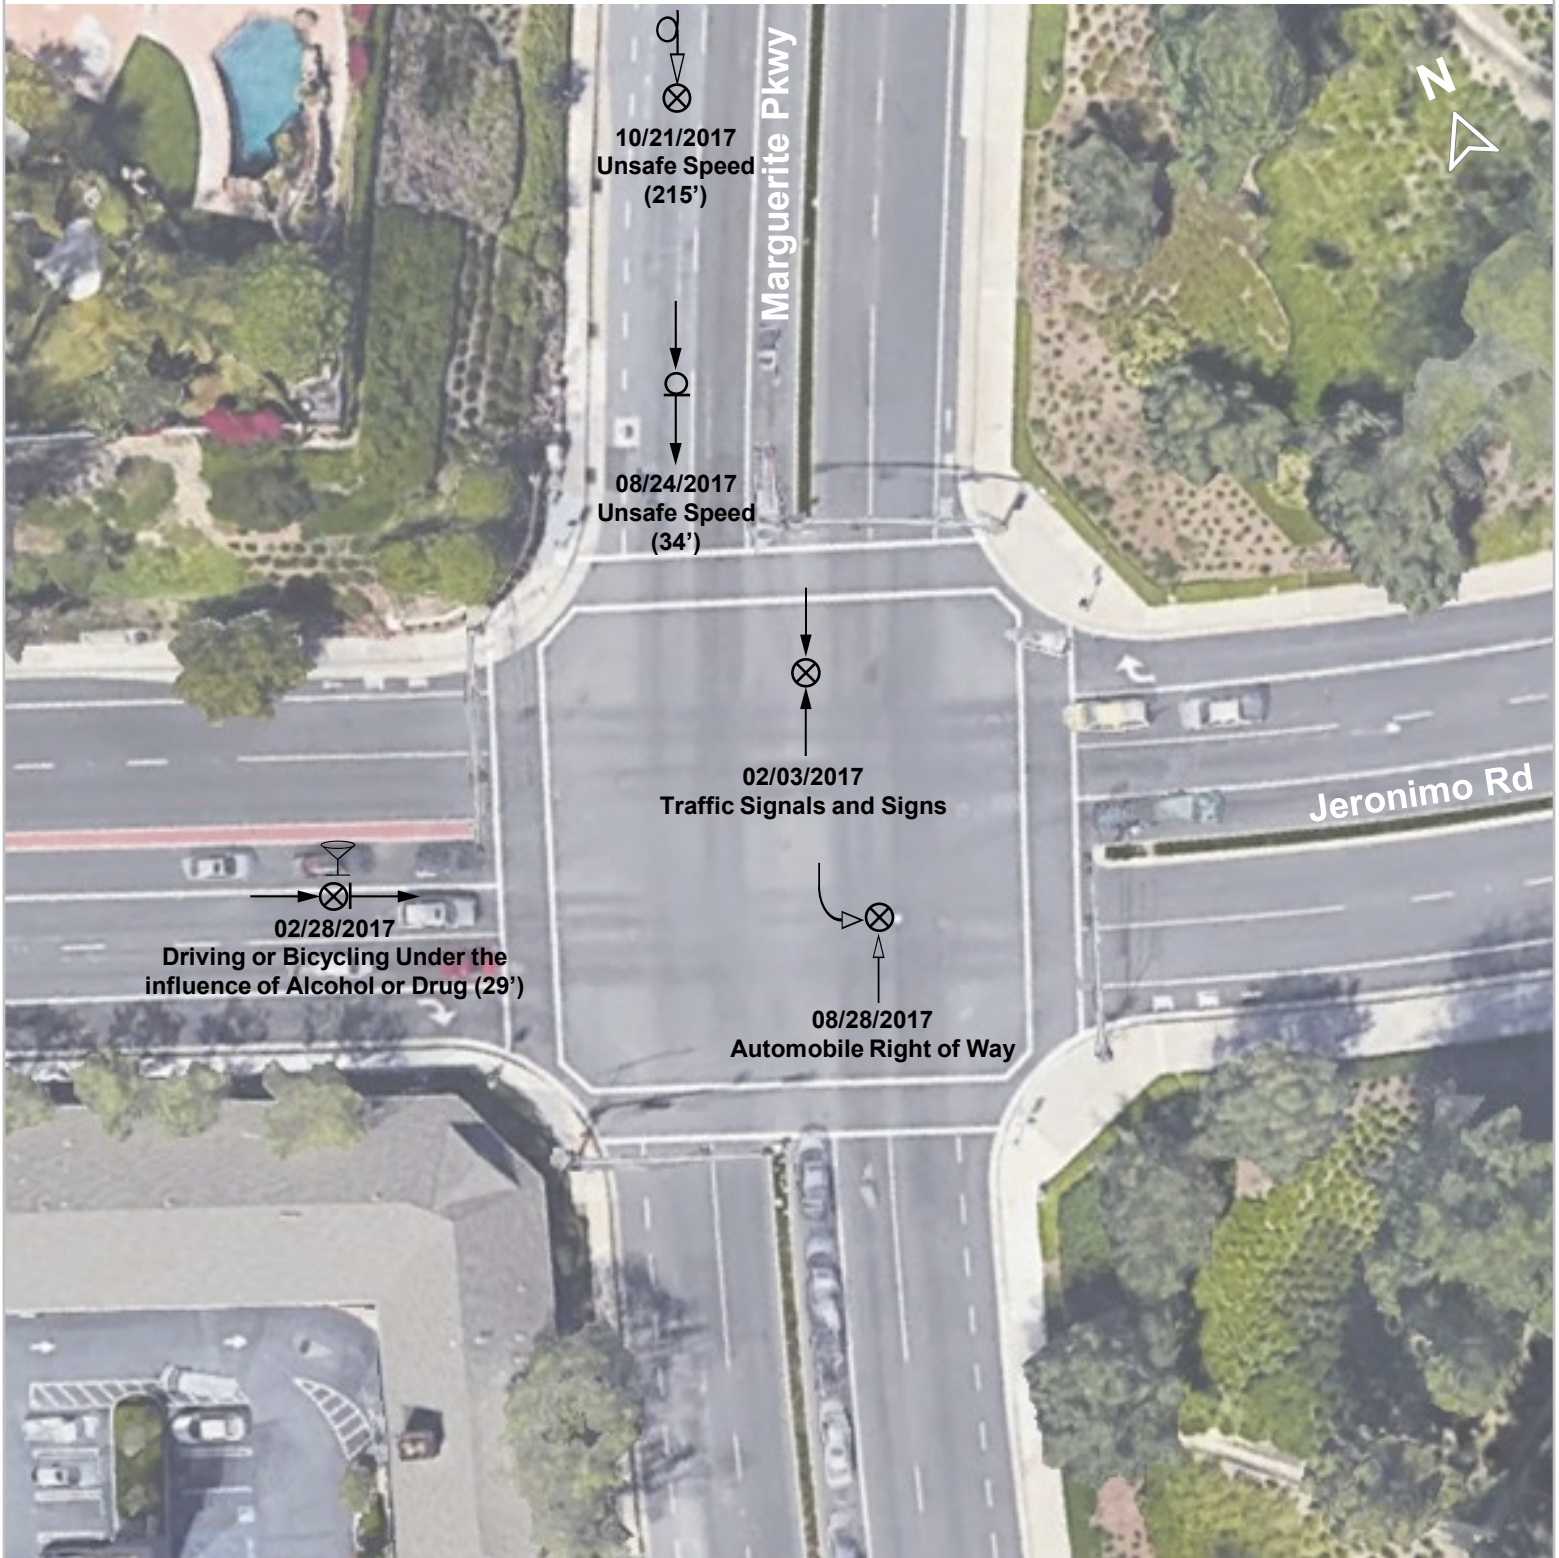
North-South Street: **Marguerite Pkwy**

1 Property Damage Only 4 Injury Collisions 0 Fatal Collisions 5 Total Collisions

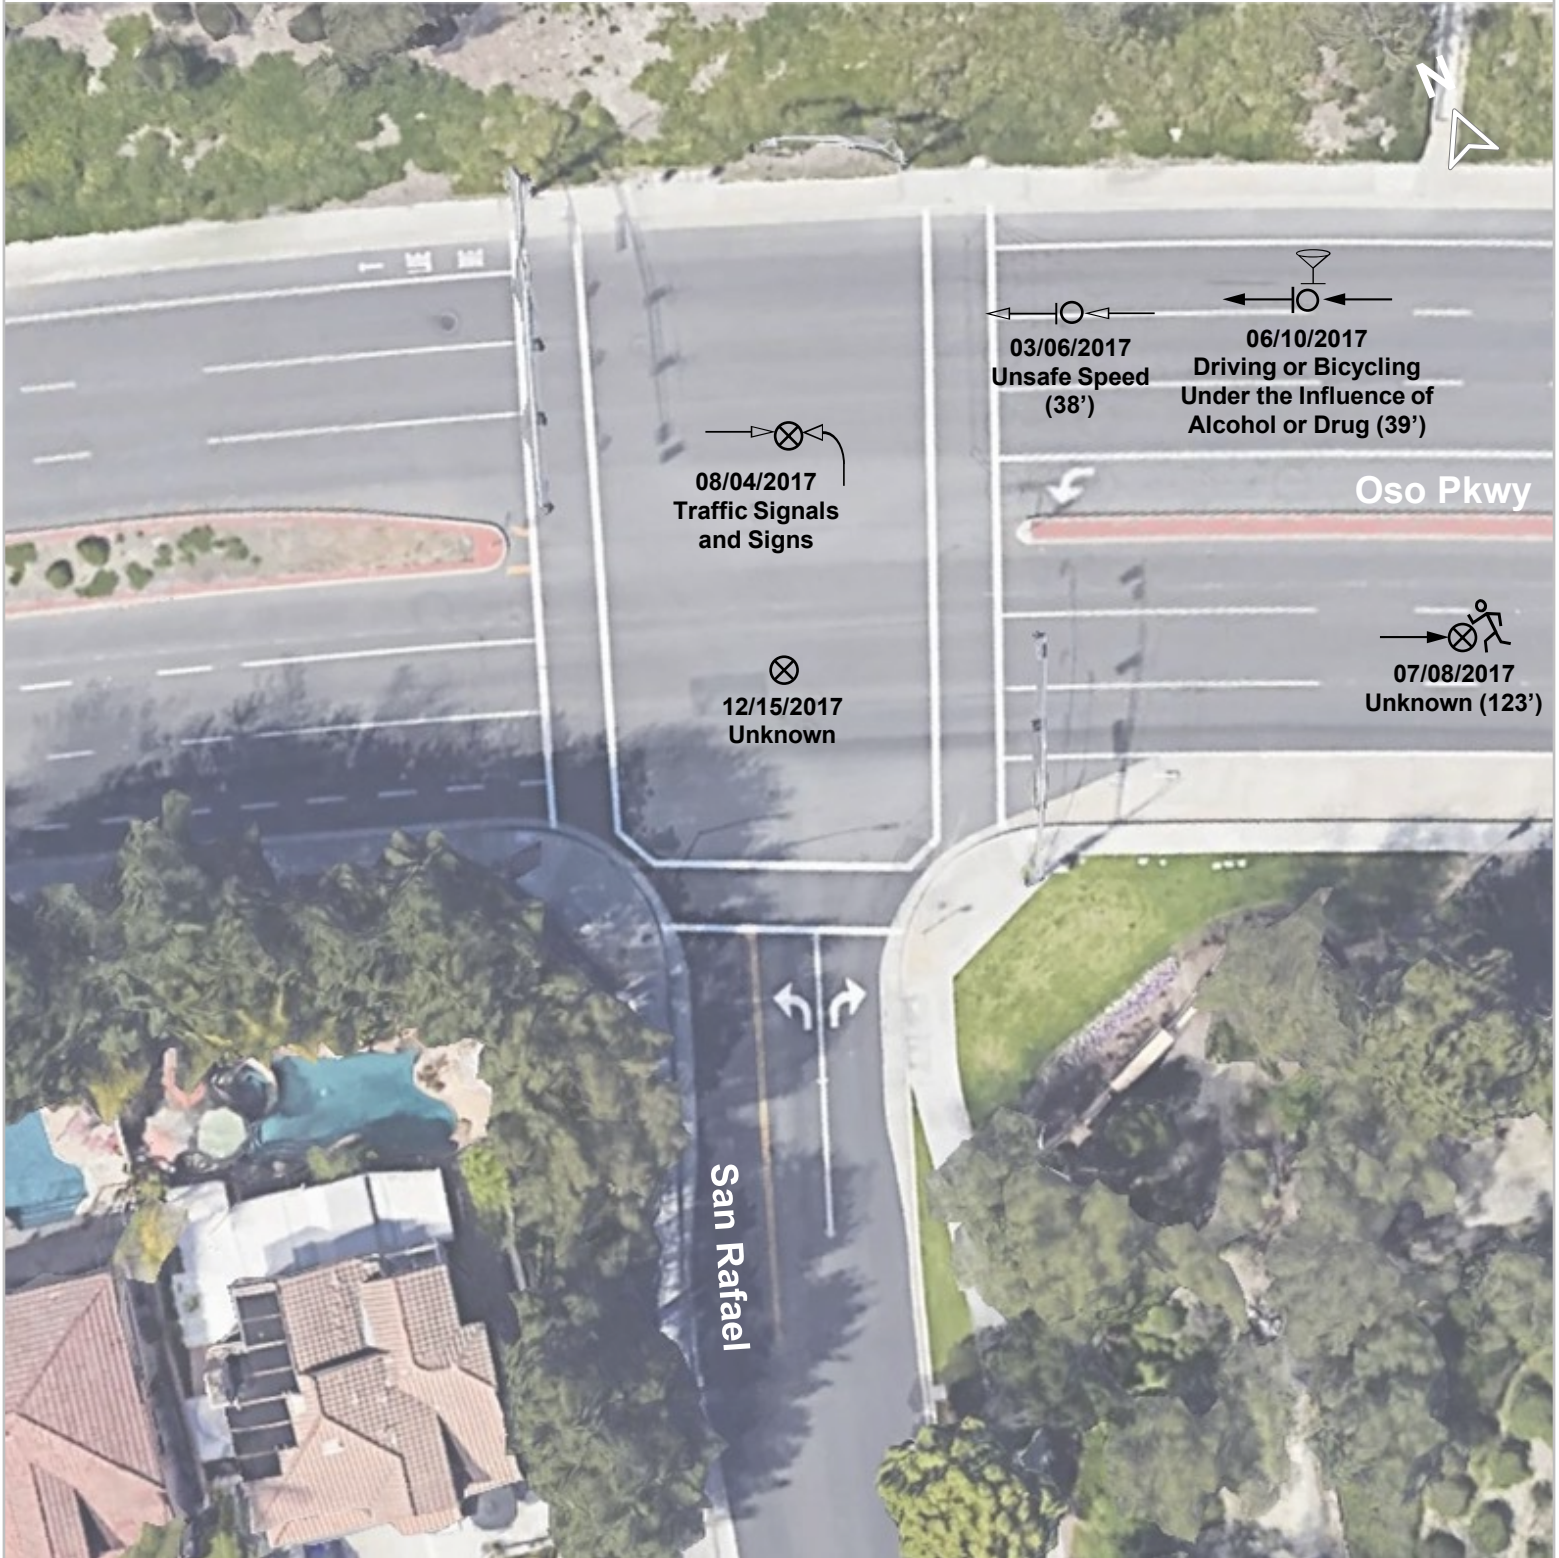
North-South Street: **San Rafael**

2 Property Damage Only 2 Injury Collisions 1 Fatal Collisions 5 Total Collisions

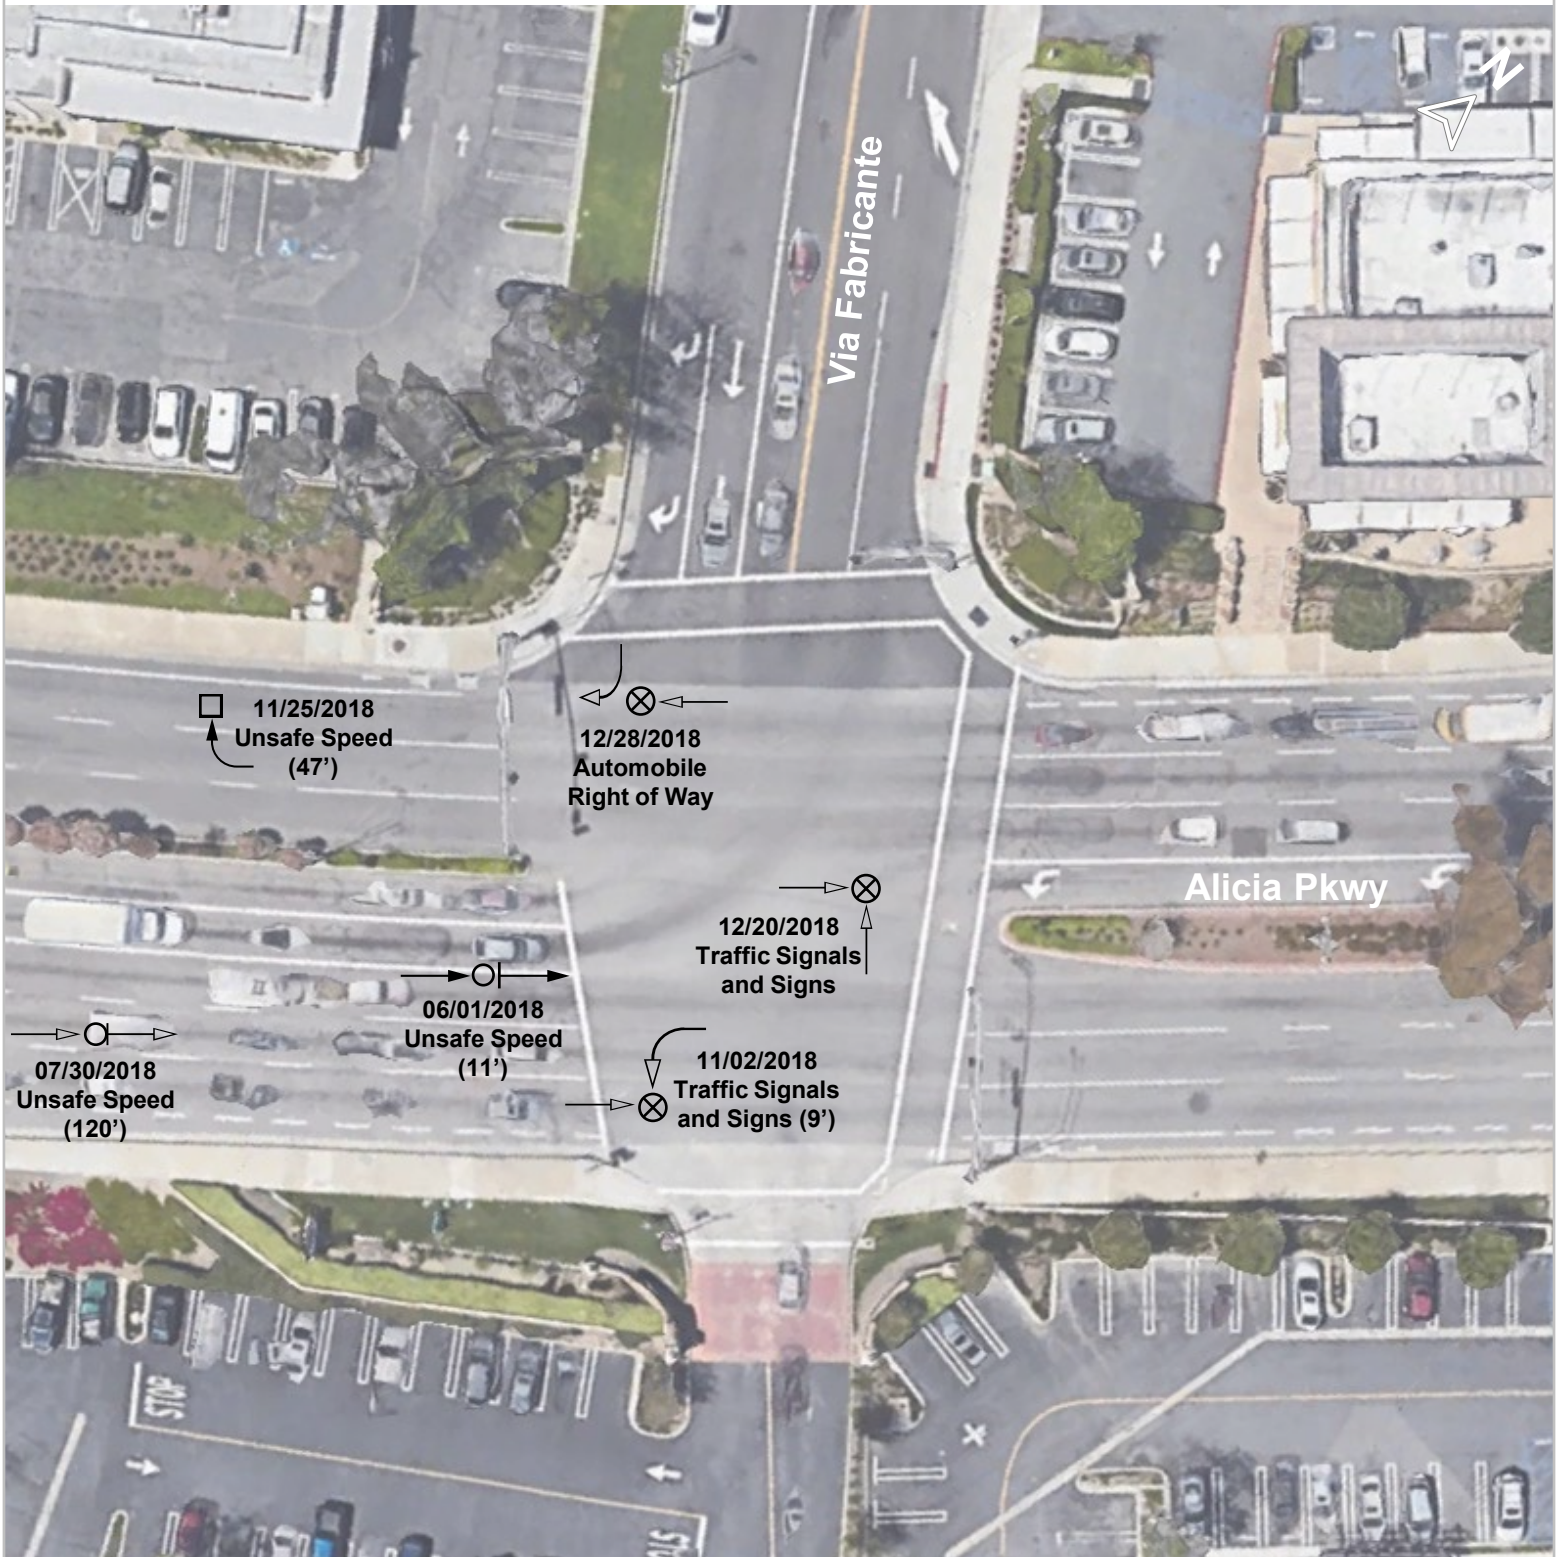
North-South Street: **Via Fabricante**

3 Property Damage Only 3 Injury Collisions 0 Fatal Collisions 6 Total Collisions

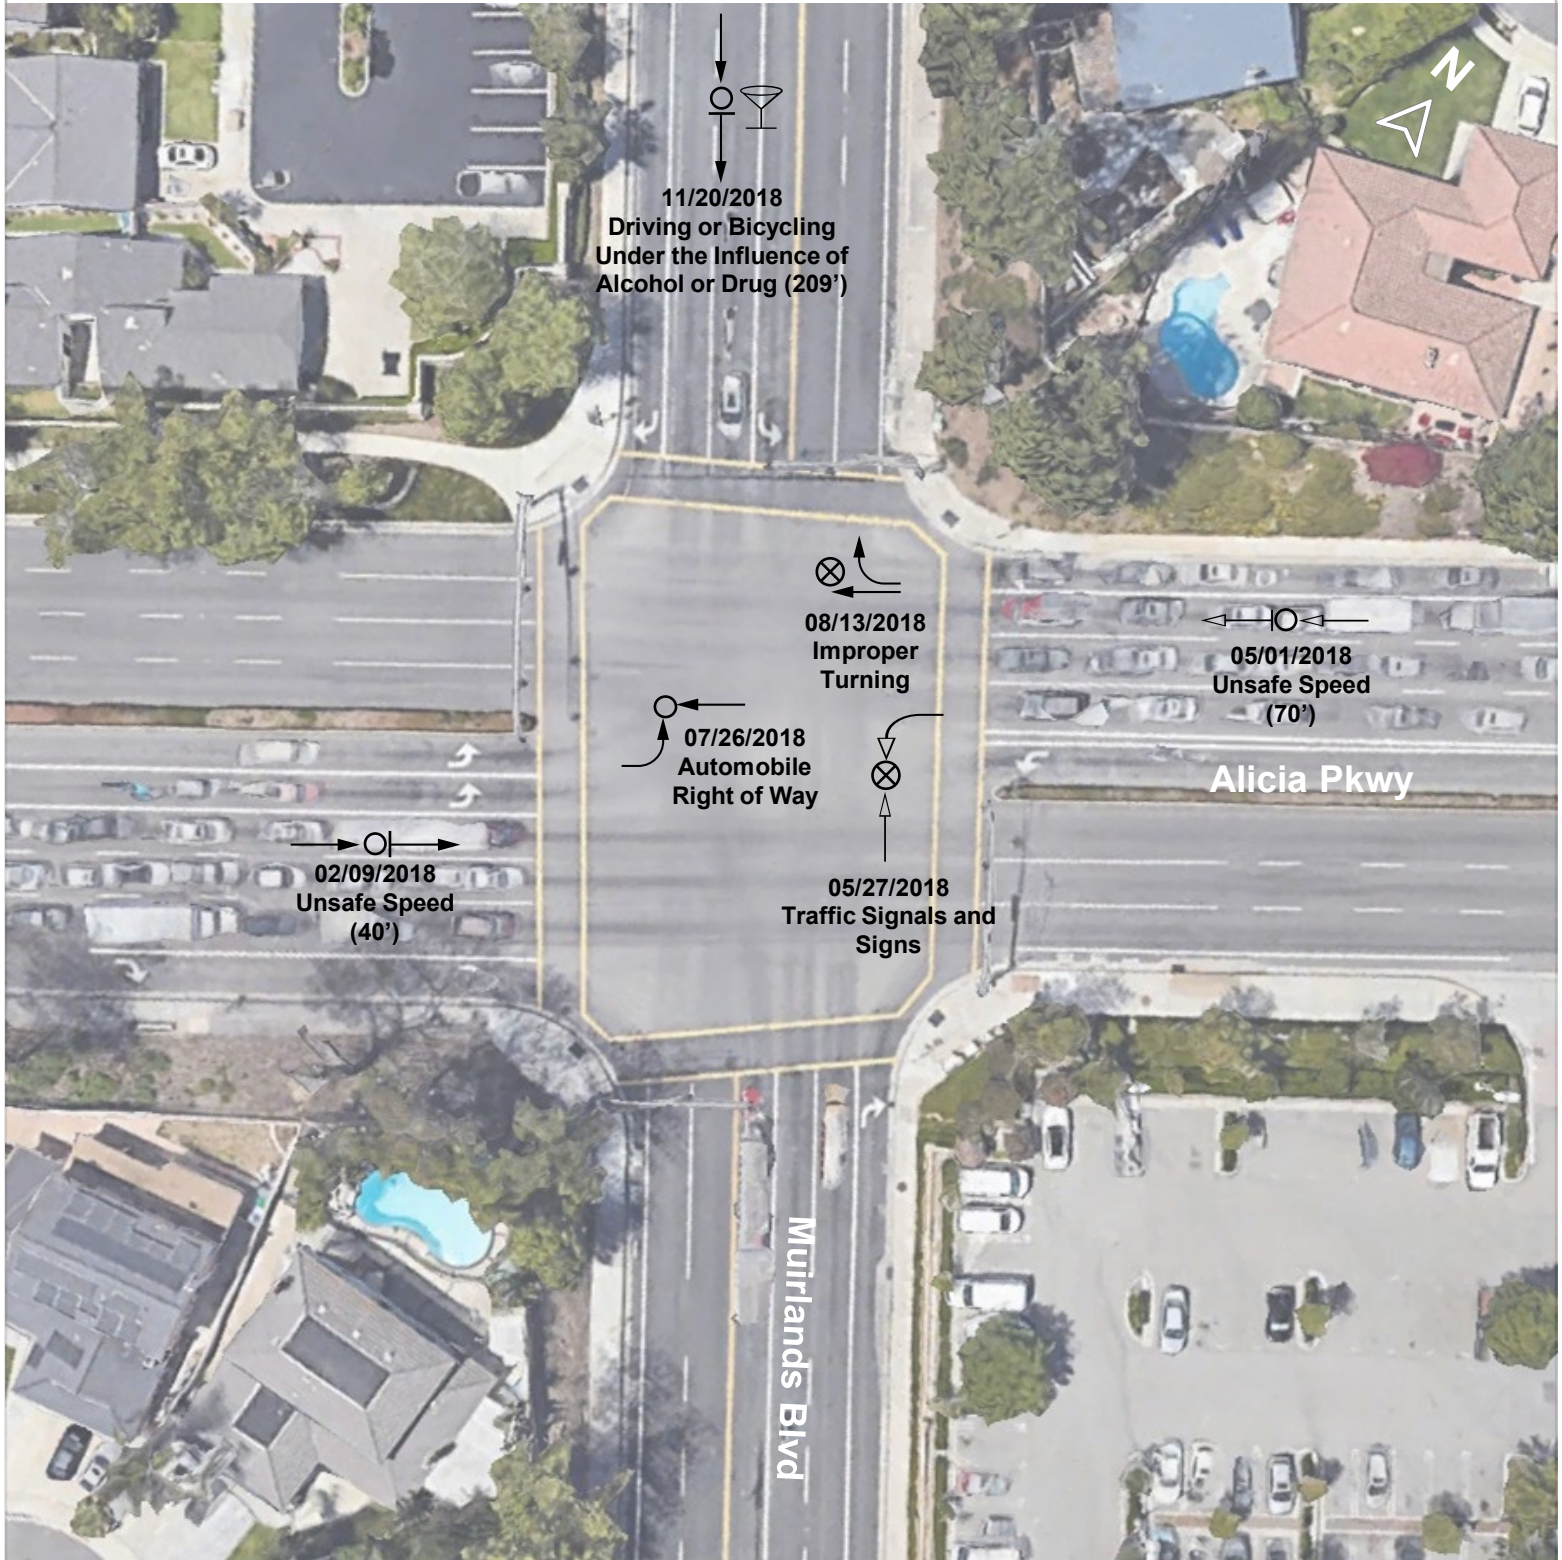
North-South Street: **Muirlands Blvd**

4 Property Damage Only 2 Injury Collisions 0 Fatal Collisions 6 Total Collisions

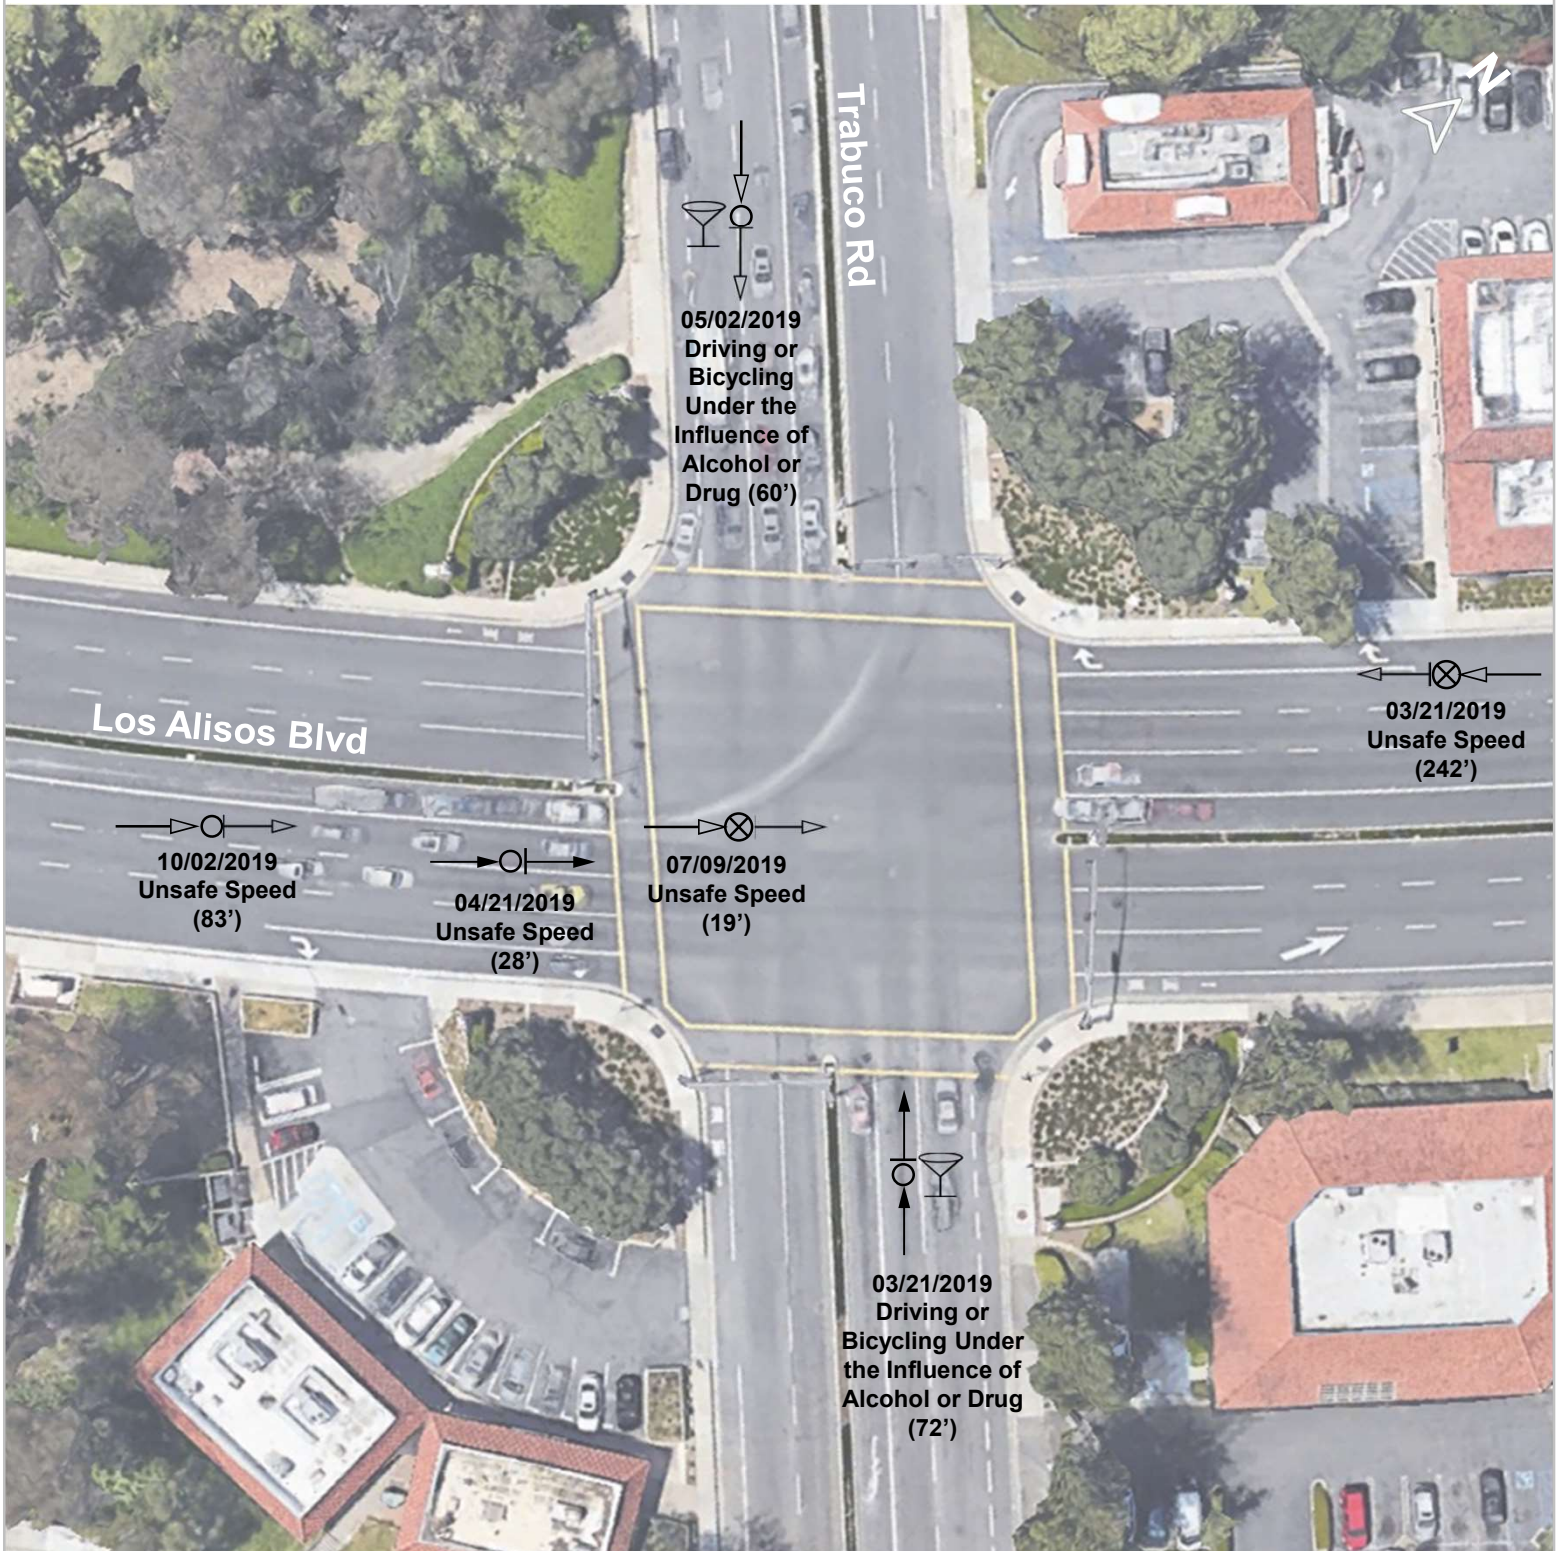
North-South Street: **Trabuco Rd**

4 Property Damage Only 2 Injury Collisions 0 Fatal Collisions 6 Total Collisions
