Mission Viejo

SYSTEMIC SAFETY ANALYSIS REPORT & LOCAL ROAD SAFETY PLAN

December 2021

Prepared by:
Kittelson & Associates, Inc.
750 The City Drive, Suite 410
Orange, CA 92868
714.468.1997

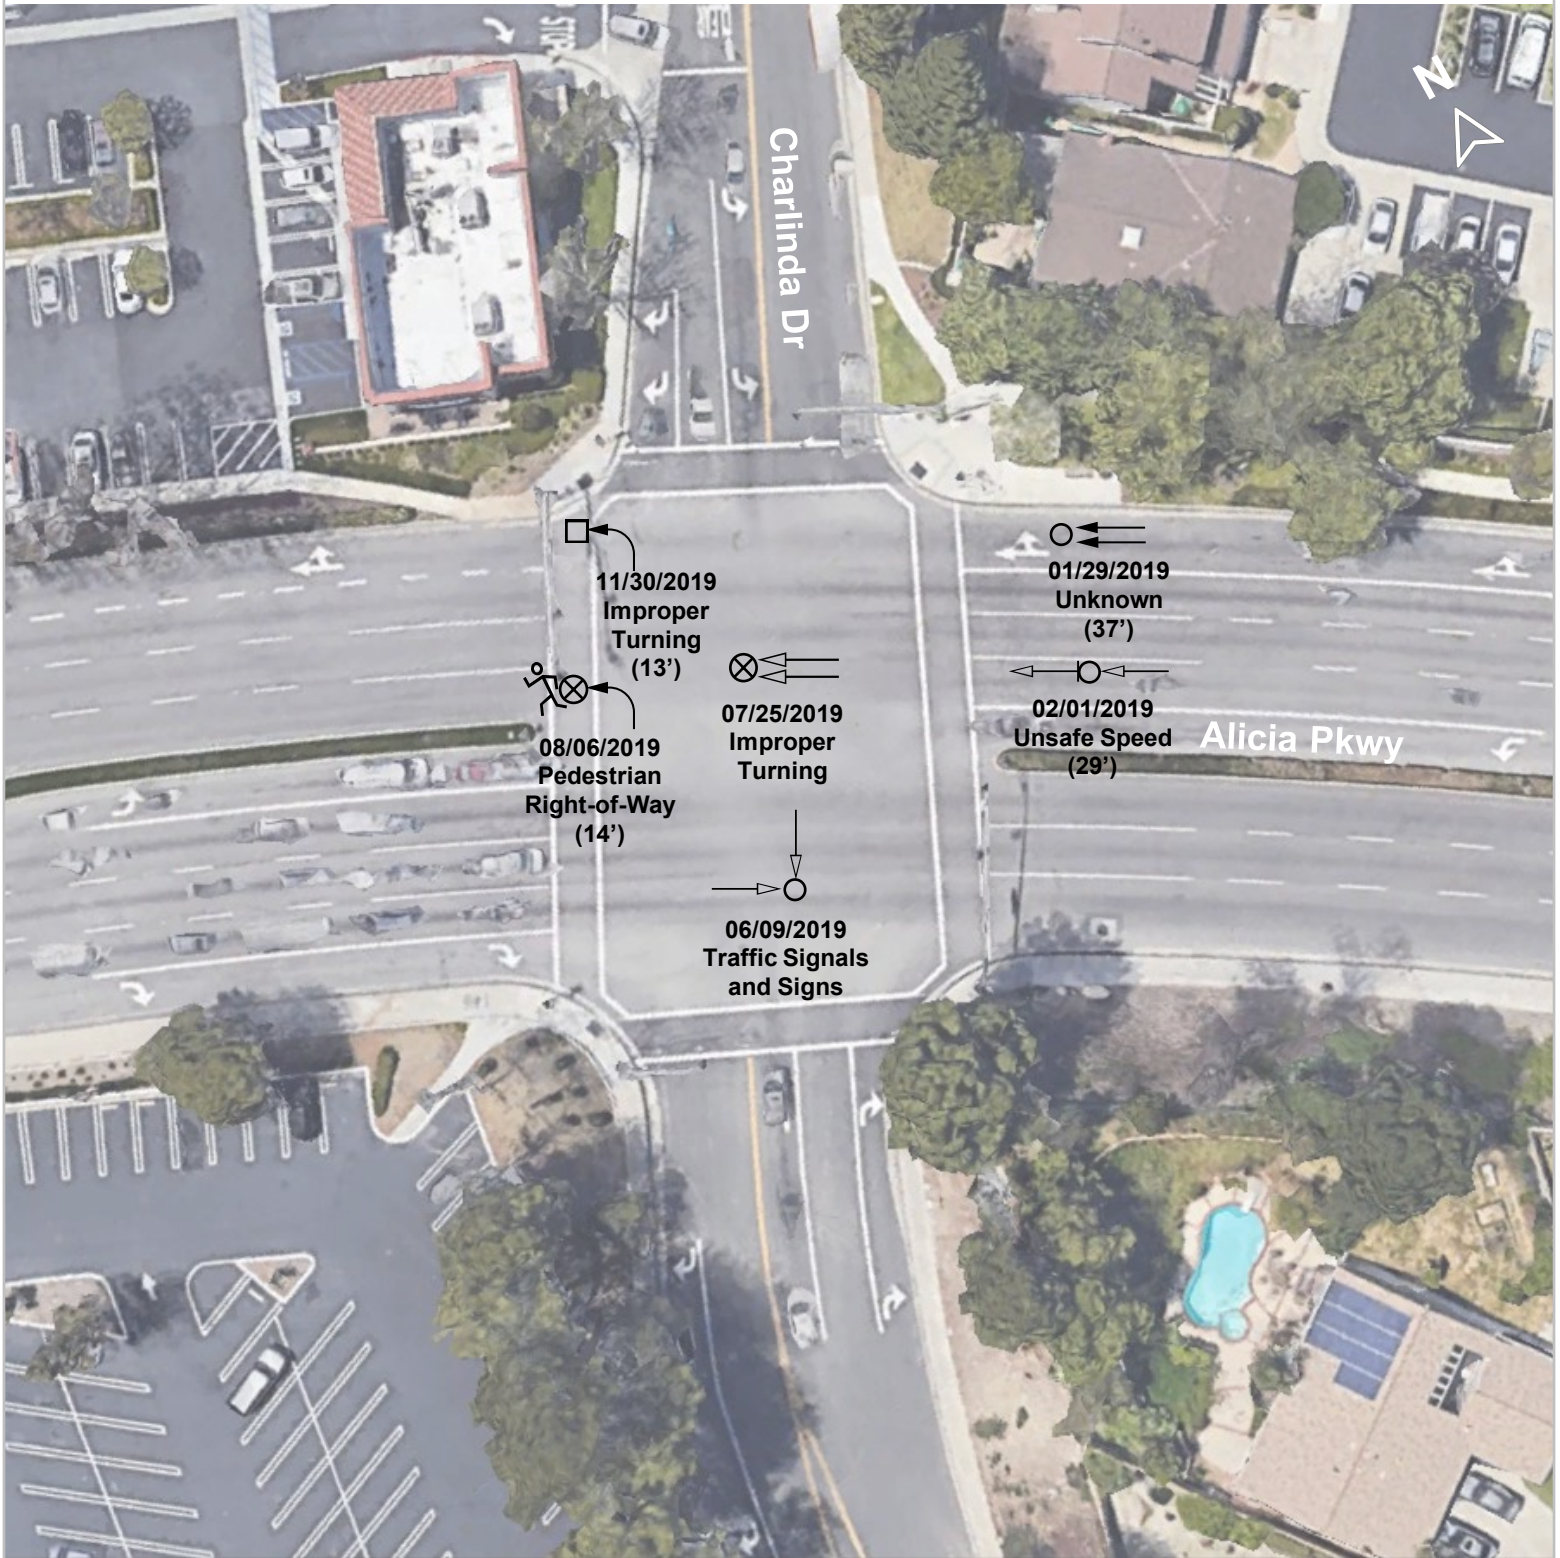
North-South Street: **Charlinda Dr**

<u>4</u> Property Damage Only	<u>2</u> Injury Collisions	<u>0</u> Fatal Collisions	<u>6</u> Total Collisions
-------------------------------	----------------------------	---------------------------	---------------------------

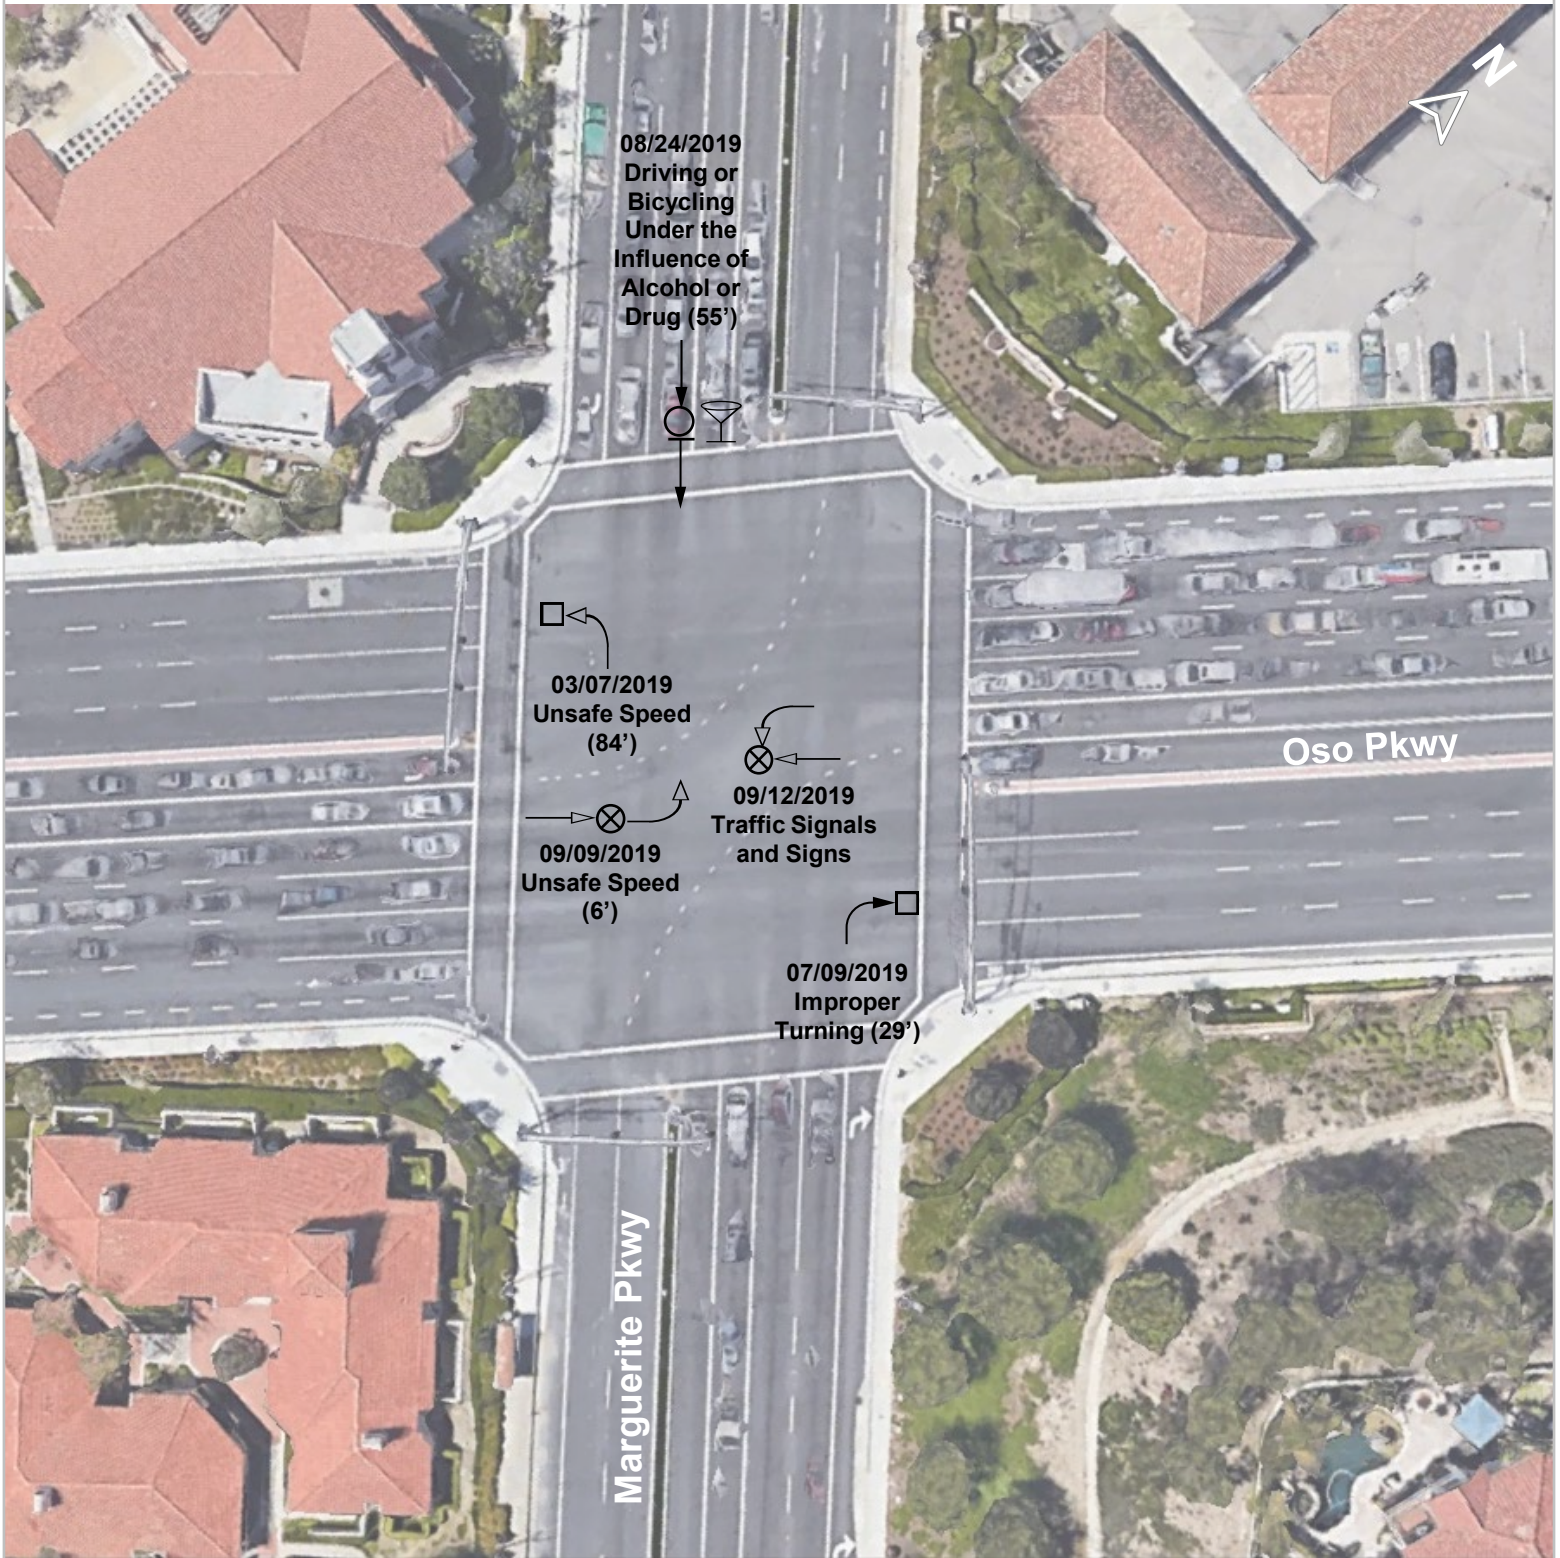
North-South Street: **Marguerite Pkwy**

3 Property Damage Only 2 Injury Collisions 0 Fatal Collisions 5 Total Collisions

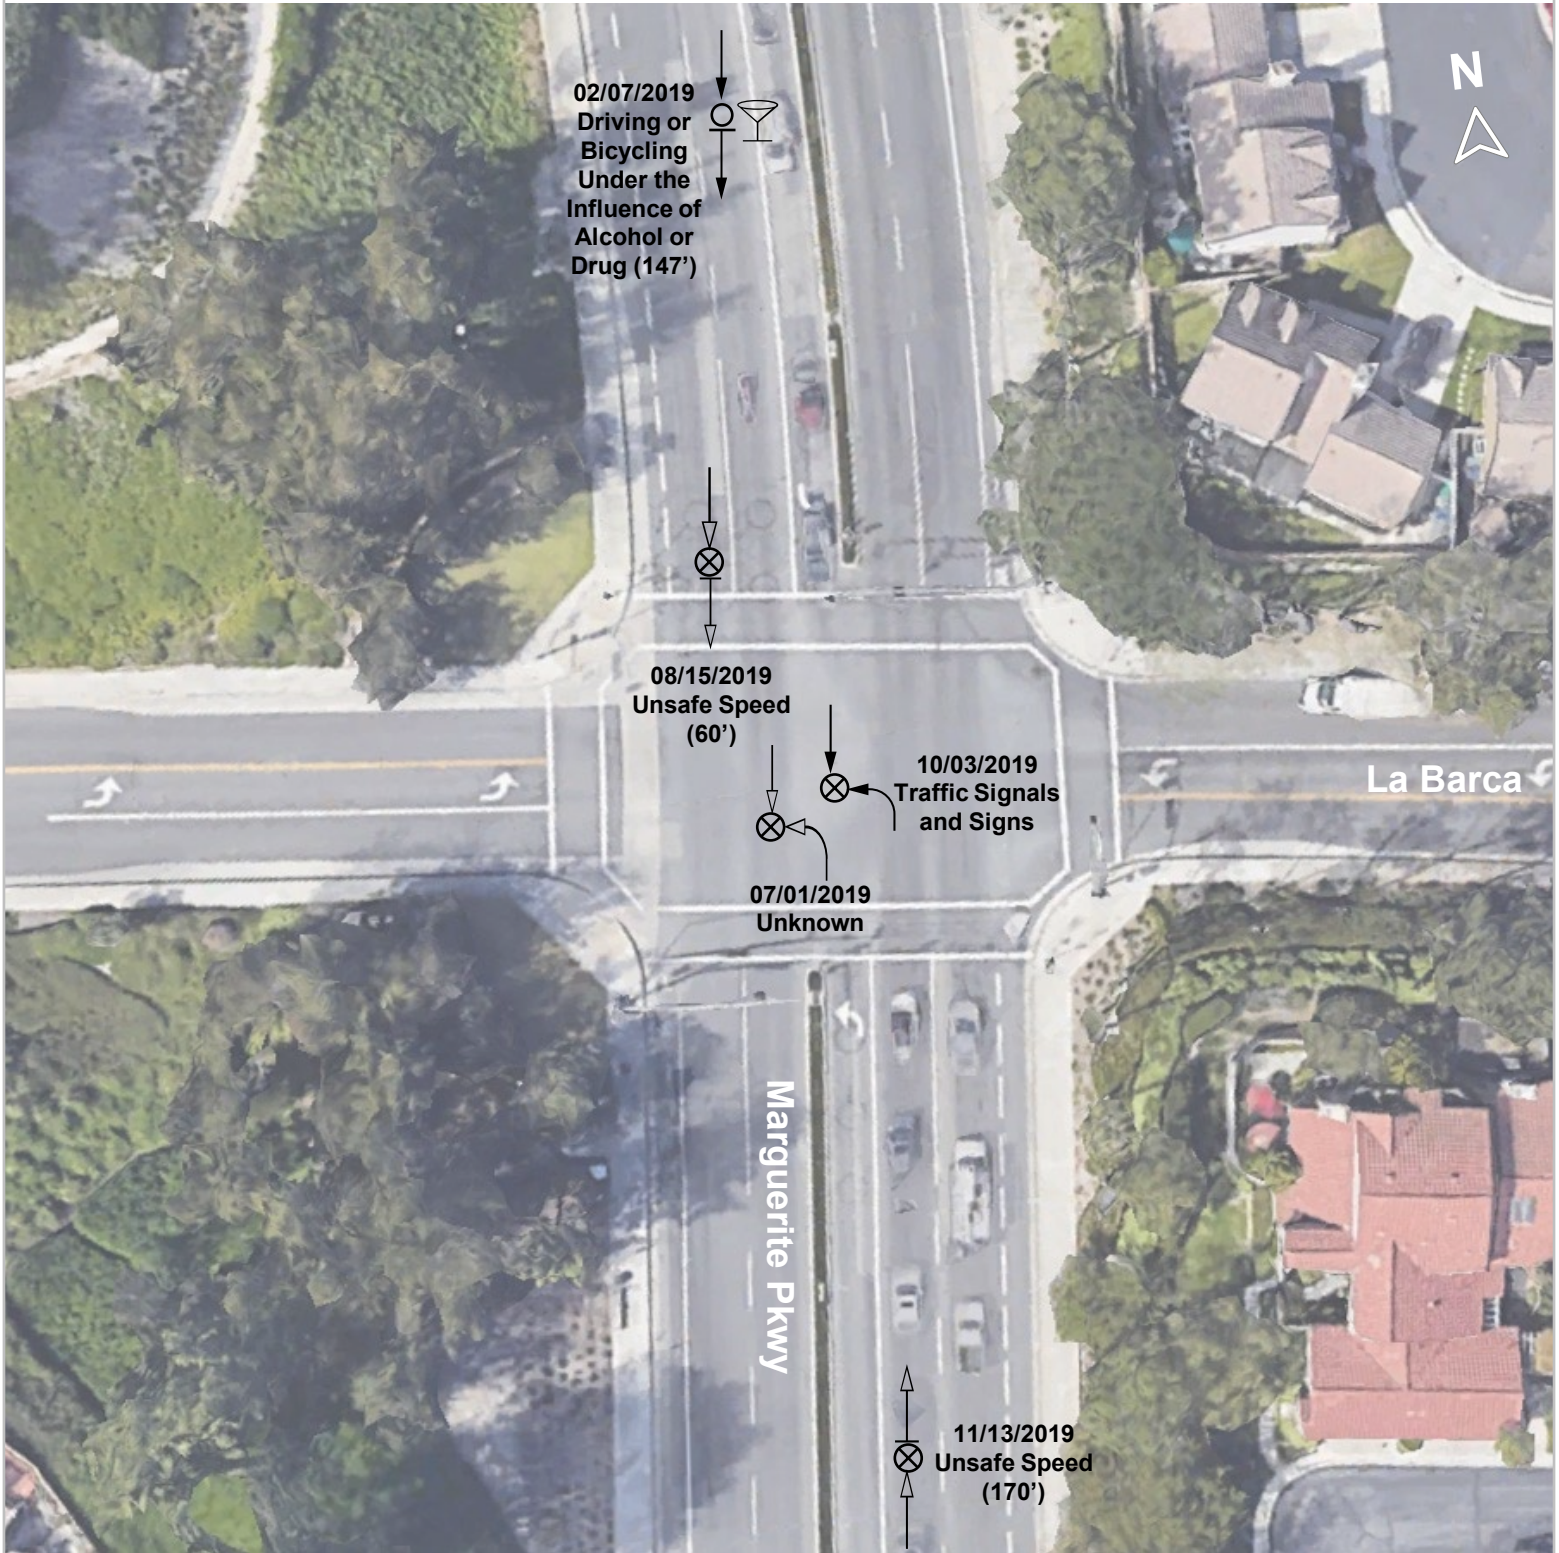
North-South Street: **Marguerite Pkwy**

1 Property Damage Only 4 Injury Collisions 0 Fatal Collisions 5 Total Collisions

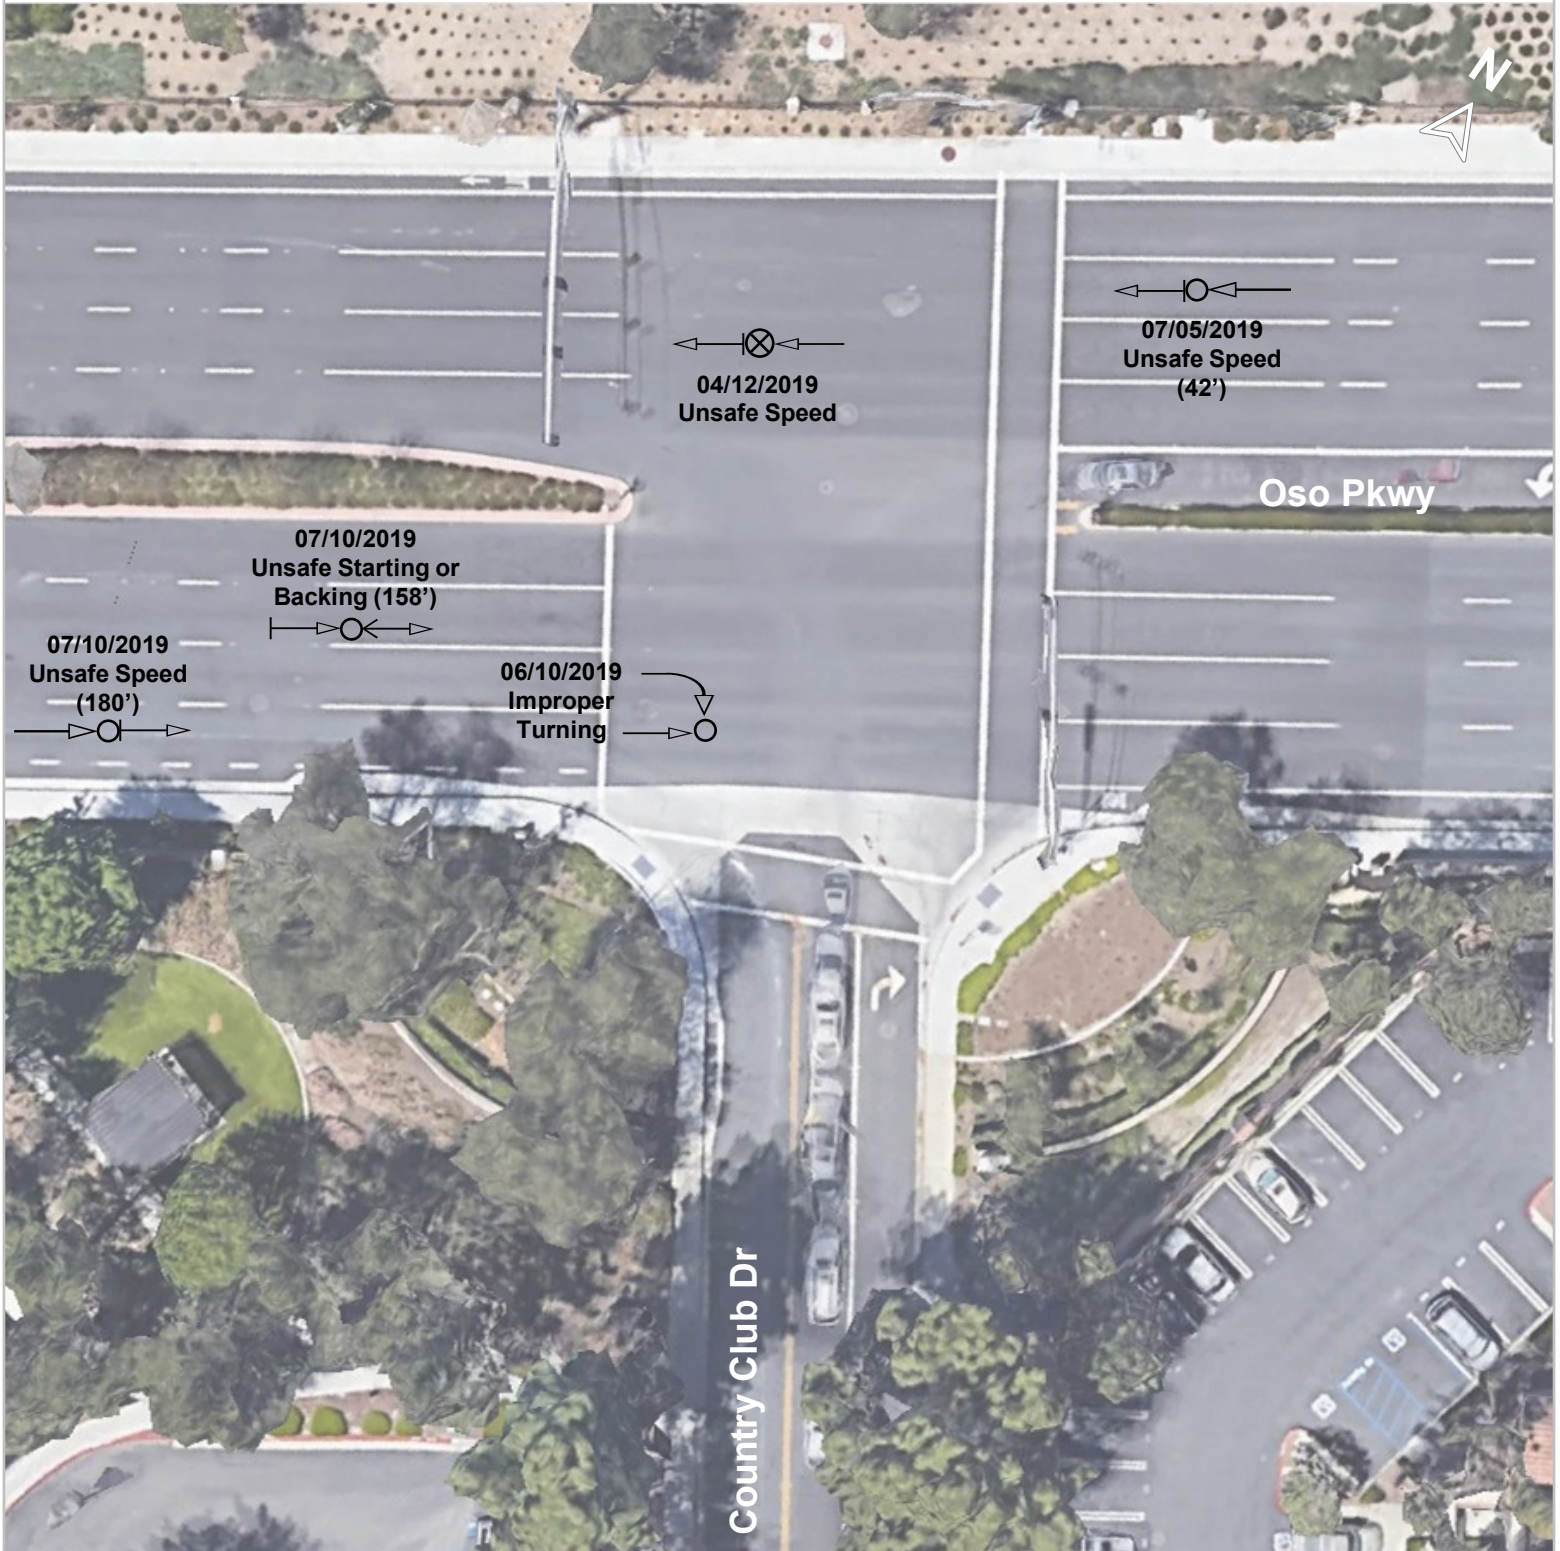
North-South Street: **Country Club Dr**

4 Property Damage Only 1 Injury Collisions 0 Fatal Collisions 5 Total Collisions

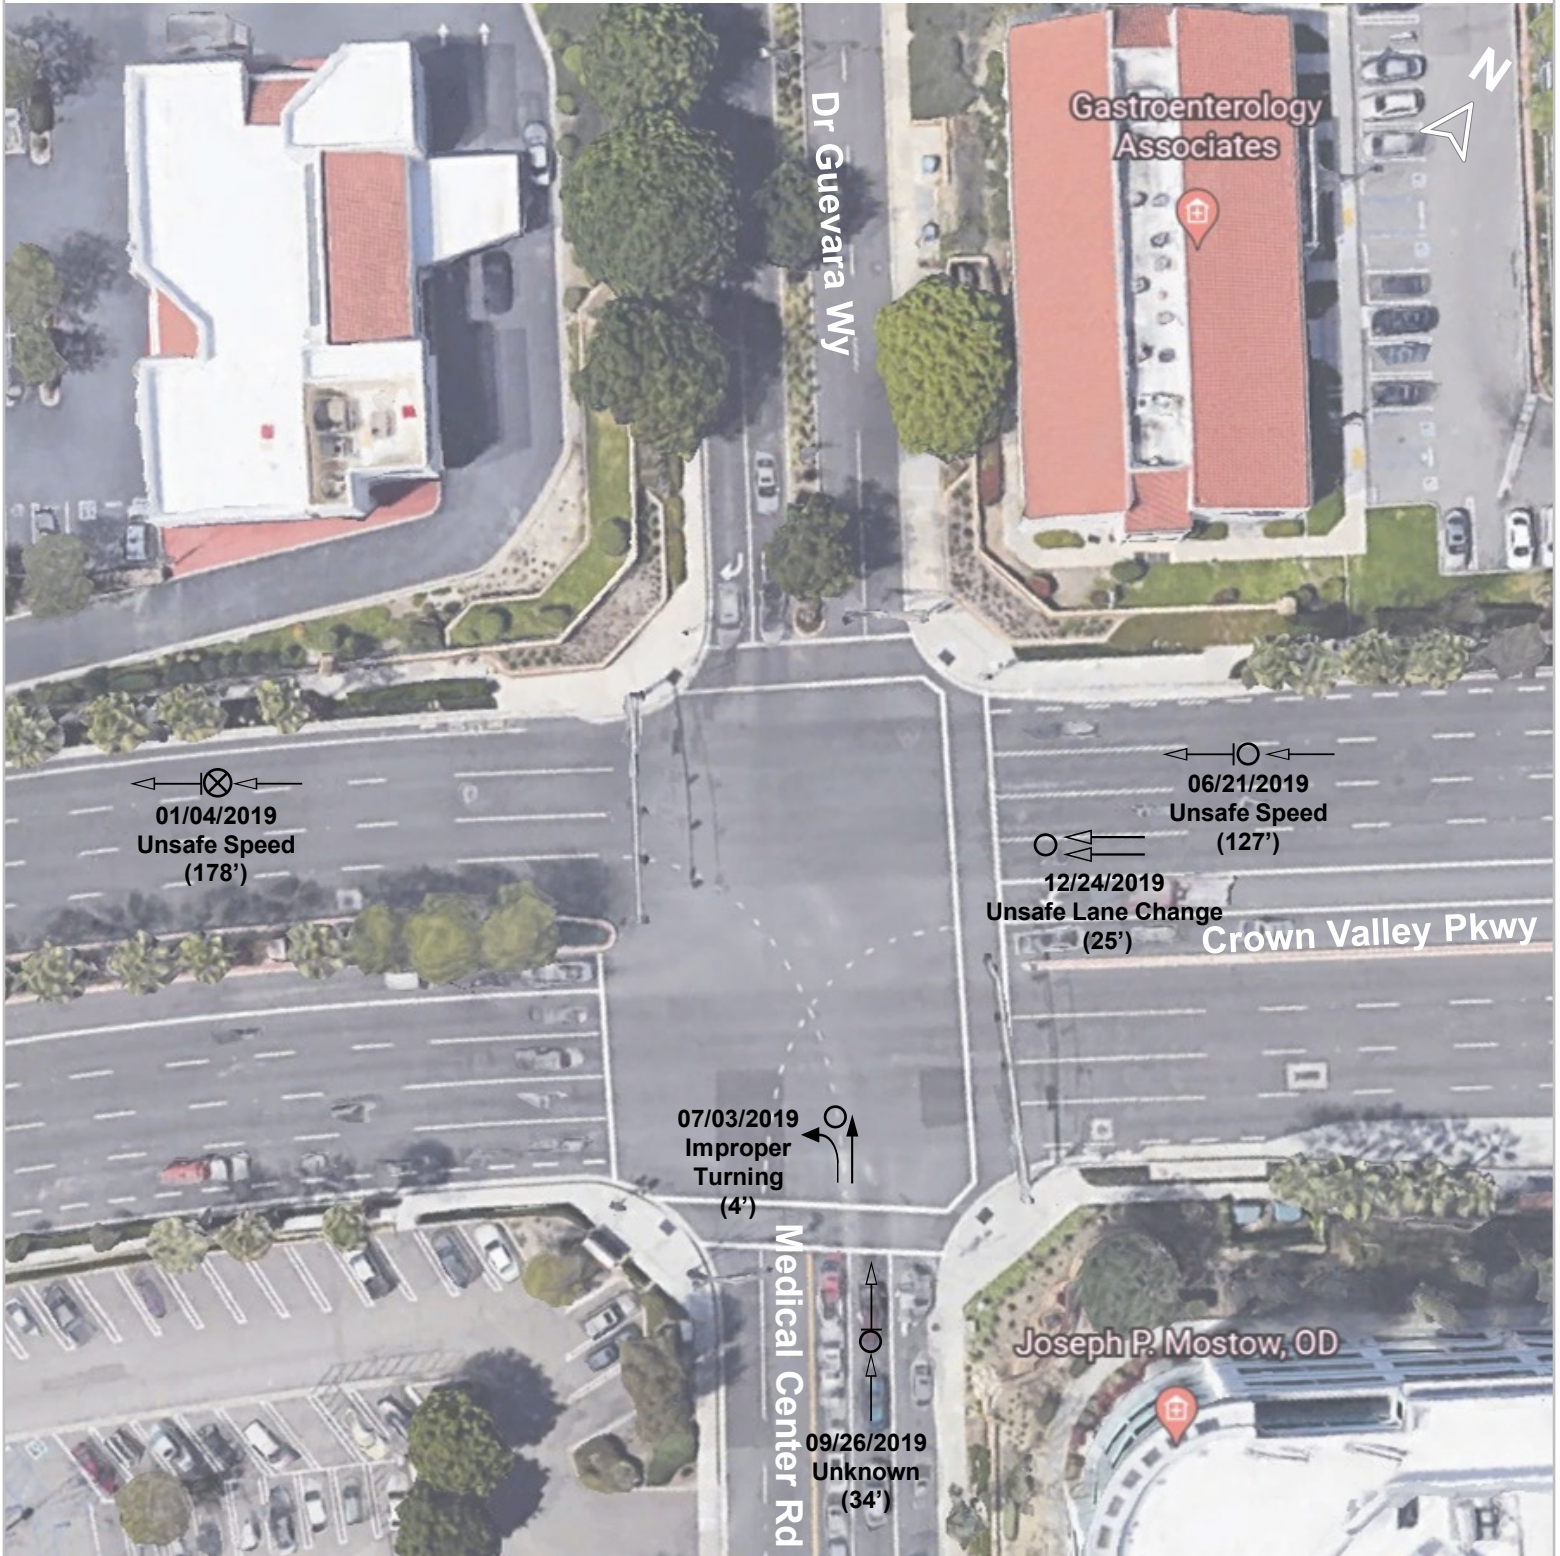
North-South Street: **Dr Guevara Wy -
Medical Center Rd**

<u>4</u> Property Damage Only	<u>1</u> Injury Collisions	<u>0</u> Fatal Collisions	<u>5</u> Total Collisions
-------------------------------	----------------------------	---------------------------	---------------------------

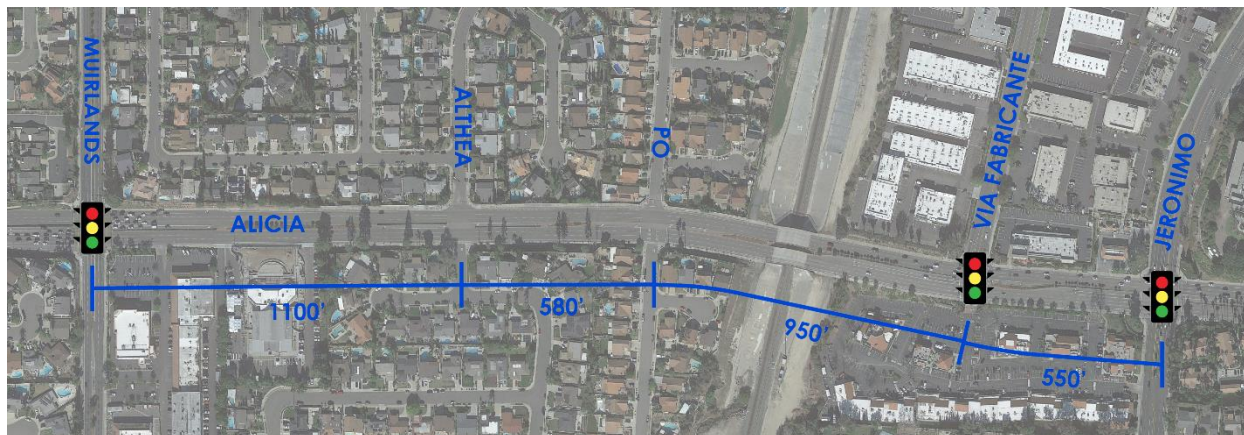
Figure 2 Alicia Parkway signalized corridor

However, the Alicia Parkway corridor between Muirlands Boulevard and Jeronimo Road could be an area of further review. Figure 2 shows the area in question.

A coordinated traffic signal at either Althea Avenue or Po Avenue could provide benefits for the corridor coordinated system, but a signal at either location should be further evaluated for platooning because of the close spacing. The previous Watch List update (2020) included a high point value for the Po Avenue intersection, which indicates that this location has been carefully considered in the past. Neither intersection satisfies the conditions of the vehicular volume warrants (i.e. Warrants 1-3), however if a signal is considered at either location solely based on Warrant 6, then the Althea intersection would likely be a superior choice because of slightly higher overall minor-street volumes. **Warrant 6 was considered to be met for the intersection of Alicia @ Po, but Alicia @ Althea could be considered instead.**

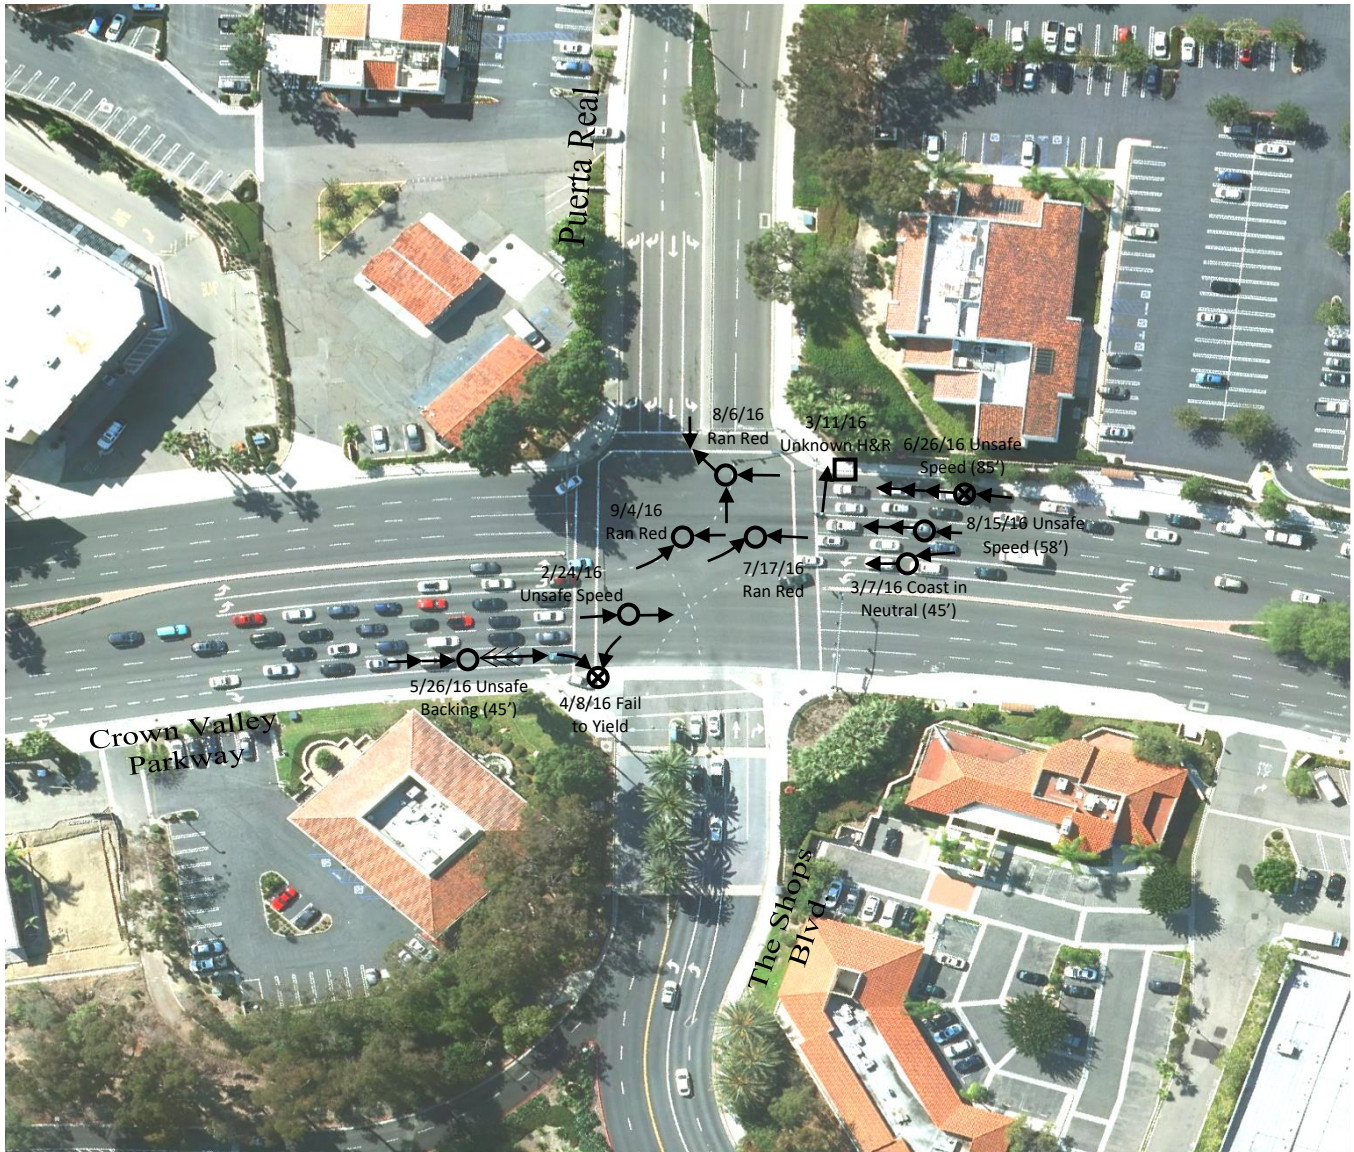
Street (1) Puerta Real-The Shops Blvd. (N-S)

2016 Totals : 10 (0 FataIs – 2 Injury – 8 Property)

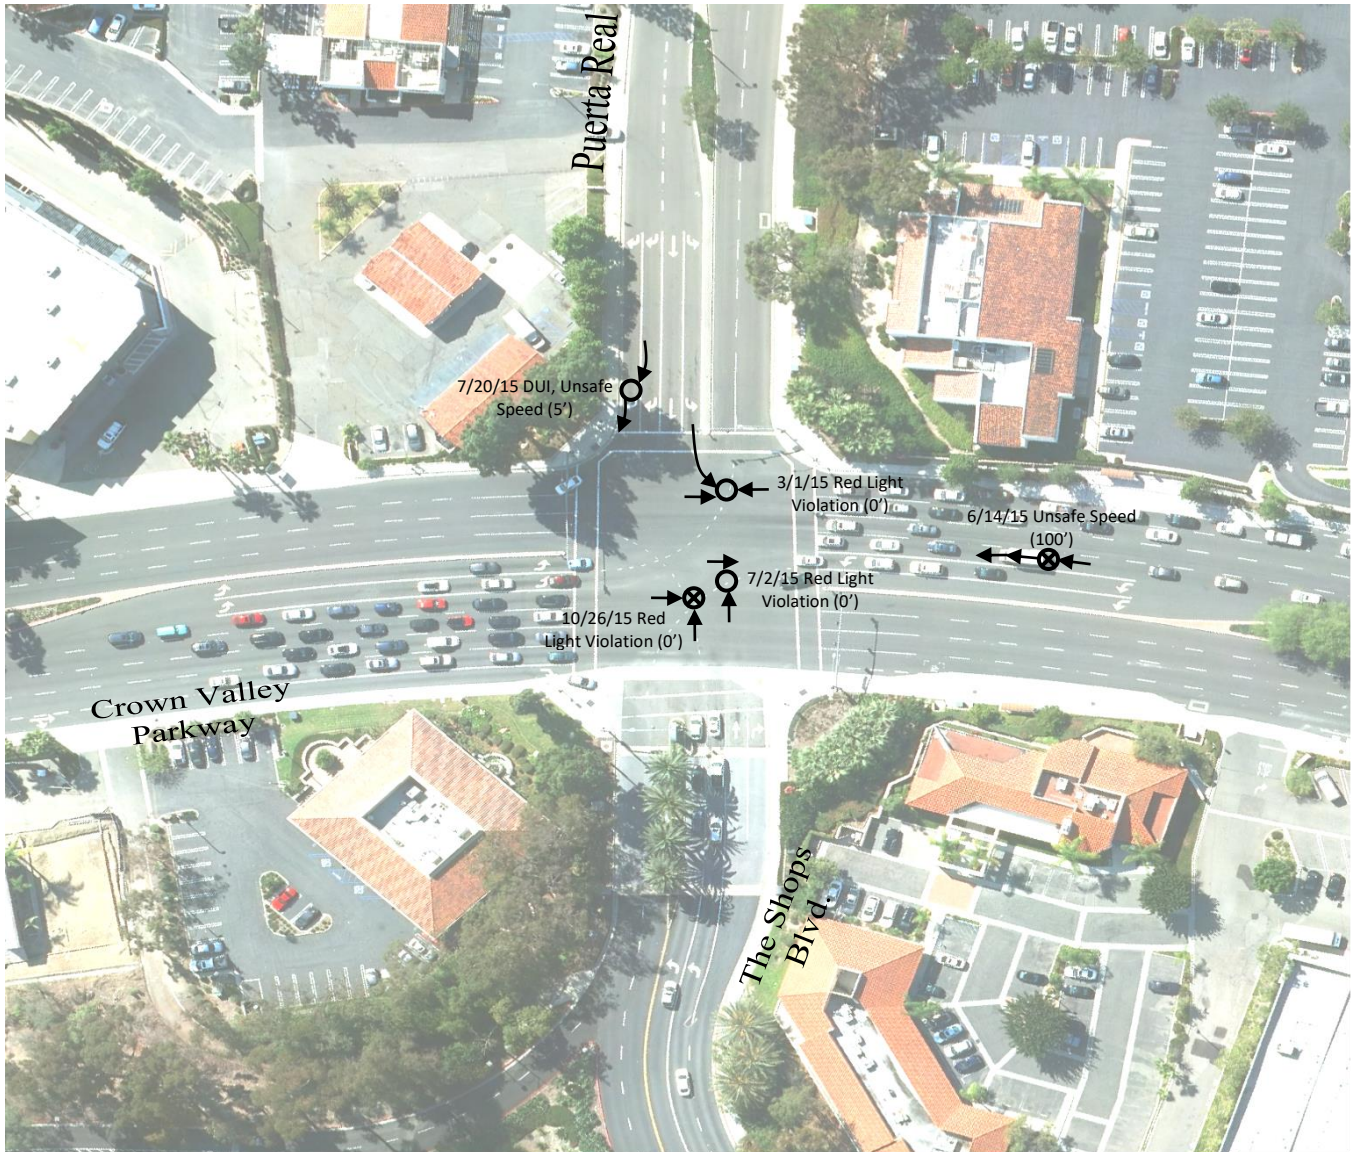
Street (1) Puerta Real-The Shops Blvd. (N-S)

2015 Totals : 5 (0 FataIs – 2 Injury – 3 Property)

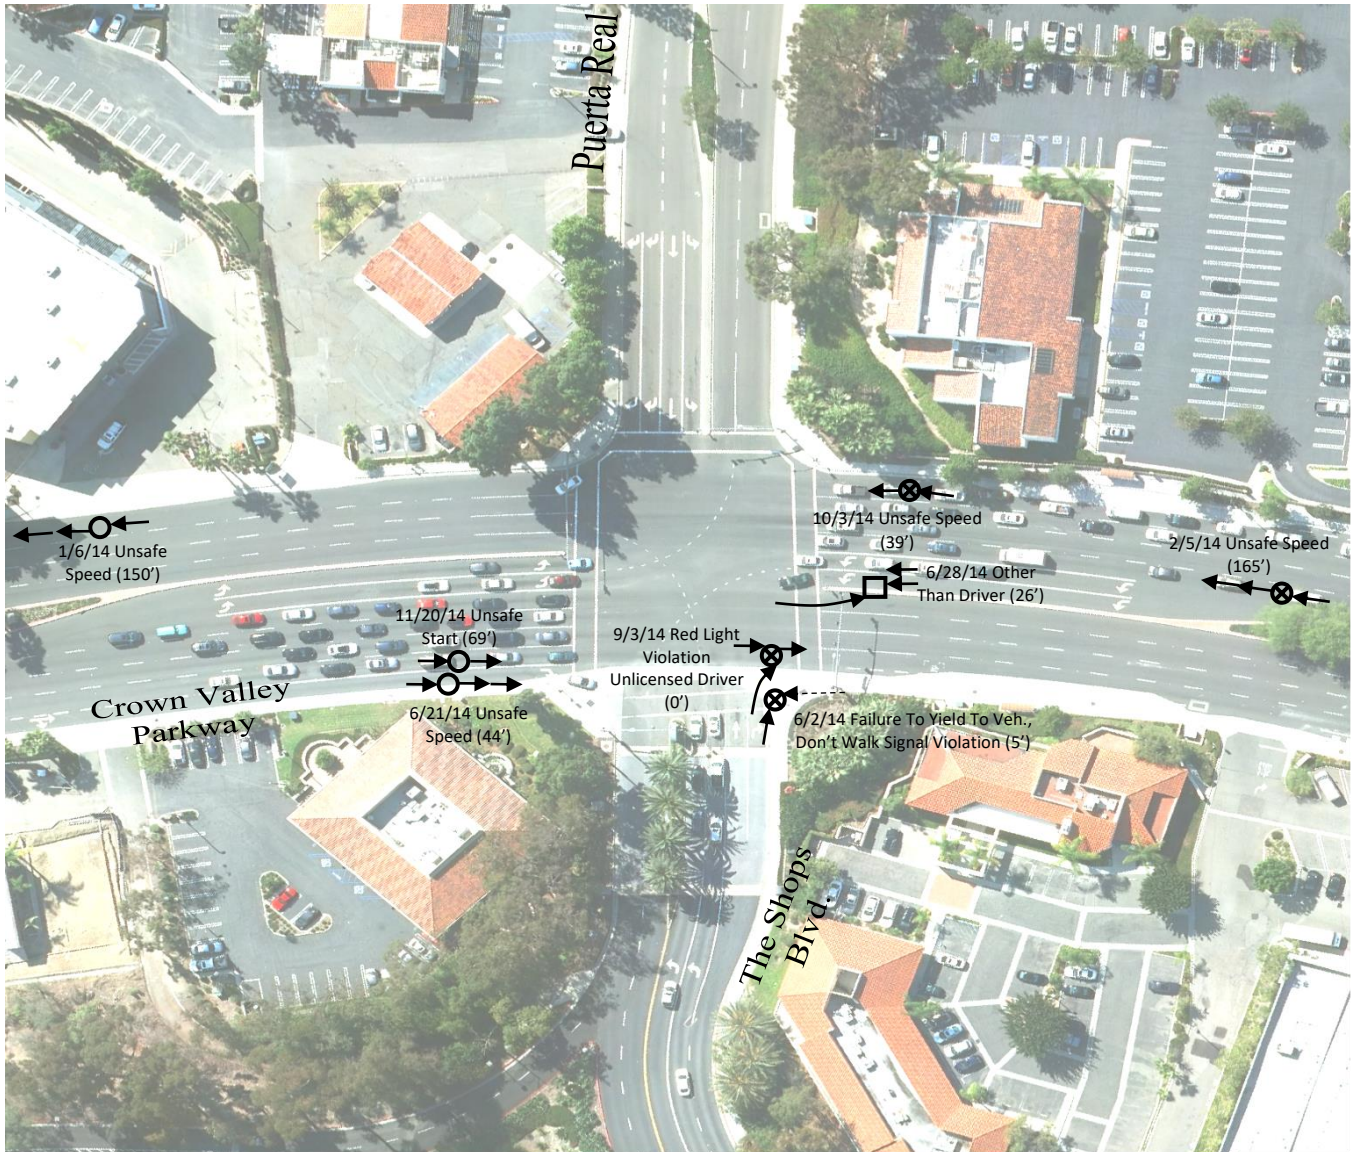
Street (1) Puerta Real-The Shops Blvd. (N-S)

2014 Totals : 8 (0 FataIs – 4 Injury – 4 Property)

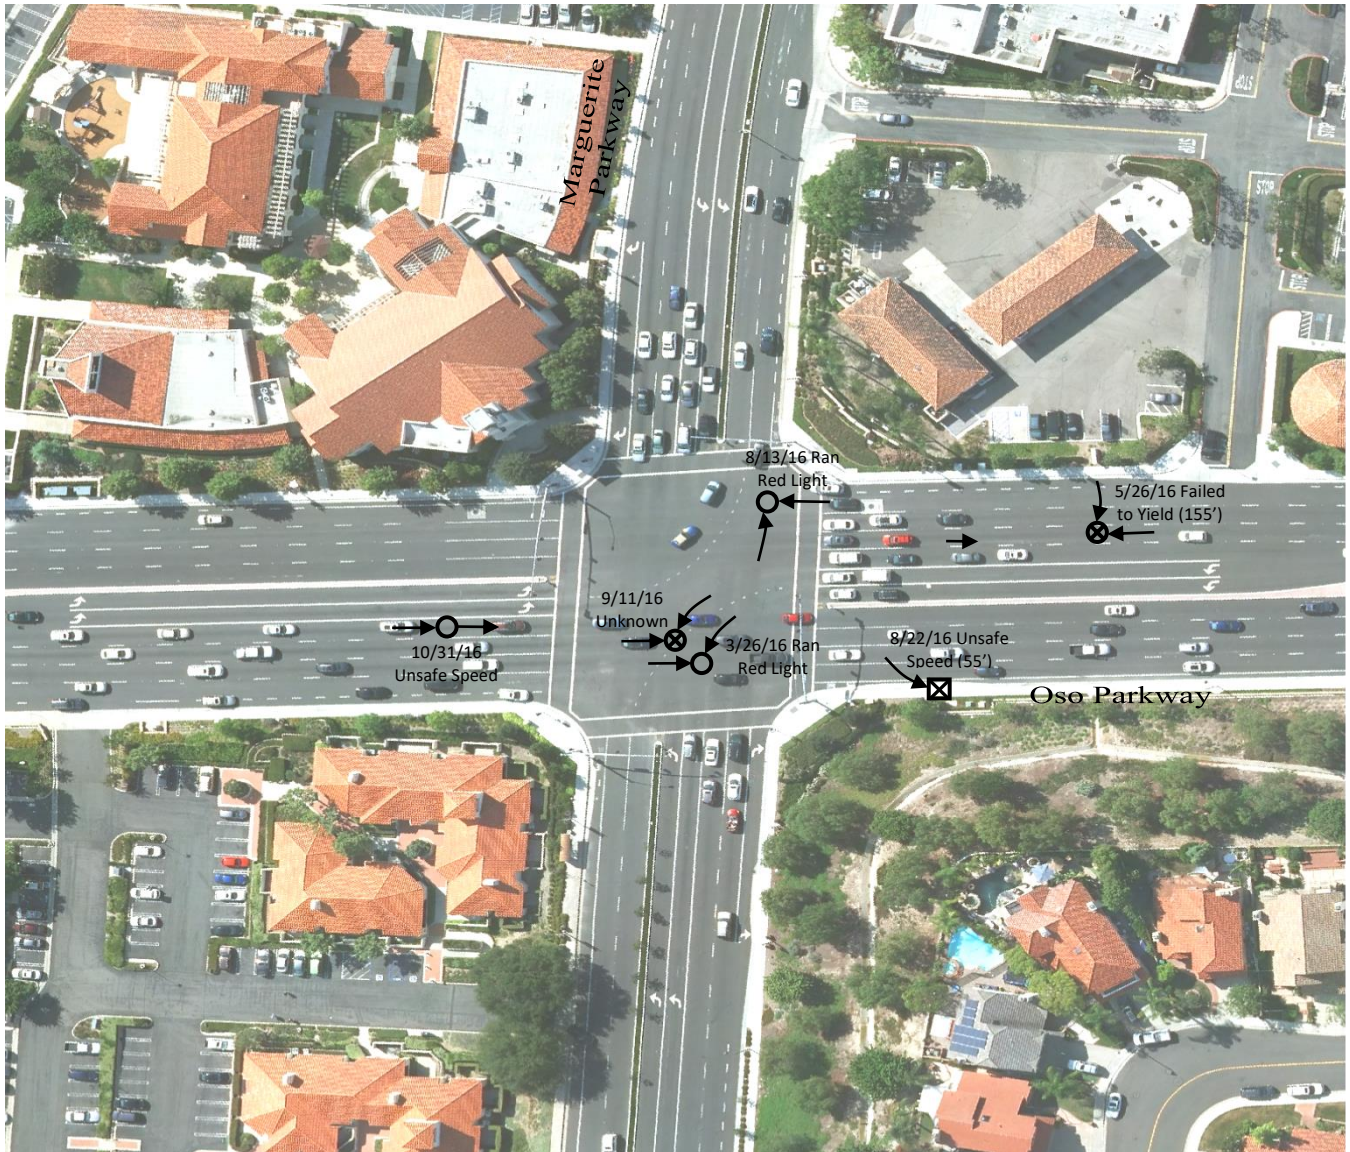
Street (1) Marguerite Parkway (N-S)

2016 Totals : 6 (0 Fatals – 3 Injury – 3 Property)

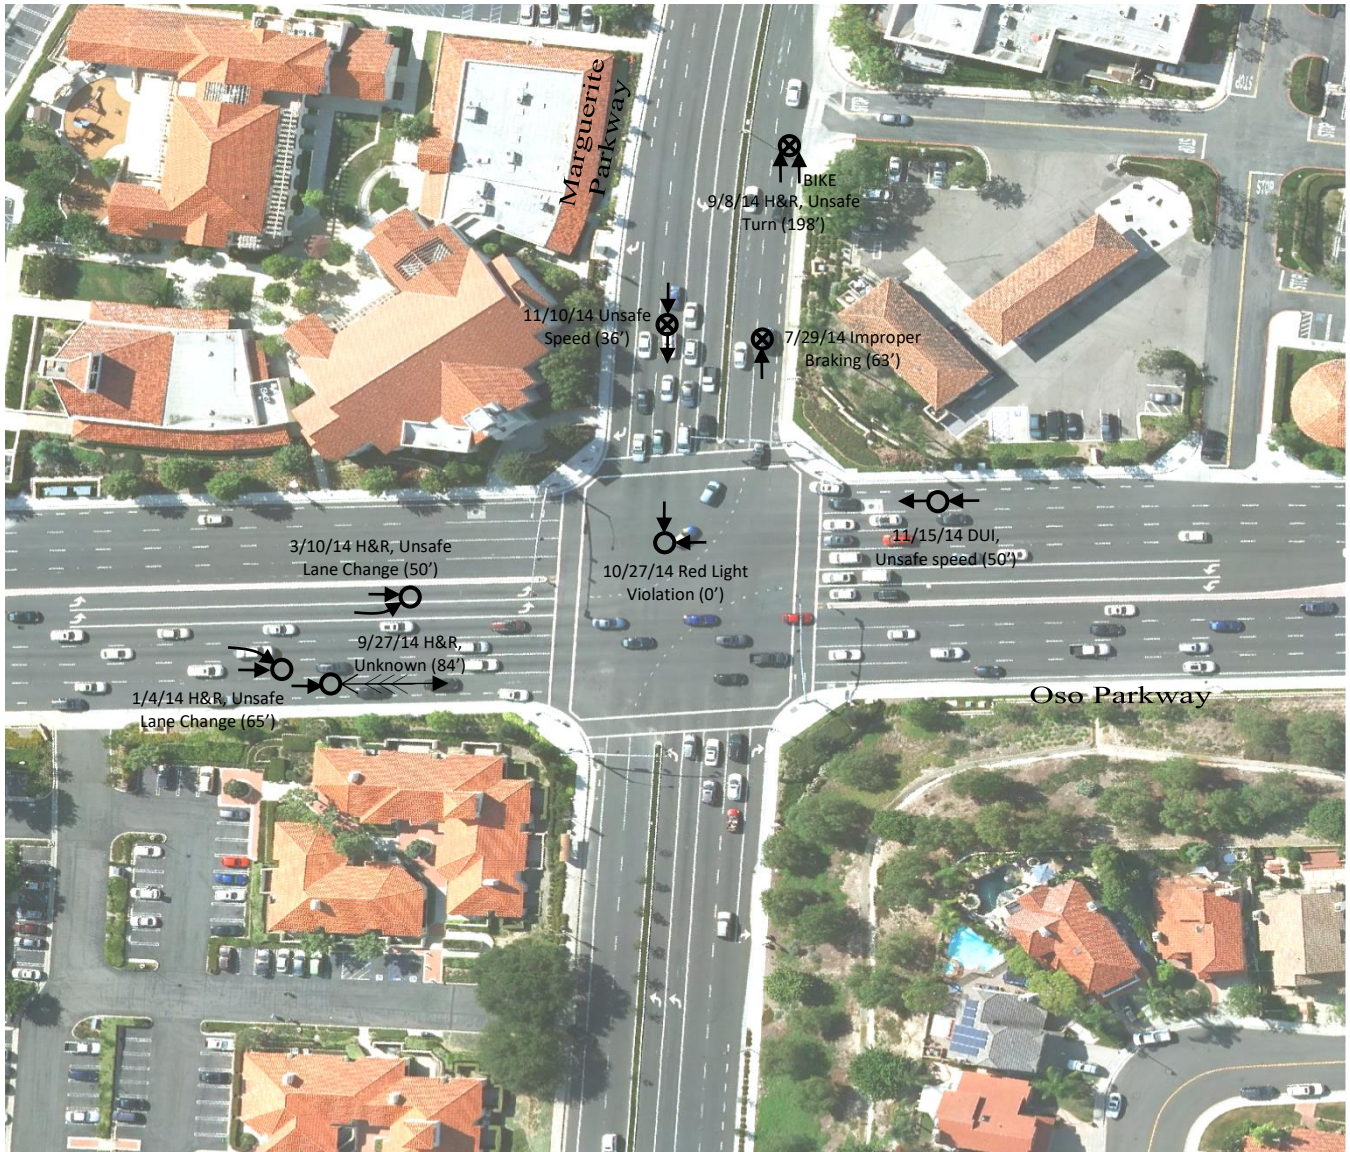
Street (1) Marguerite Parkway (N-S)

2014 Totals : 8 (0 Fatafs – 3 Injury – 5 Property)

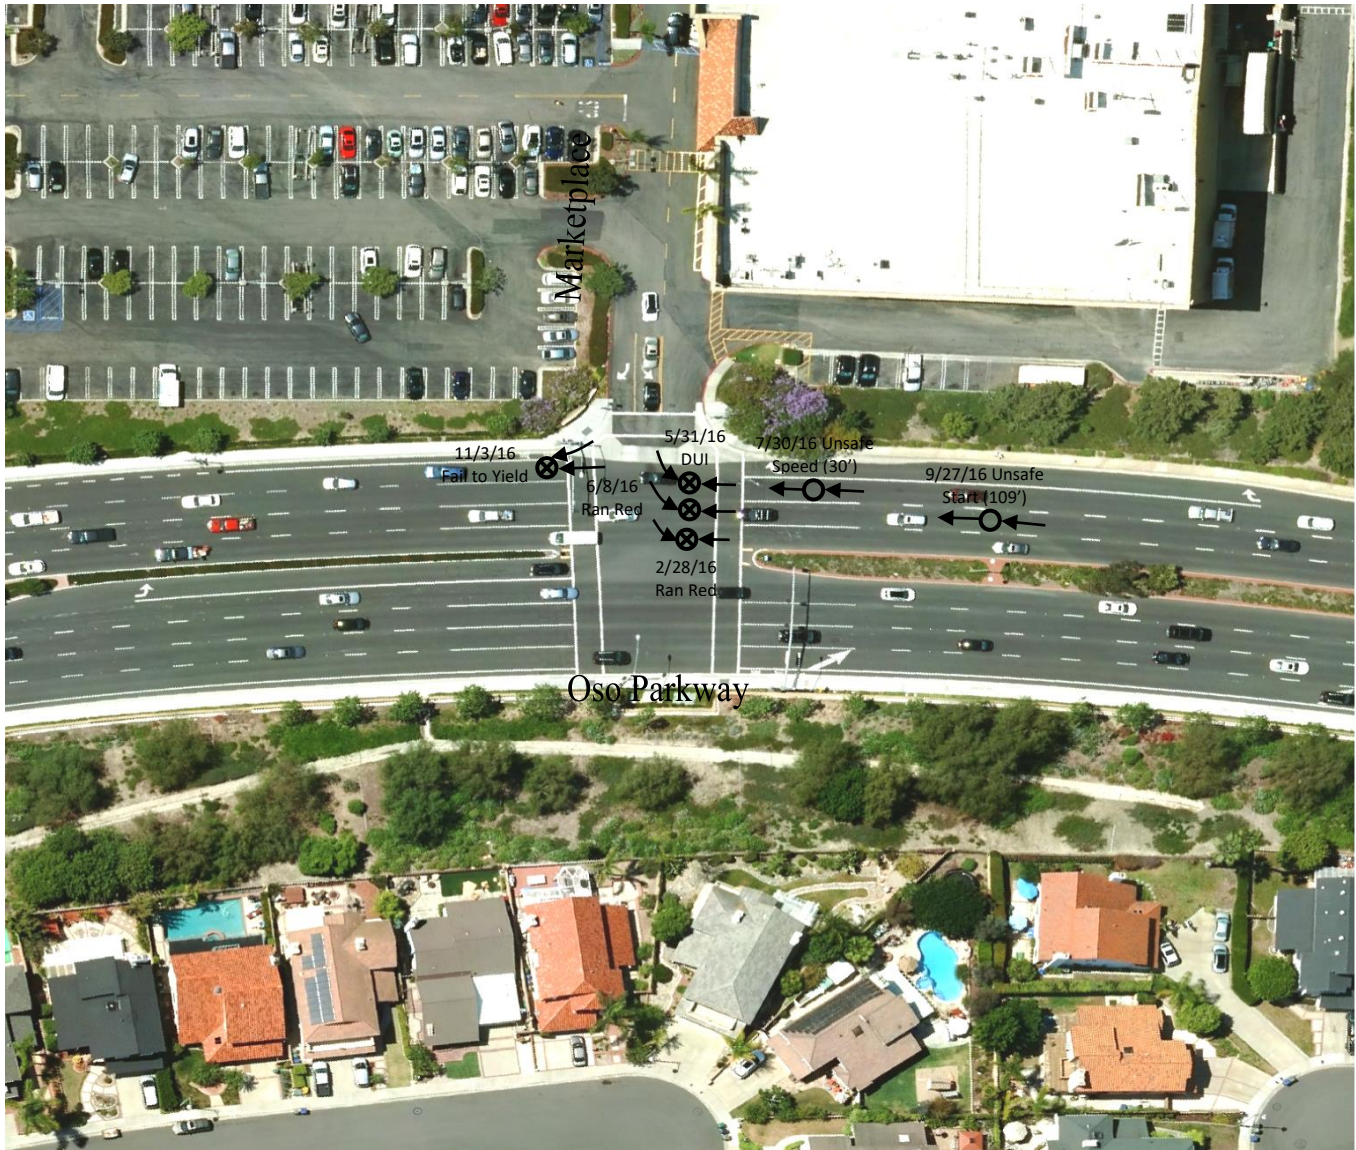
Street (1) Marketplace (N-S)
Street (2) Oso Parkway (E-W)

2016 Totals : 6 (0 FataIs – 4 Injury – 2 Property)
