Mission Viejo

SYSTEMIC SAFETY ANALYSIS REPORT & LOCAL ROAD SAFETY PLAN

December 2021

Prepared by:
Kittelson & Associates, Inc.
750 The City Drive, Suite 410
Orange, CA 92868
714.468.1997

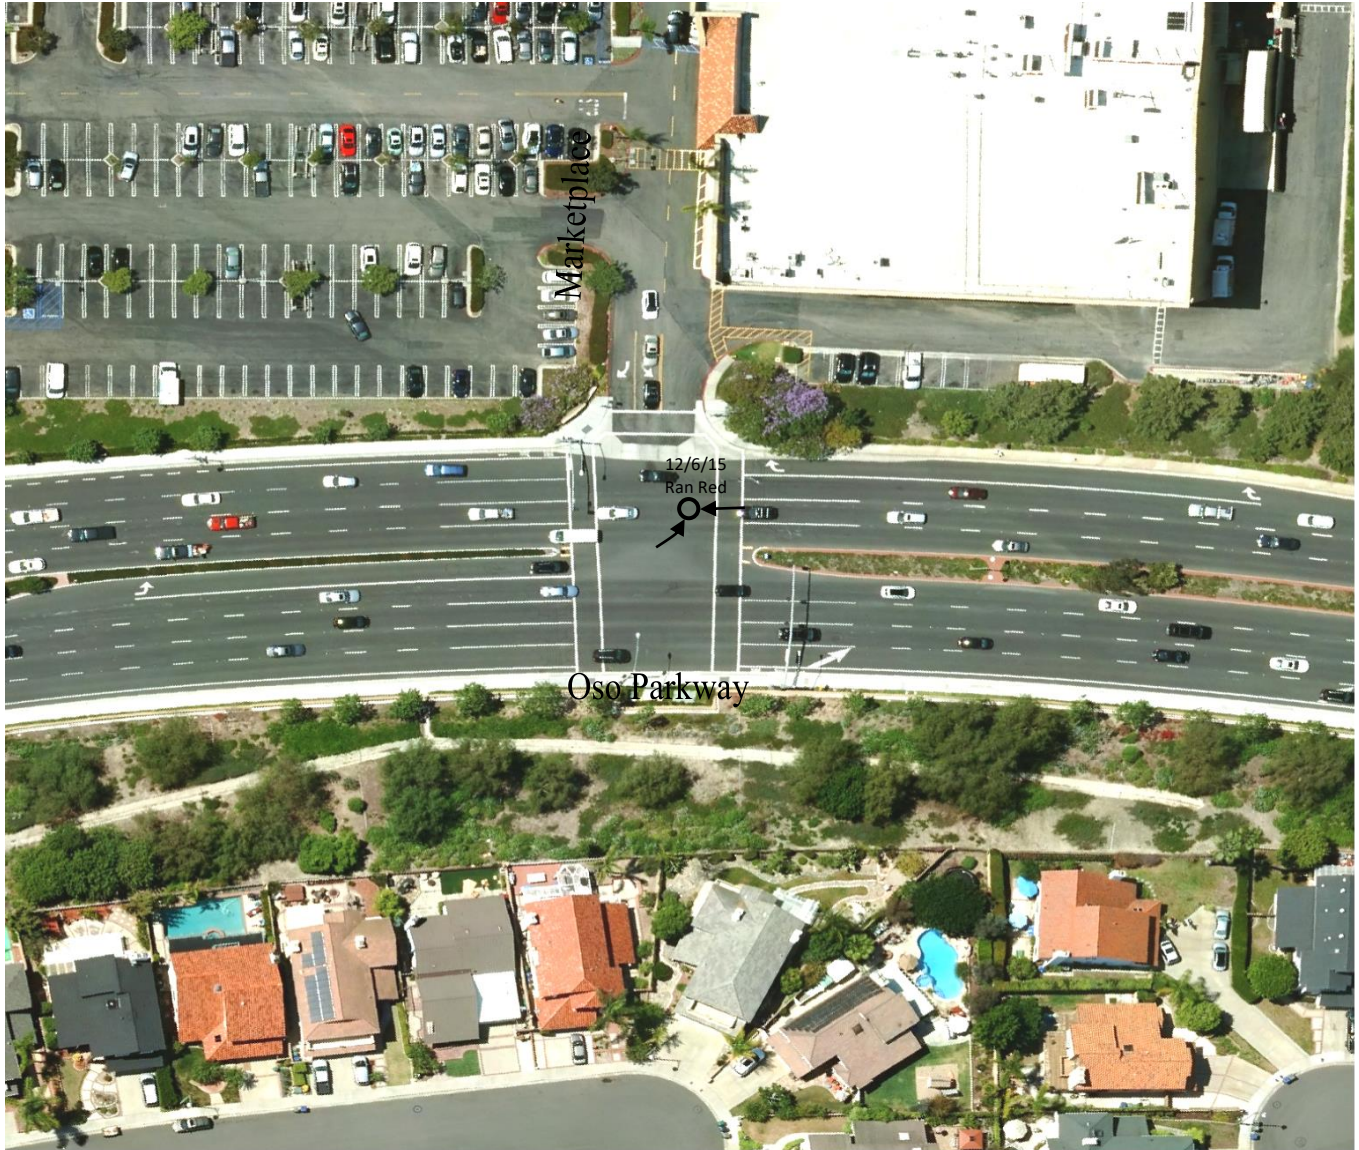
Street (1) Marketplace (N-S)

2015 Totals : 1 (0 FataIs – 0 Injury – 1 Property)

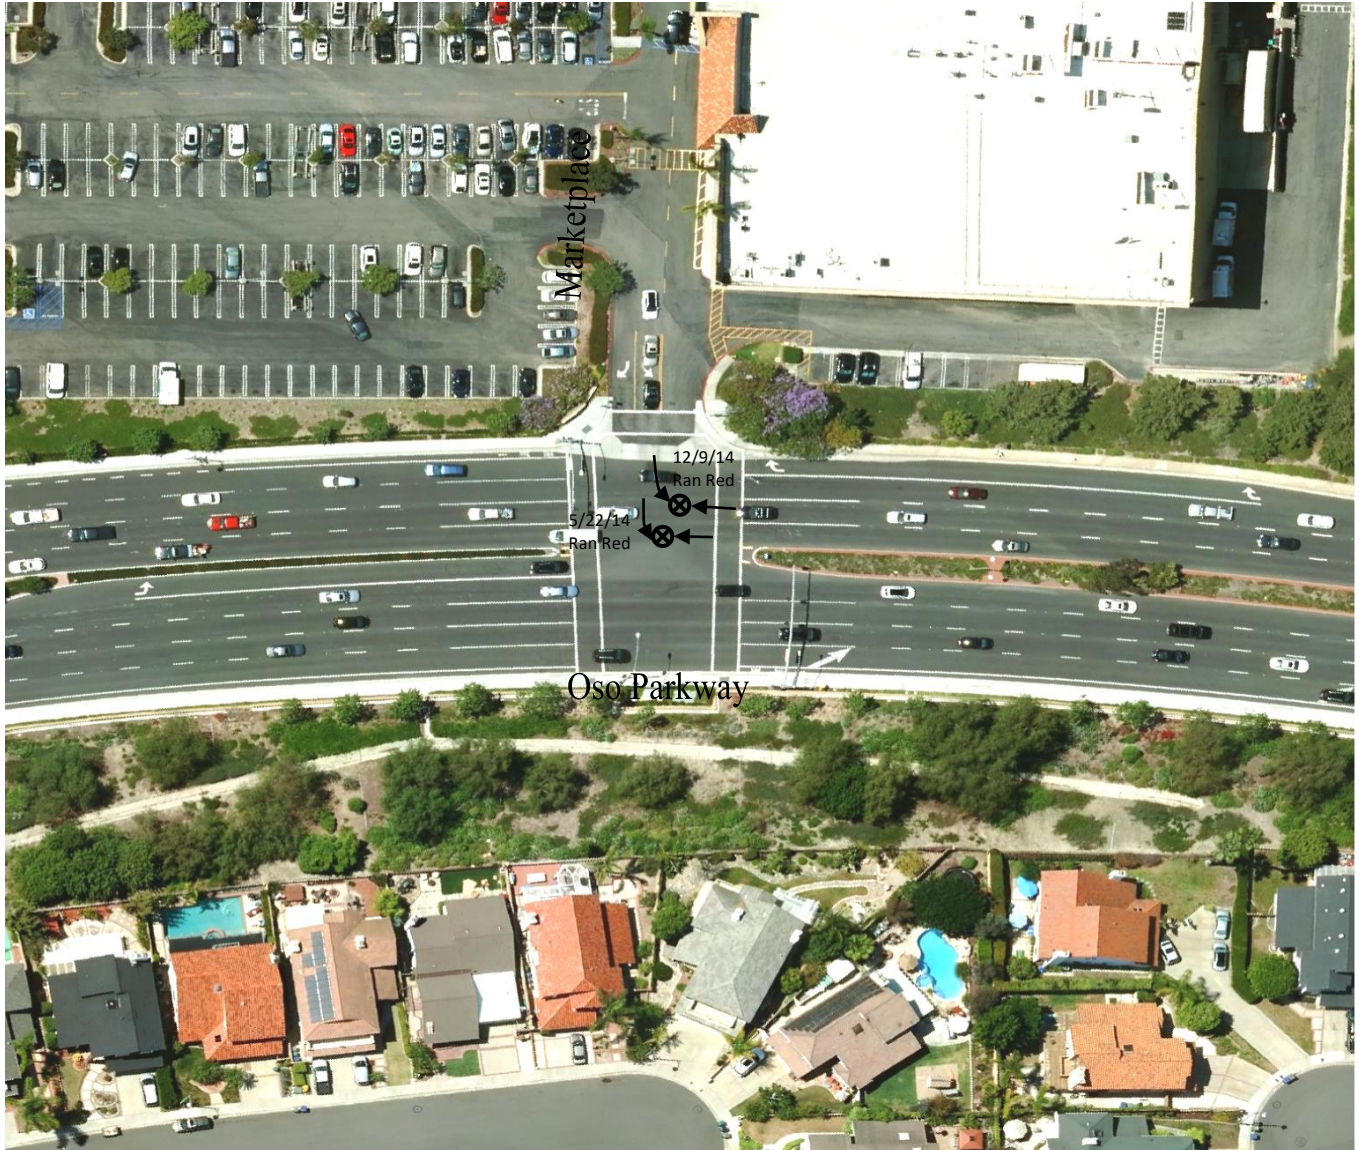
Street (1) Marketplace (N-S)

2014 Totals : 2 (0 Fatafs – 2 Injury – 0 Property)

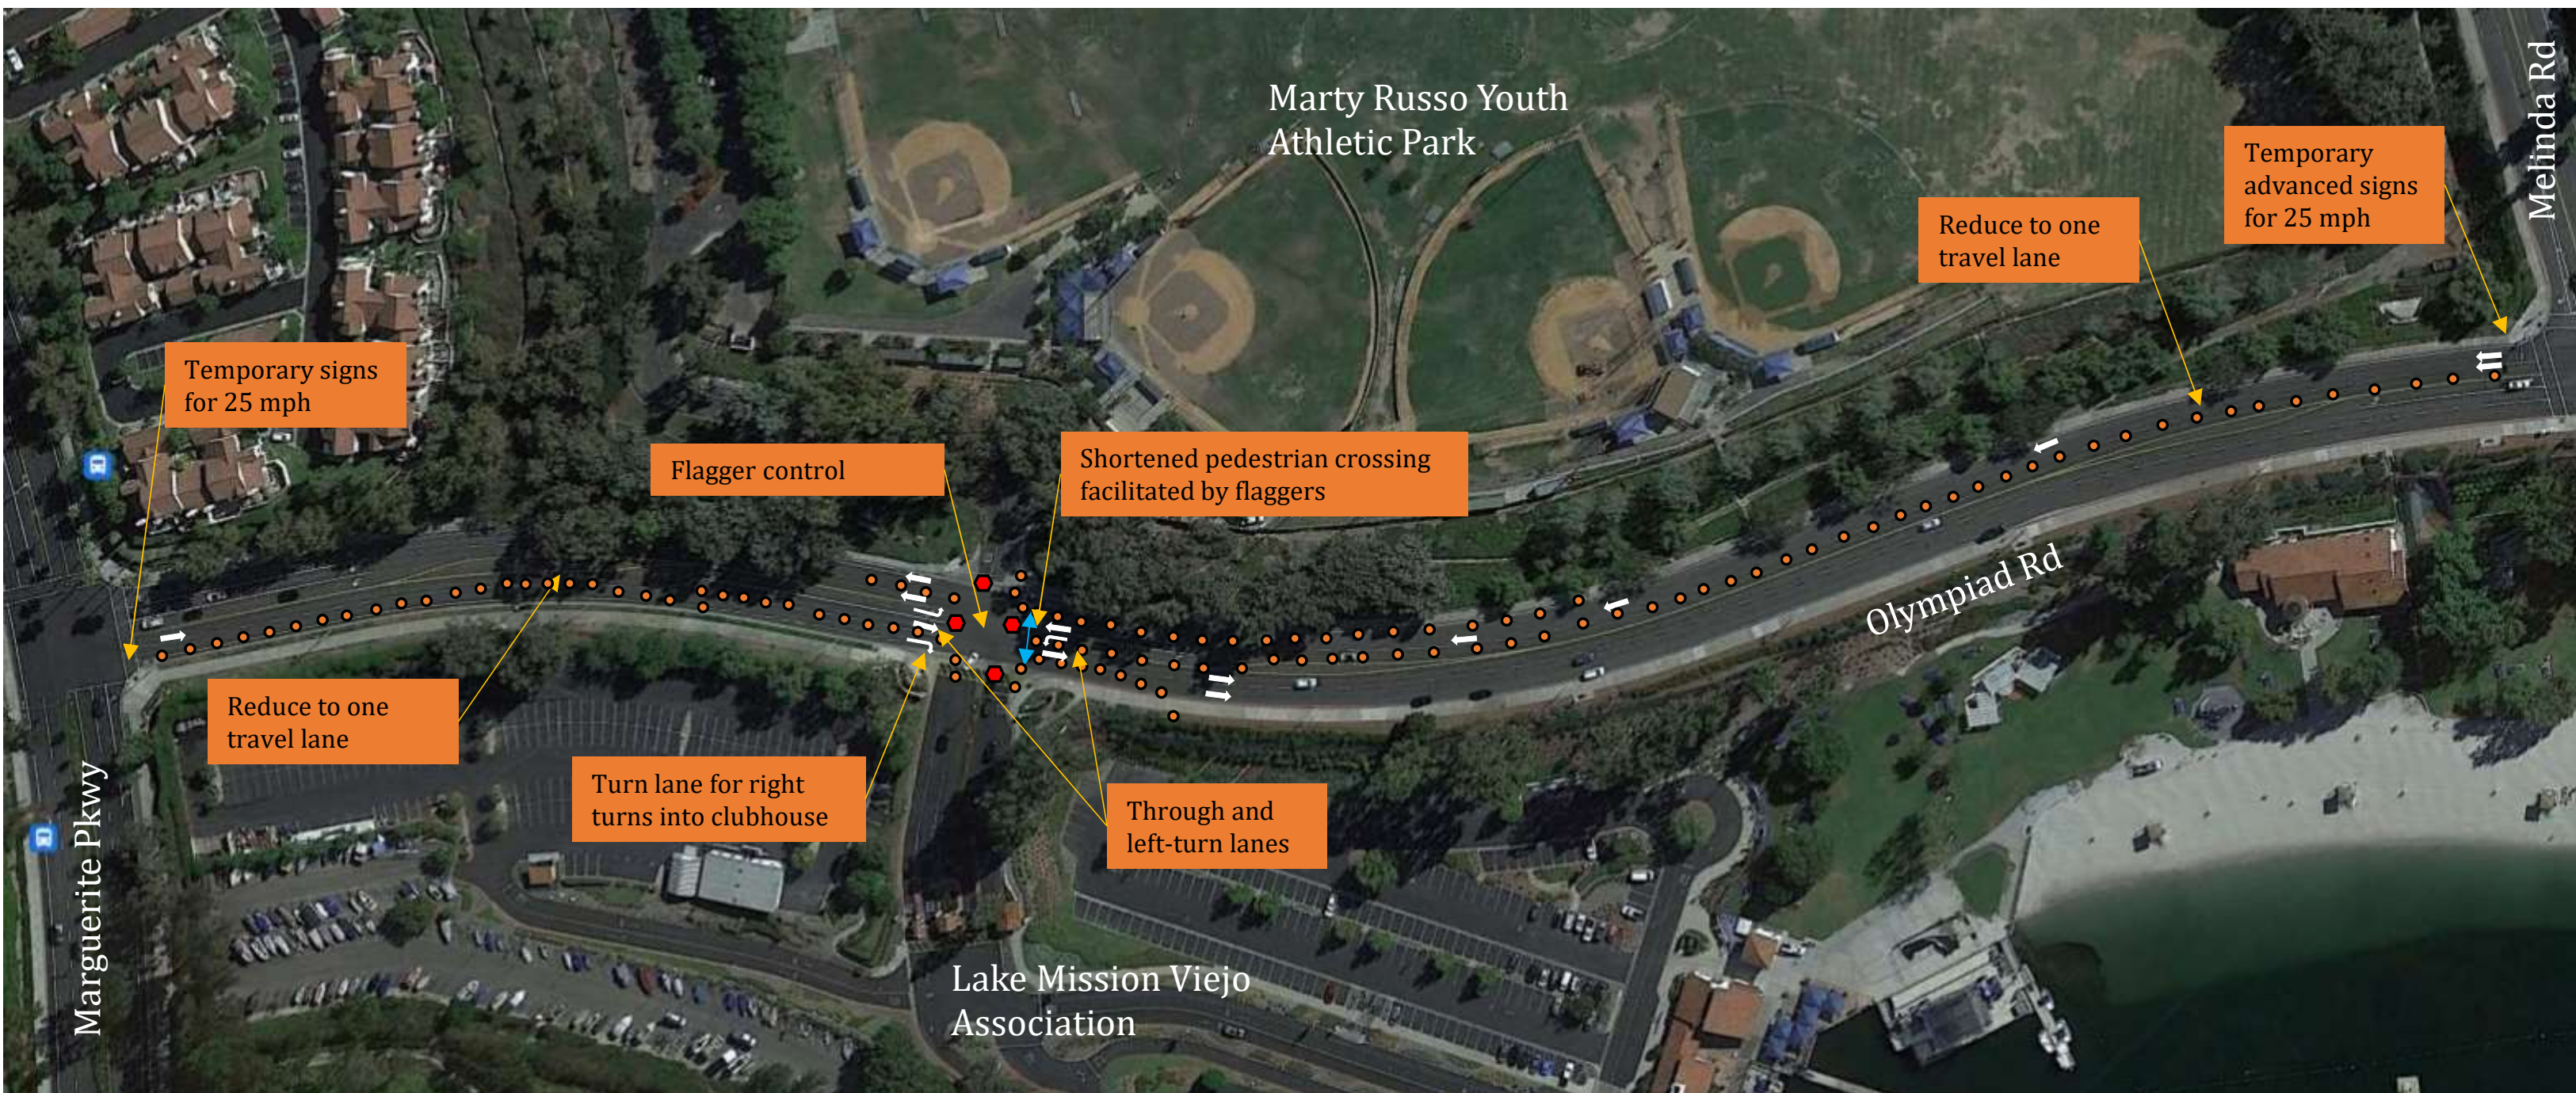
Olympiad Rd/LMVA Driveway Special Event Control Concept

Posted speed limit = 45 mph
Special event speed limit = 25 mph

Note: This layout is conceptual only and further detail on temporary signage, advanced signage, cone spacing, flagger control, and other applicable measures are needed prior to implementation.
