September 30, 2005
J.N. 173-05

Subject: Preliminary Geotechnical Investigation of the Ferrocarril Landslide, City of Mission Viejo, California.

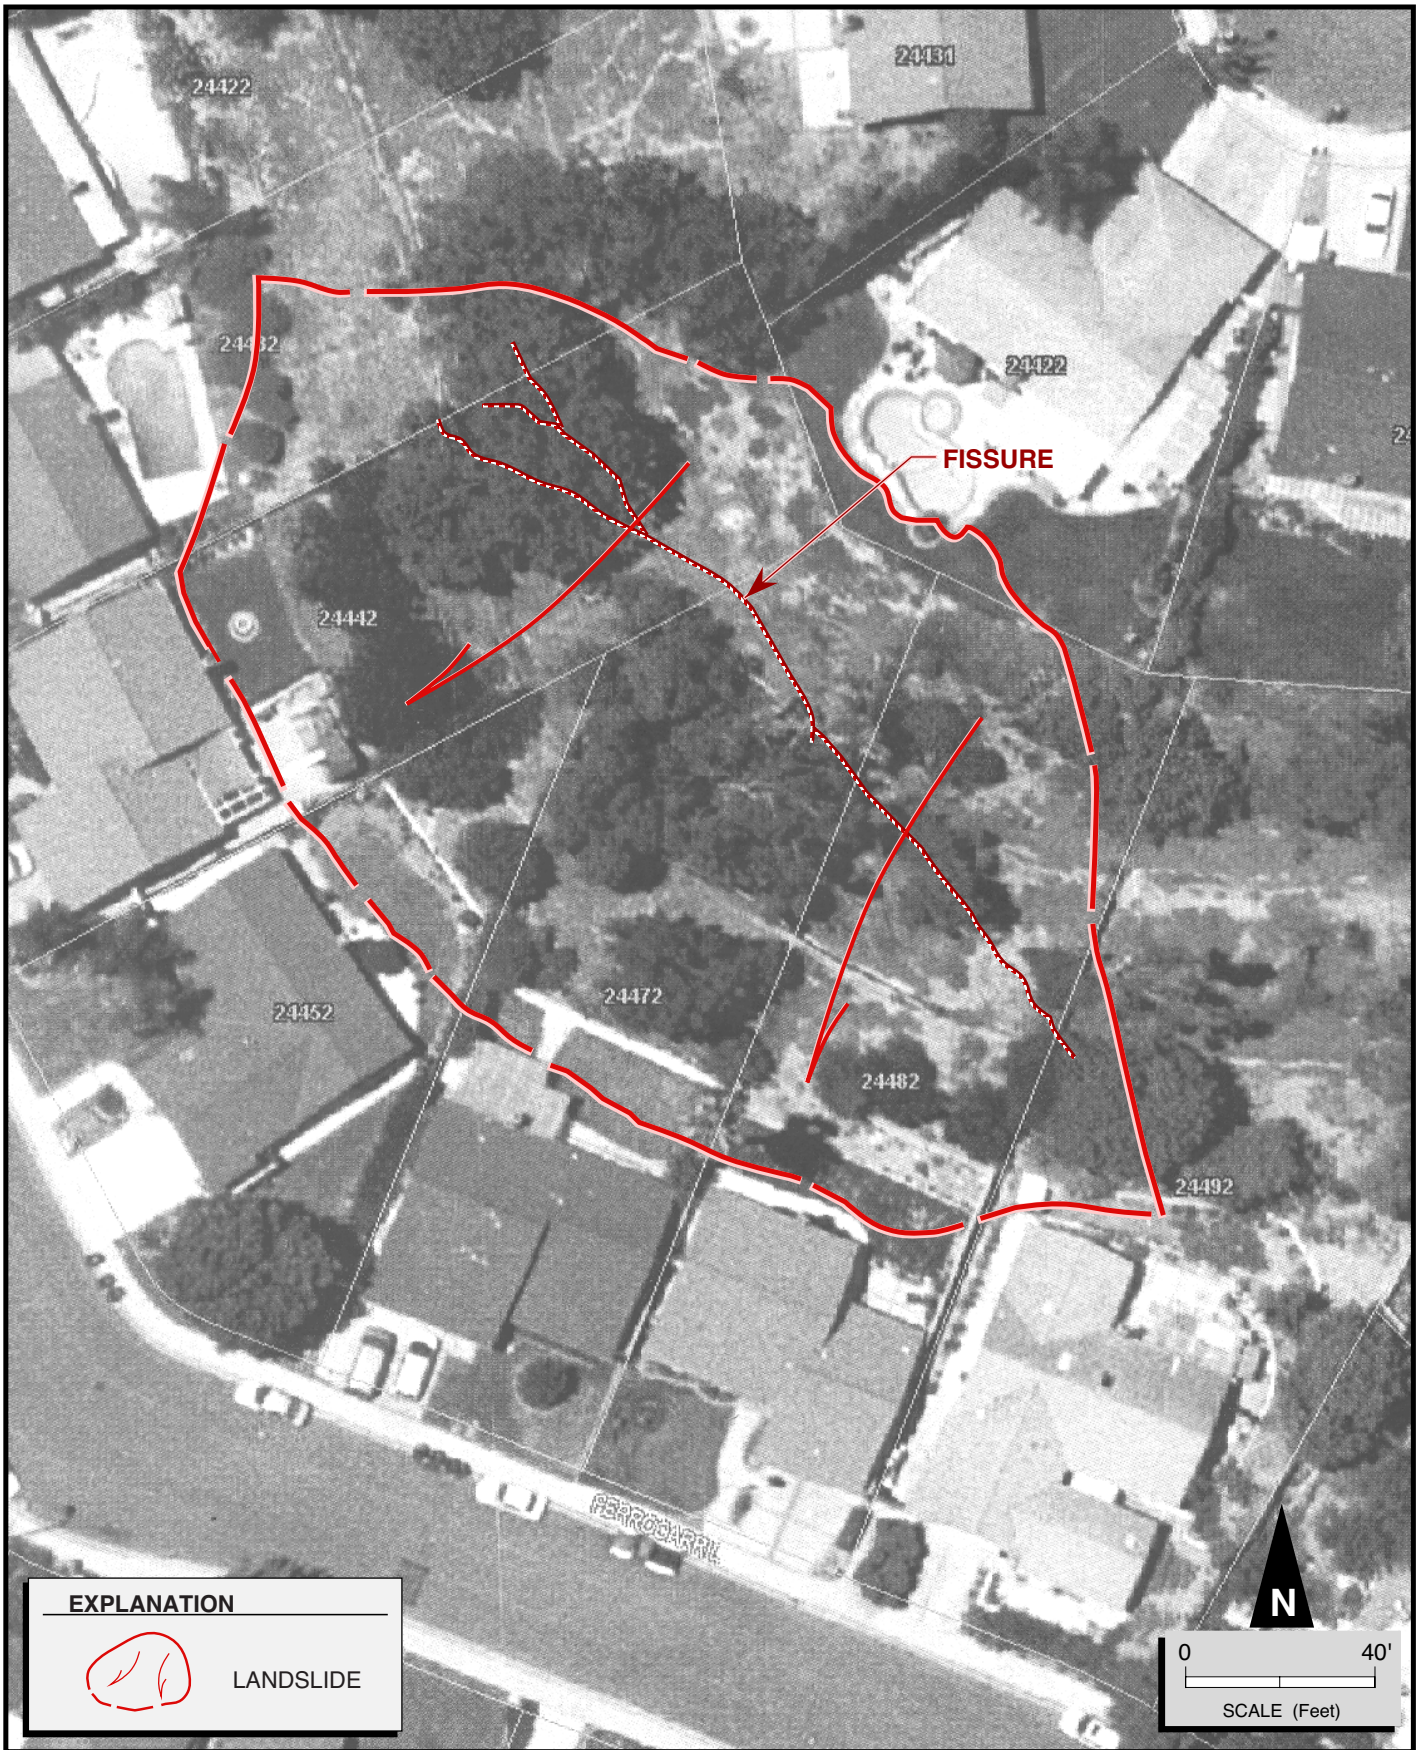
LANDSLIDE LOCATION MAP

The Ferrocarril landslide began moving on January 20, 2005 and occurred on a man-made (graded) slope located in the rear portions of 24432, 24442, 24452, 24472, 24482, and 24492 Ferrocarril in the City of Mission Viejo, California (Figure 1). The slope where the landslide occurred ascends approximately 70 feet in height to residences along Encorvado Lane. The top or main scarp of the landslide encroached into the rear yard of 24422 Encorvado Lane and undermined the western portion of an existing swimming pool and adjacent pool decking. The landslide encompassed an area of about ½ acres, with maximum horizontal dimensions of about 275 feet wide by 140 feet long (Figure 2).

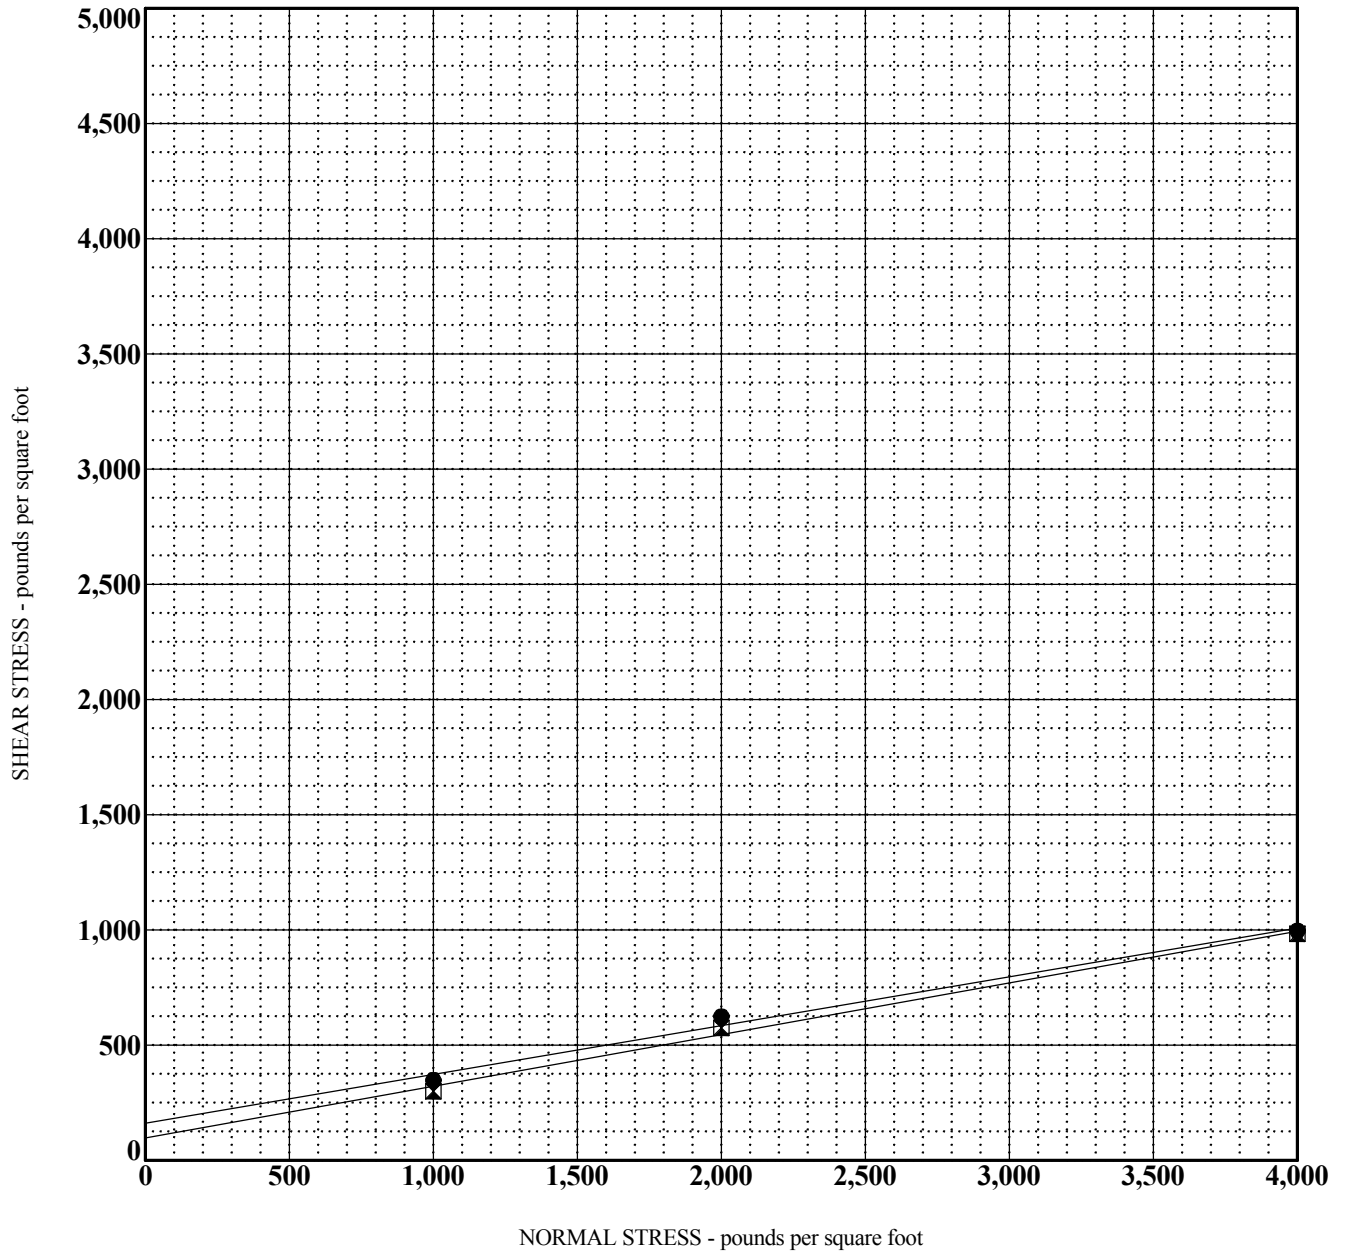
| PETRA GEOTECHNICAL, INC. | | PLATE B-2 |

| SAMPLE LOCATION | DESCRIPTION | FRICTION ANGLE (°) | COHESION (PSF) |
|---|---|---|---|
| ● B-2 @ 9.0 | Rupture Surface - Peak | 12 | 160 |

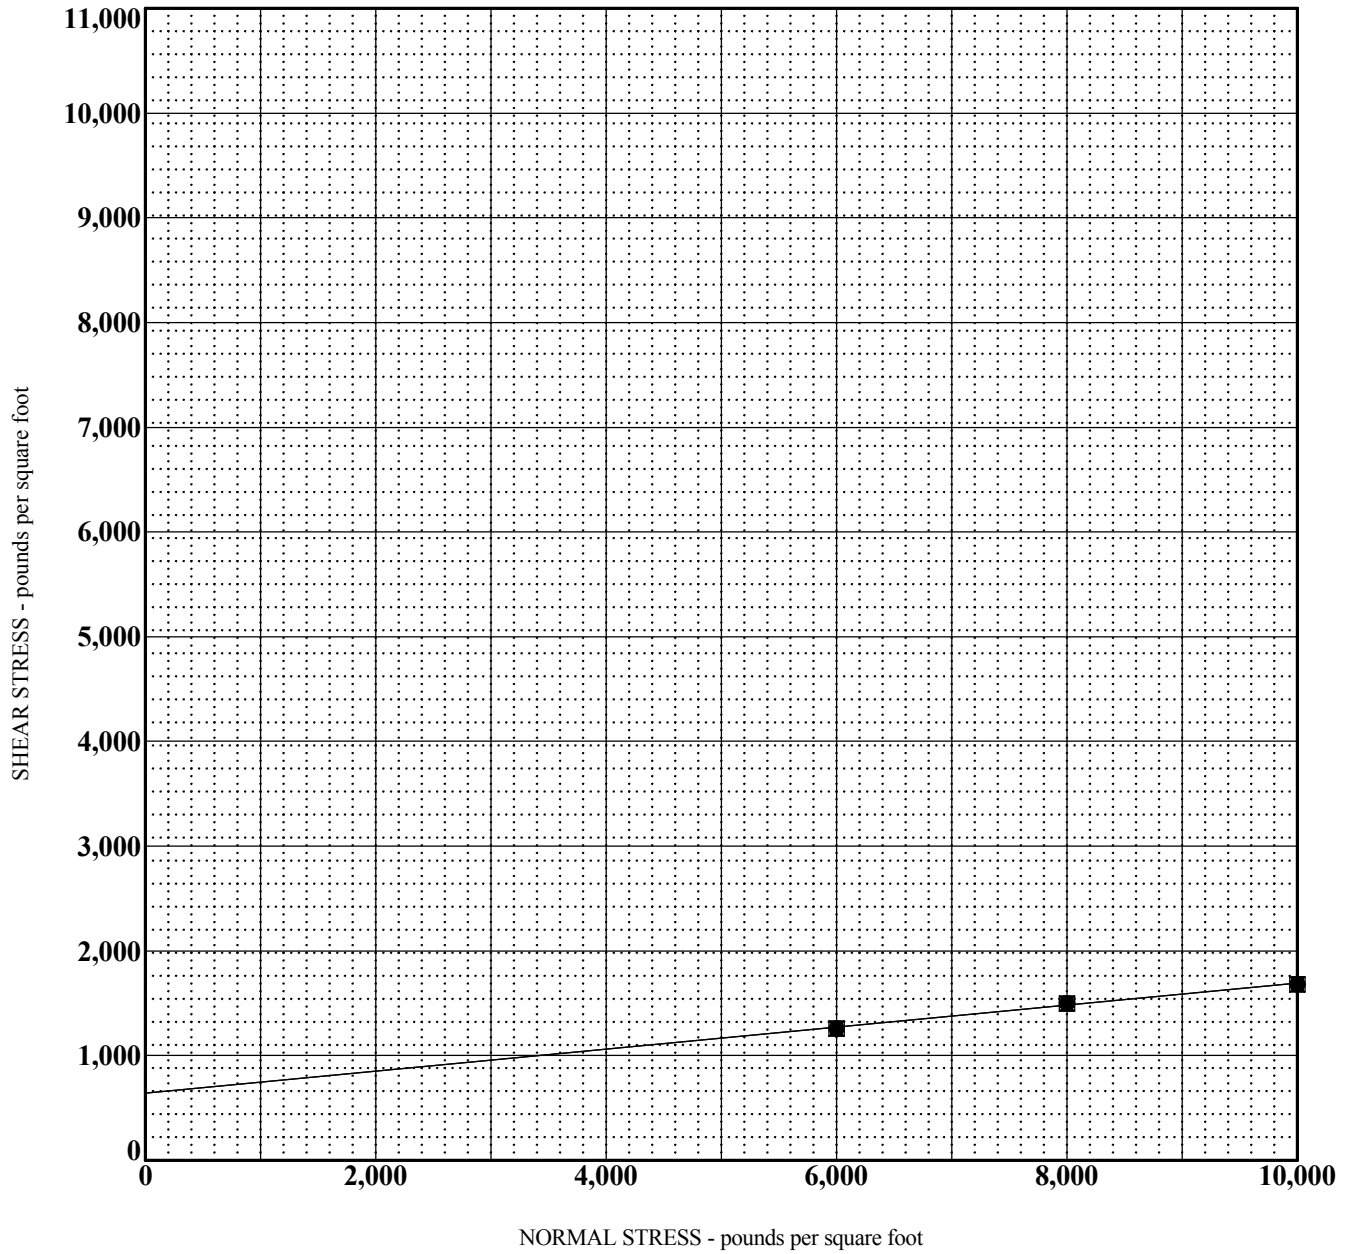
| PETRA GEOTECHNICAL, INC. | | PLATE B-3 |

| SAMPLE LOCATION | DESCRIPTION | FRICTION ANGLE (°) | COHESION (PSF) |
|---|---|---|---|
| ● B-2 @ 9.0 | Rupture Surface - Peak | 6 | 640 |
