Project No. 18184-01

**Subject: Preliminary Geotechnical Report for Proposed Development of Tentative Tract Map 19035, Mission Viejo, California**

**LGC Geotechnical, Inc.**

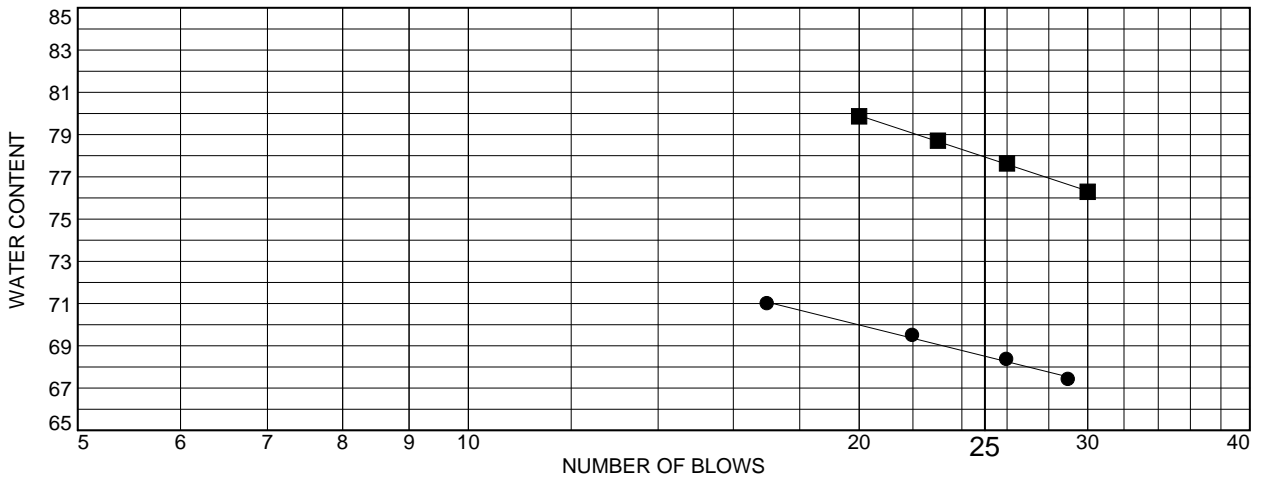
# LIQUID AND PLASTIC LIMITS TEST REPORT

MATERIAL DESCRIPTION	LL	PL	PI	%<#40	%<#200	USCS
● Gray Fat CLAY w/ Sand	68.5	28.2	40.3			
■ Dark Greenish Gray Fat CLAY	77.9	32.2	45.7

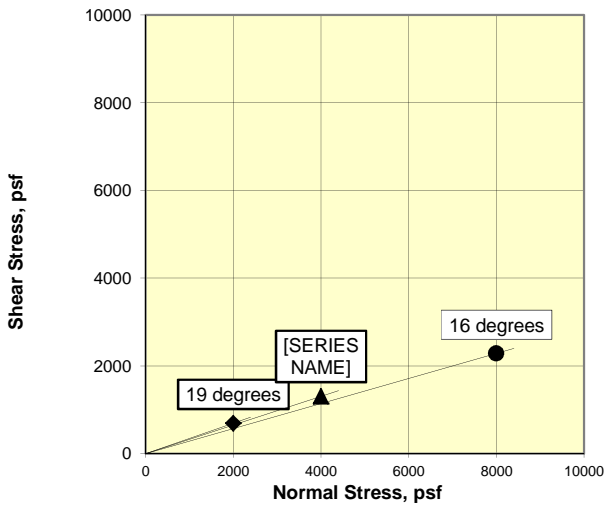
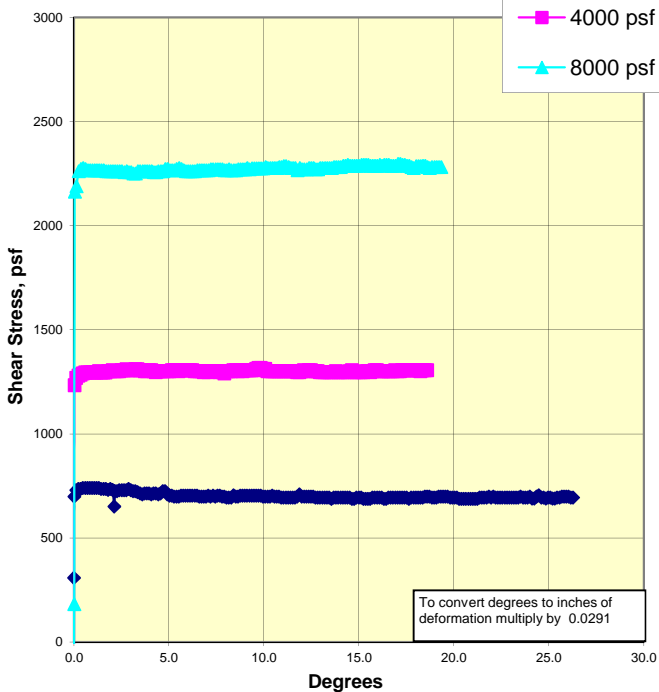
<b>BGL Job No.:</b> 040-002	<b>Boring:</b> BA-1	<b>Date:</b> 5/28/2019	<b>Clay, %:</b>	
<b>Client:</b> LGC Geotechnical	<b>Sample:</b> GB-1	<b>By:</b> PJ	<b>LL:</b> 68.5	
<b>Project Name:</b> El Toro	<b>Depth (ft):</b> 28	<b>Checked:</b> PJ	<b>PL:</b> 28.2	
<b>Project Number:</b> 18184-01	<b>Test Type:</b> Reconstituted Residual	<b>Sample Preparation:</b> <#40		
<b>Soil Type:</b> Gray Fat CLAY w/ Sand			<b>Remarks:</b> A small friction correction was applied to each point.	
<b>Normal Stress, psf</b>	2000	4000		8000
<b>Secant Phi, deg.:</b>	19	18		16

**Secant Residual Stress Friction Angles**

**Strength Envelope**

**Deformation Curves**

**Vertical Deformation**

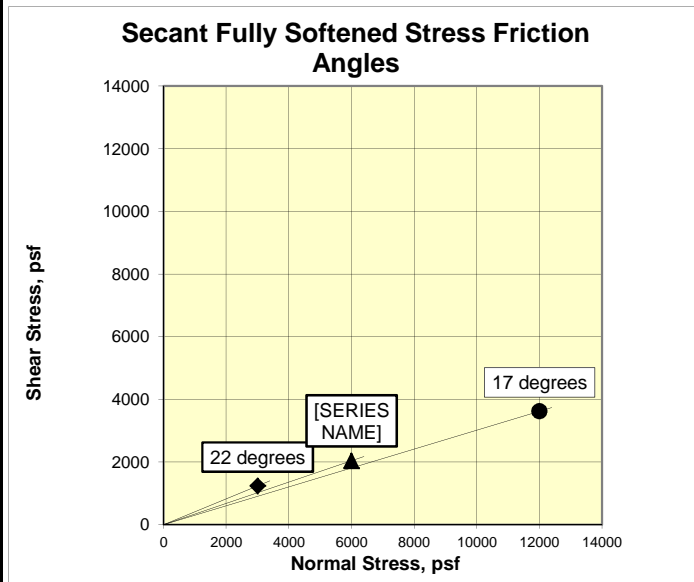
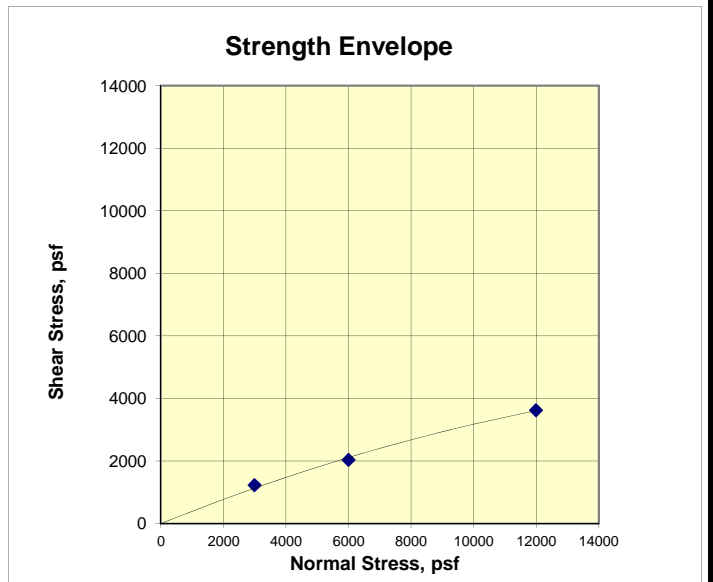
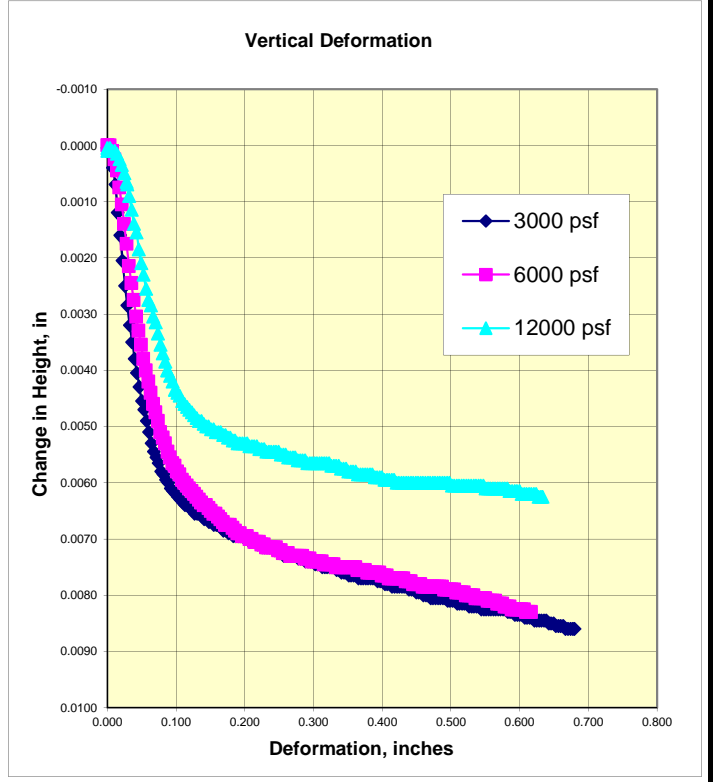
## Drained Fully Softened Torsional Shear Strength (ASTM D7608)

<b>BGL Job No.:</b> 040-002	<b>Boring:</b> BA-2	<b>Date:</b> 5/28/2019	<b>Clay, %:</b>
<b>Client:</b> LGC Geotechnical	<b>Sample:</b> GB-2	<b>By:</b> PJ	<b>LL:</b> 77.9
<b>Project Name:</b> El Toro	<b>Depth (ft):</b> 59.5	<b>Checked:</b> PJ	<b>PL:</b> 32.2
<b>Project Number:</b> 18184-01	<b>Test Type:</b> Reconstituted Fully Softened	<b>Sample Preparation:</b> <#40	
<b>Soil Type:</b> Dark Greenish Gray Fat CLAY			<b>Remarks:</b>
<b>Normal Stress, psf</b>	3000	6000	12000
<b>Secant Phi, deg.:</b>	22	19	17

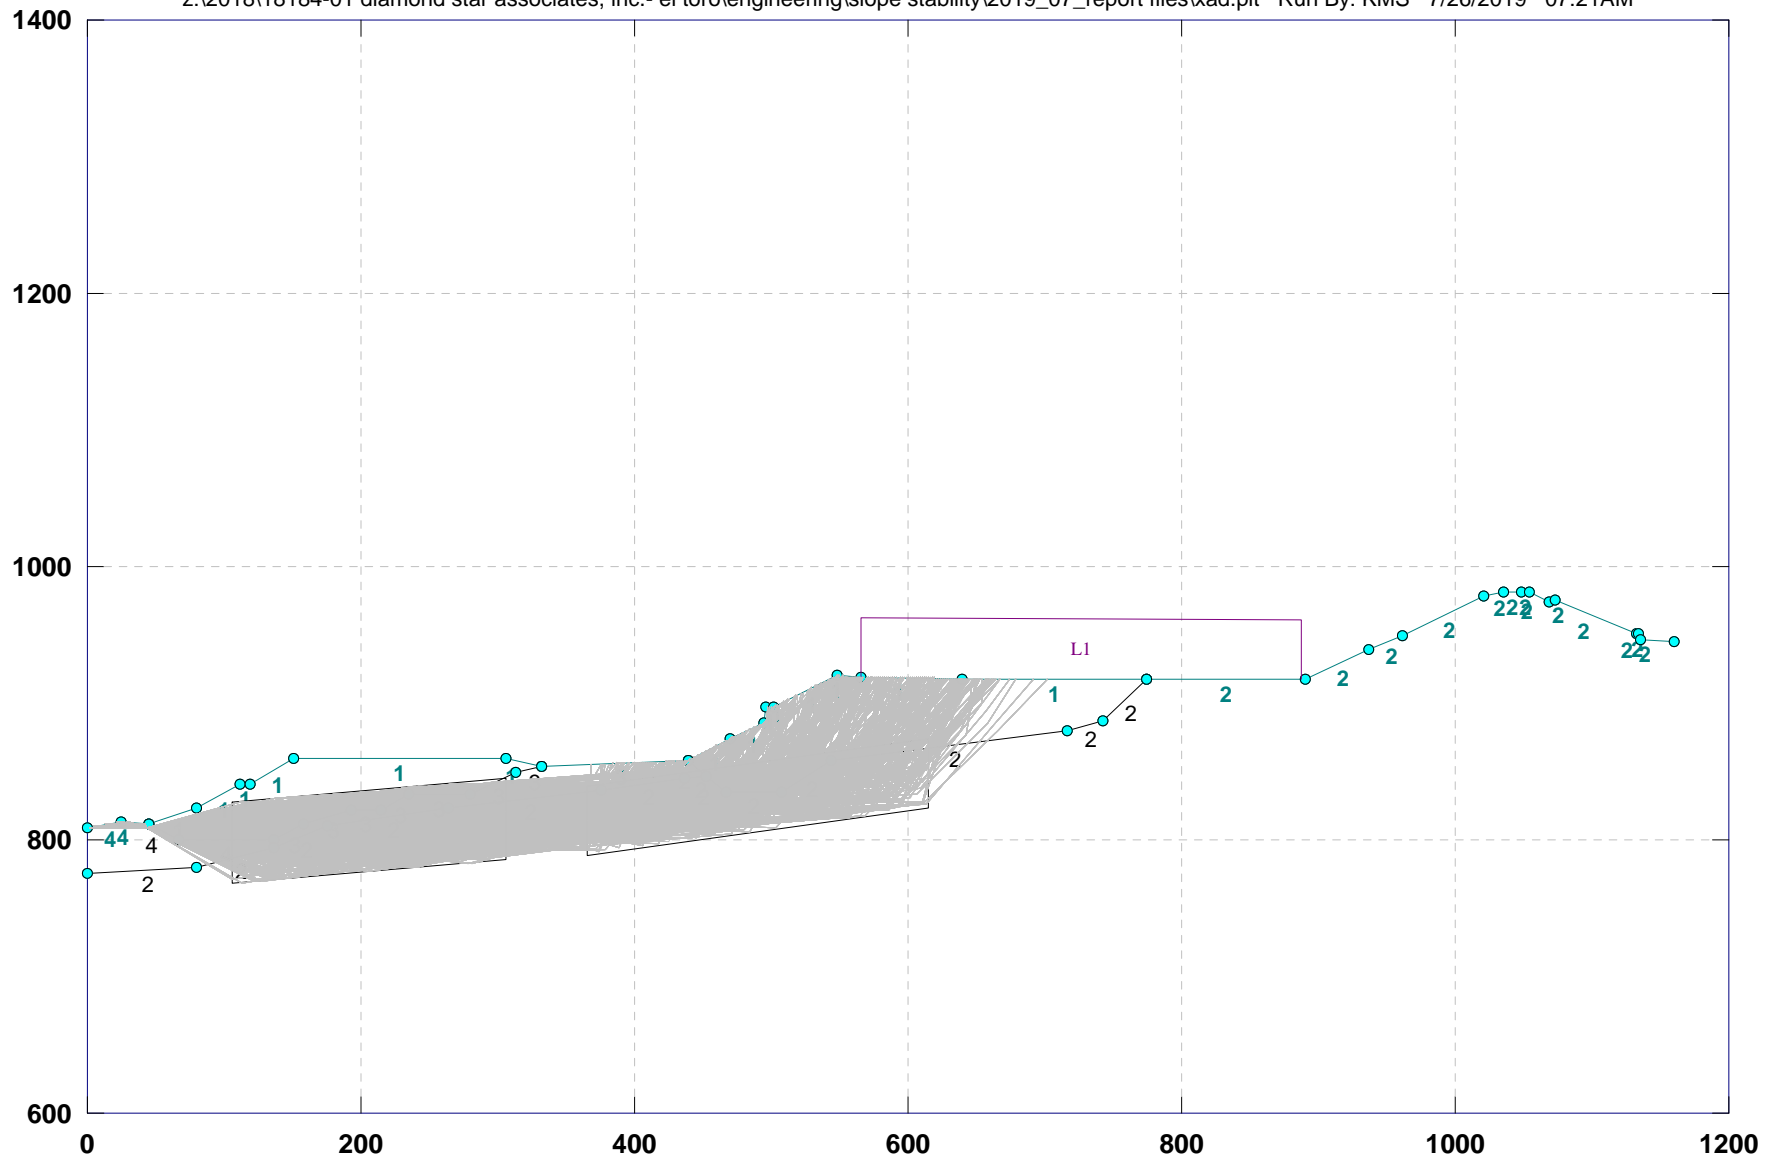
# 18184-01 / A-A' / Design /

GSTABL7 v.2 FSmin=2.14

Safety Factors Are Calculated By The Simplified Janbu Method for the case of c & phi both > 0

Slope stability analyses were performed on cross-sections positioned throughout the site based on the proposed design profile. Slope stability analysis was performed using the computer program GSTABL7 with STEDwin version 2.005.3 (Gregory Geotechnical Software, 2013). Potential rotational and block surfaces were analyzed using Bishop’s Modified Method and Janbu’s Simplified Method, respectively. A minimum factor of safety of 1.5 is typically required for static loading conditions. Seismic slope stability analysis was performed in accordance with the City of Mission Viejo Grading Manual (2010). Where applicable, the Grading Manual requires a horizontal seismic coefficient ( $K_h$ ) of 0.15 with a minimum resulting factor of safety of 1.1. Since the landslide rupture plane is less than 12 degrees from the horizontal, pseudostatic (seismic) slope stability was not performed for the onsite landslides in accordance with City of Mission Viejo Grading Manual.

Based on the proposed grading plan, slope stability analysis indicates a global factor of safety greater than 1.5 and 1.1 for static and pseudo-static (seismic) loading conditions, respectively. Slope stability analysis is provided in Appendix D.
